APPENDIX B:
Corridor Photographs

CROSSINGS ALONG REACH A (Upper Mumford River)

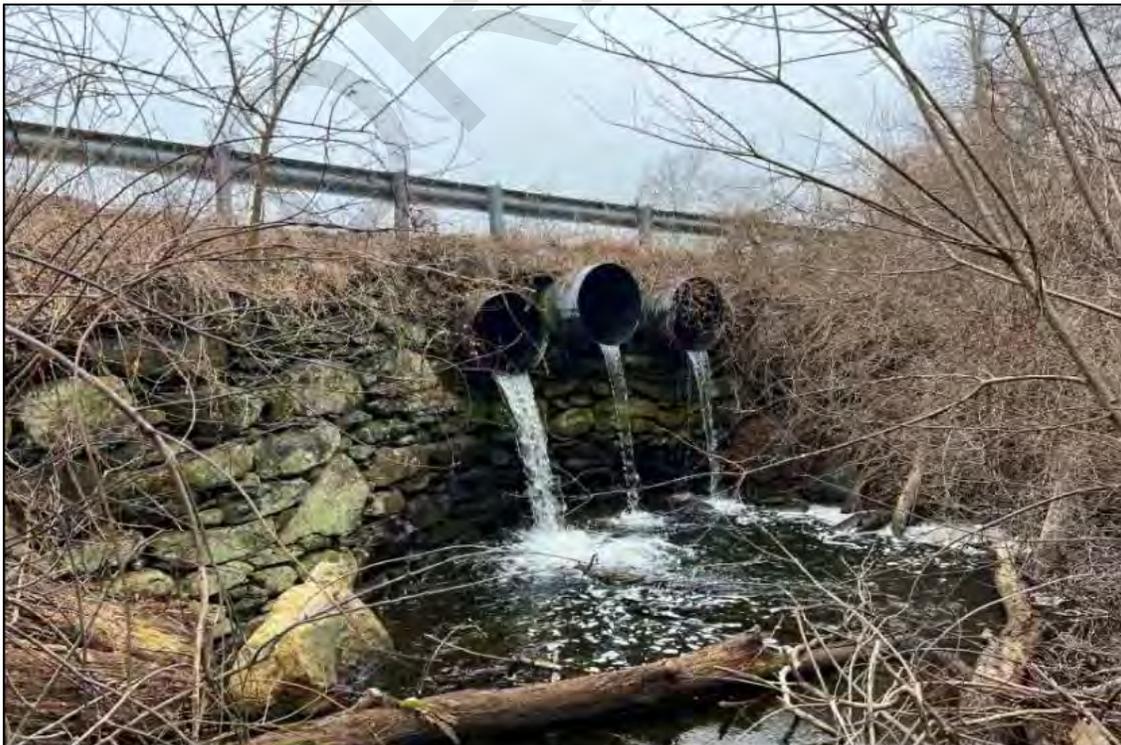
Photo No. 2.: Reach_A_#3 – Overview of the Number One Pond Dam (Town Farm Road) from downstream. (2022 Follow-up inspection – Tighe & Bond)

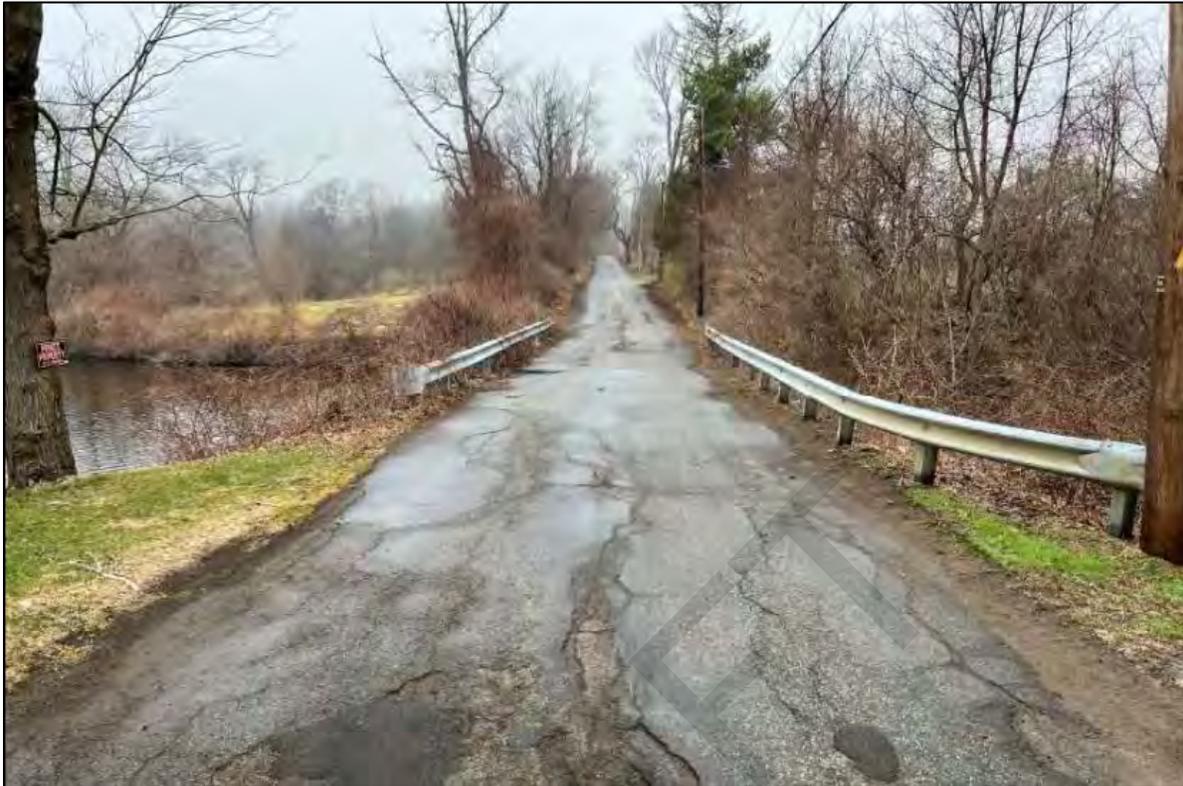
Photo No. 3.: Reach_A_#3 - Overview of Number One Pond Dam's crest, Town Farm Road, from the right abutment (2022 Follow-up inspection).

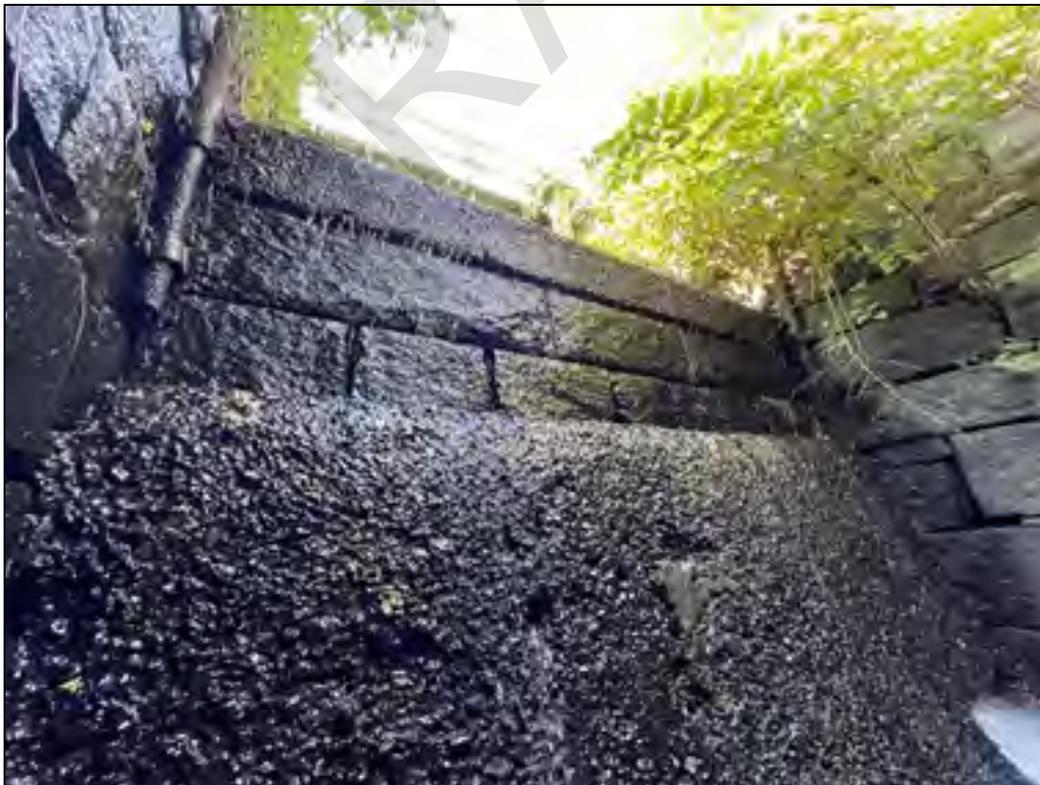
Photo No. 20.: Reach_A_#11.2 - Stevens Pond Dam's spillway. Note the LLO discharging at the base of the spillway (photo bottom right).

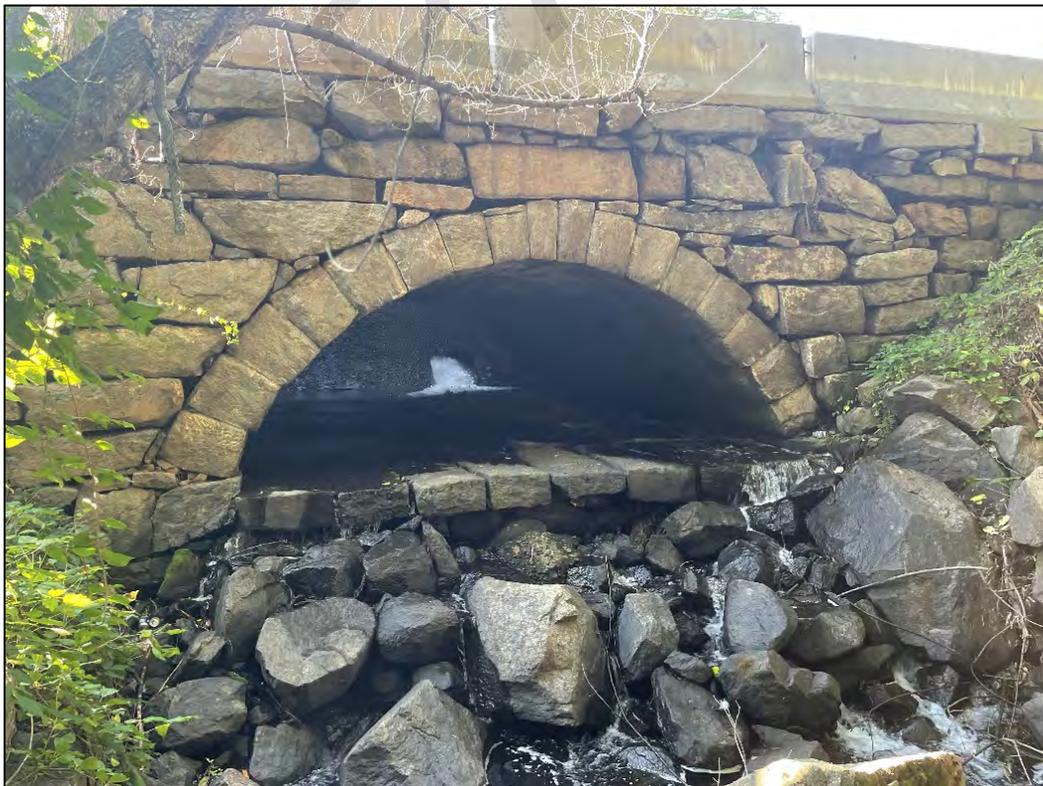
Photo No. 22.: Reach_A_#11.2 – View of the stone arch culvert of the Manchaug Road crossing downstream of Stevens Pond Dam.

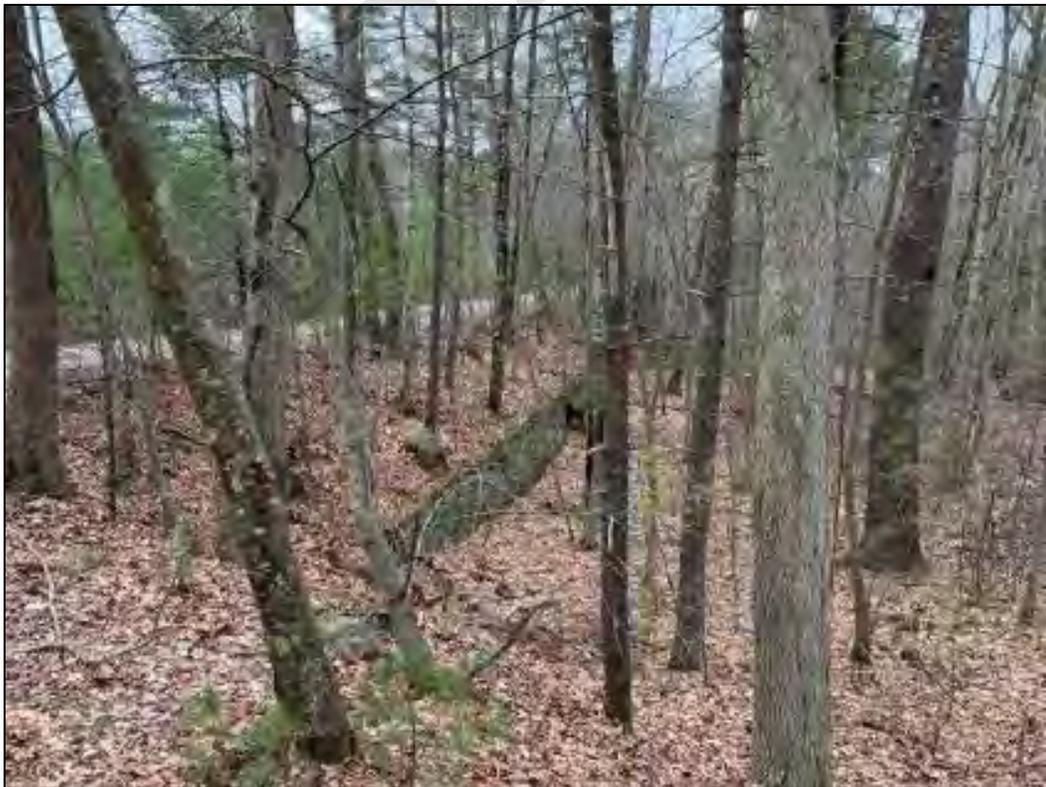
Photo No. 30.: Reach_B_#11.2 - Overview of the UTP South Dam (Cote Lane) embankment. (2022 Phase I Inspection – Tighe & Bond)

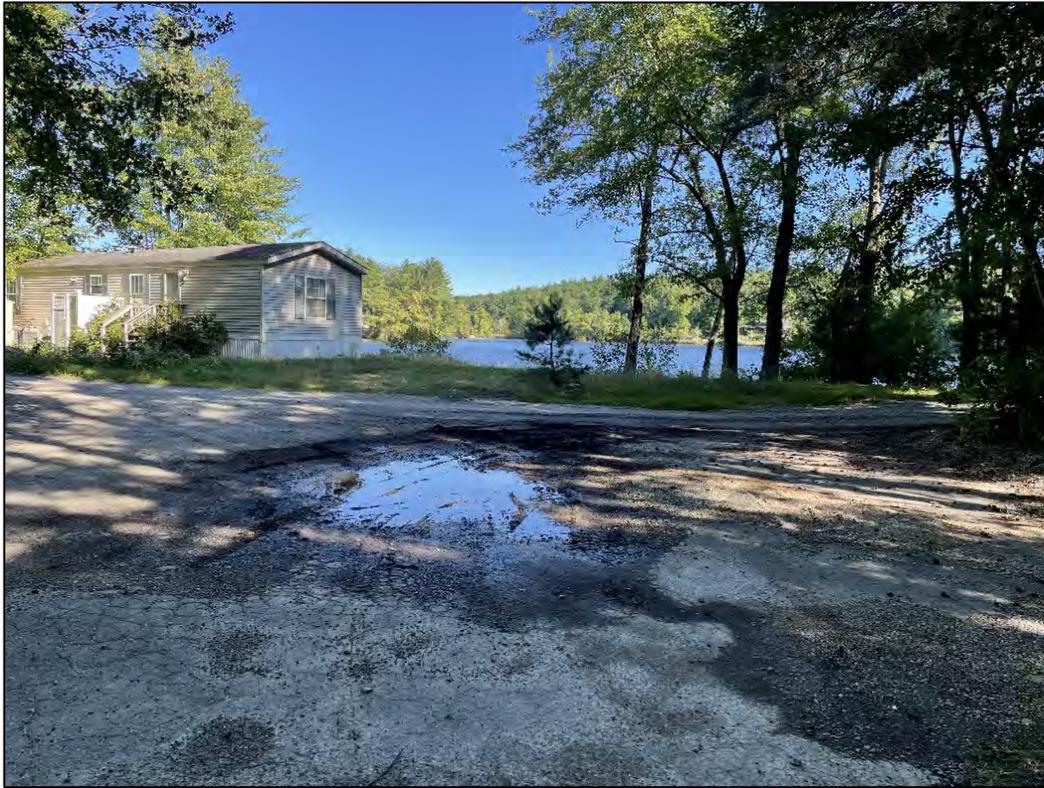
Photo No. 31.: Reach_B_#11.2 - Low right abutment area of the UTP South Dam (Cote Lane).

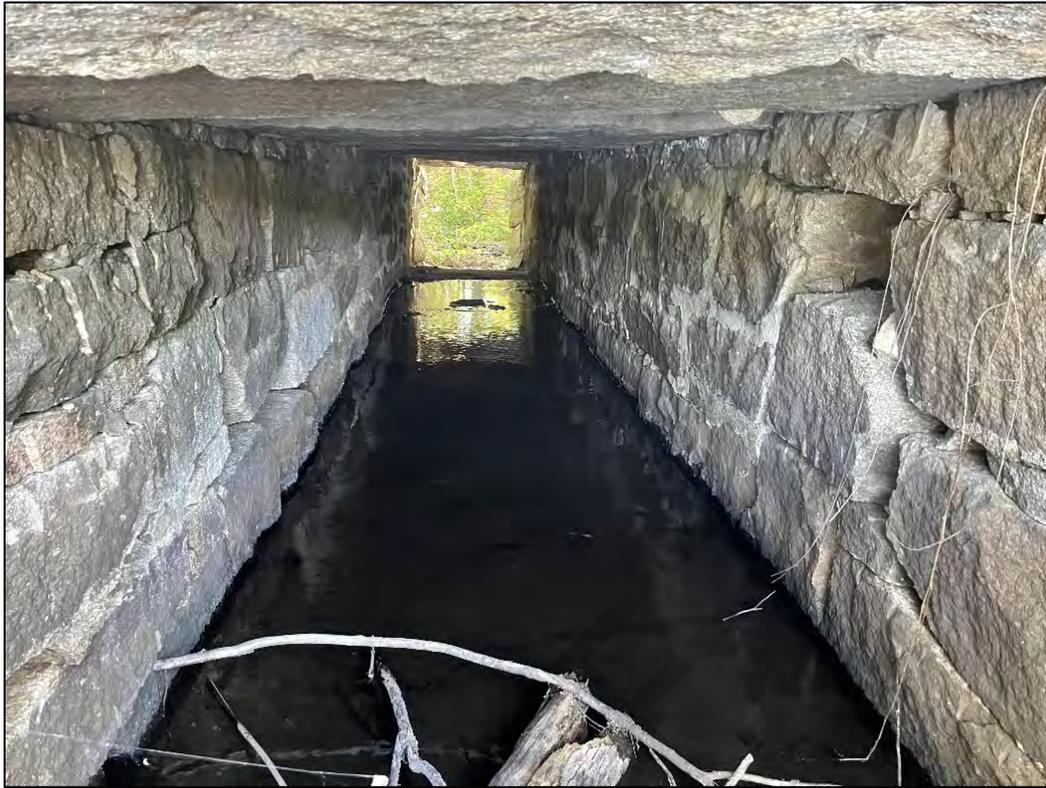
Photo No. 33.: Reach_B_#11.3 – Interior of the Putnam Hill Road culvert downstream of the UTP East Dam spillway controls.

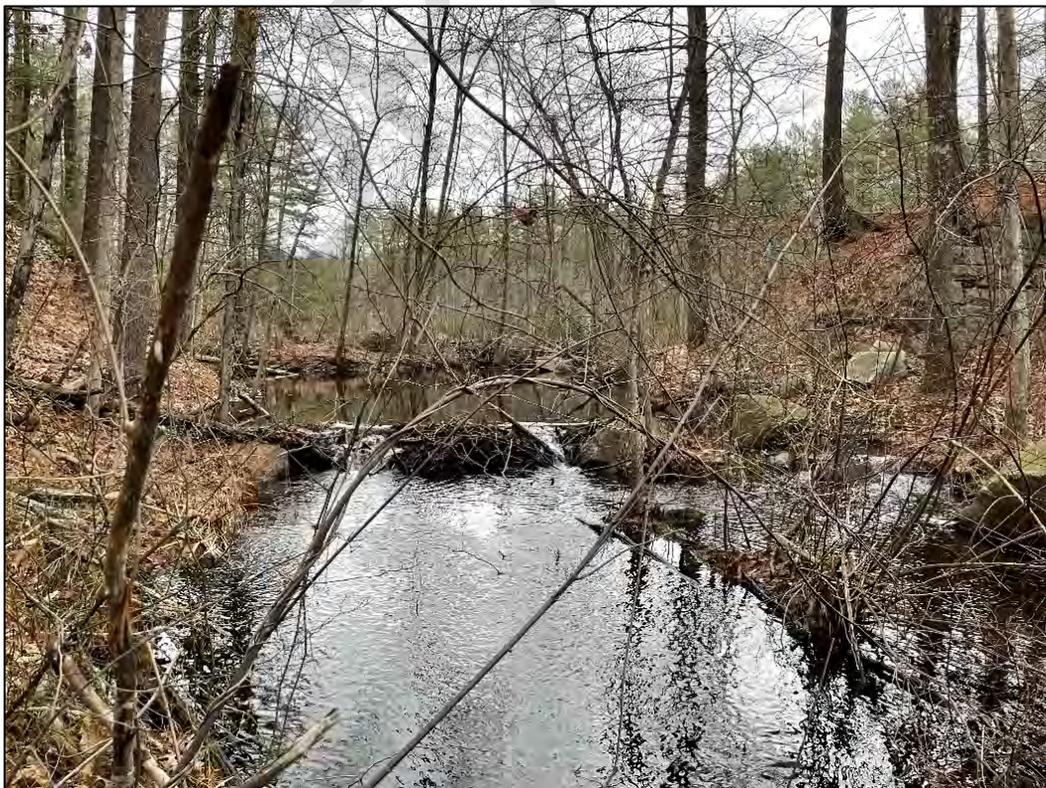
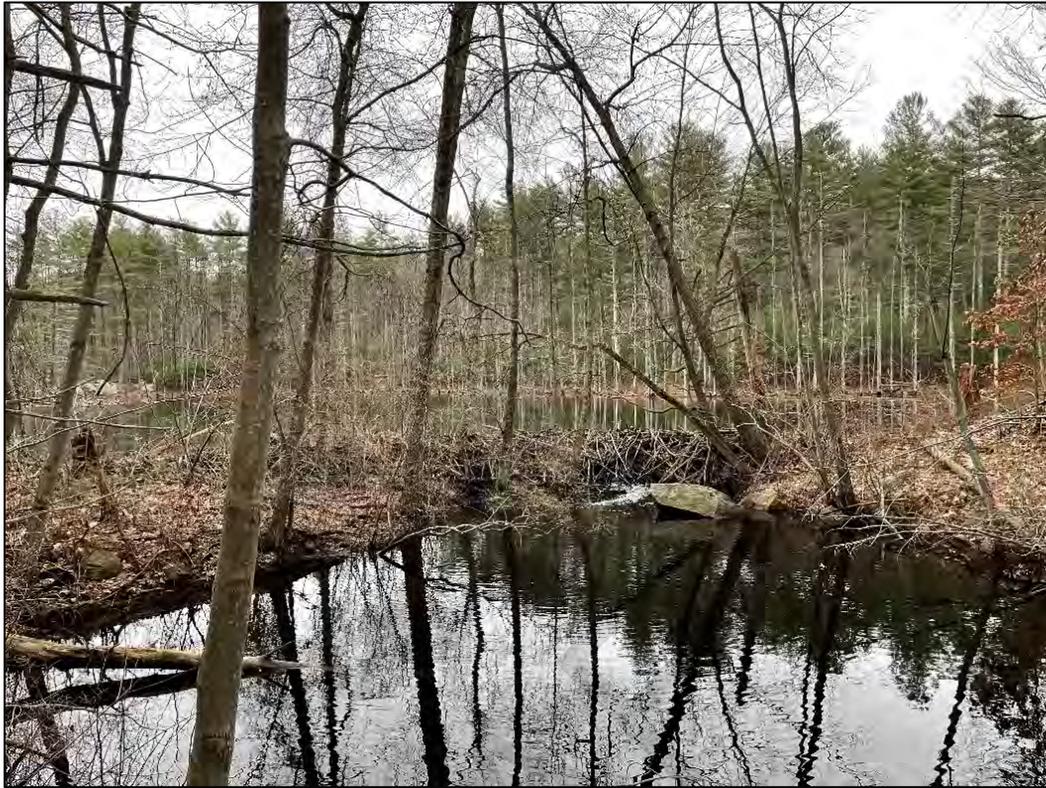
Photo No. 34.: Reach_B_#12 - Former Upper Tucker Pond Dam / Current Beaver Dam.

Photo No. 35.: Reach_B_#12 - Former Upper Tucker Pond Dam / Current Beaver Dam

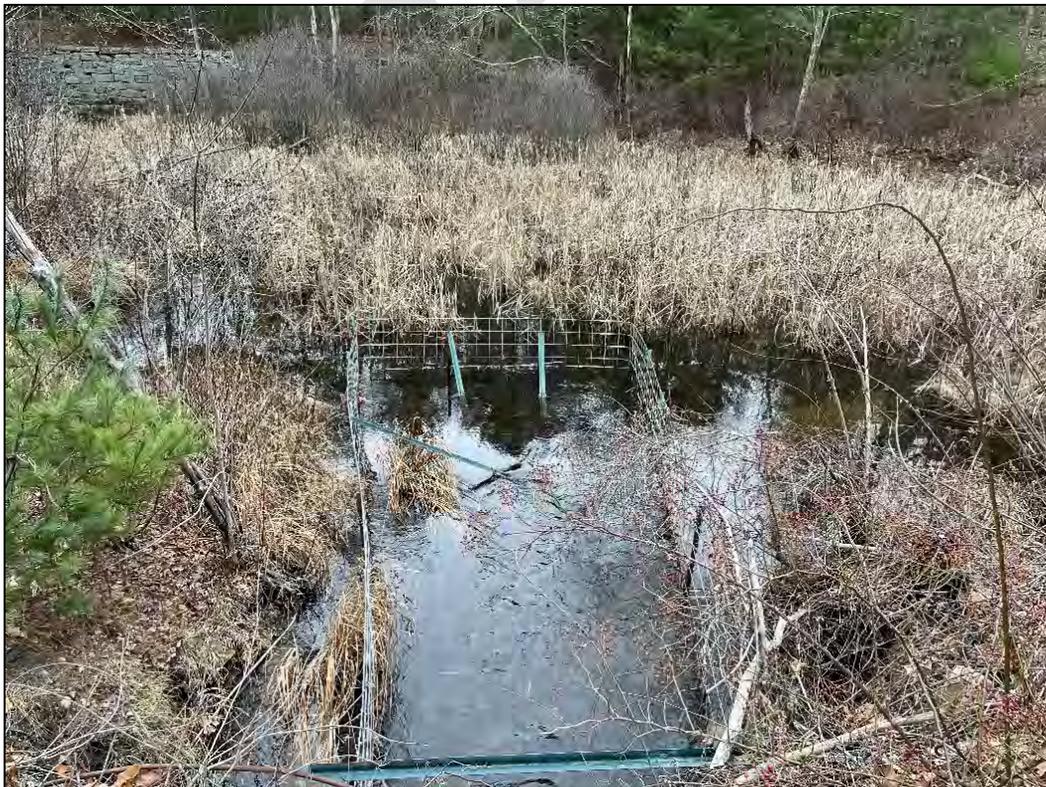
Photo No. 36.: Reach_B_#13 – Beaver deceiver installed upstream of the Putnam Hill Road culvert.

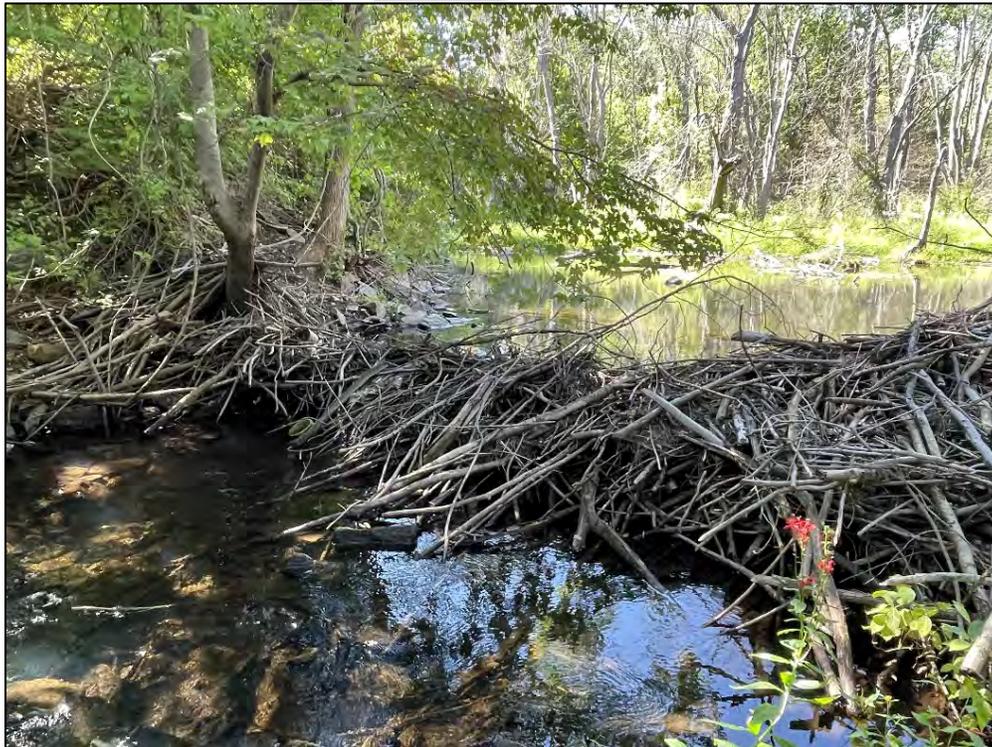
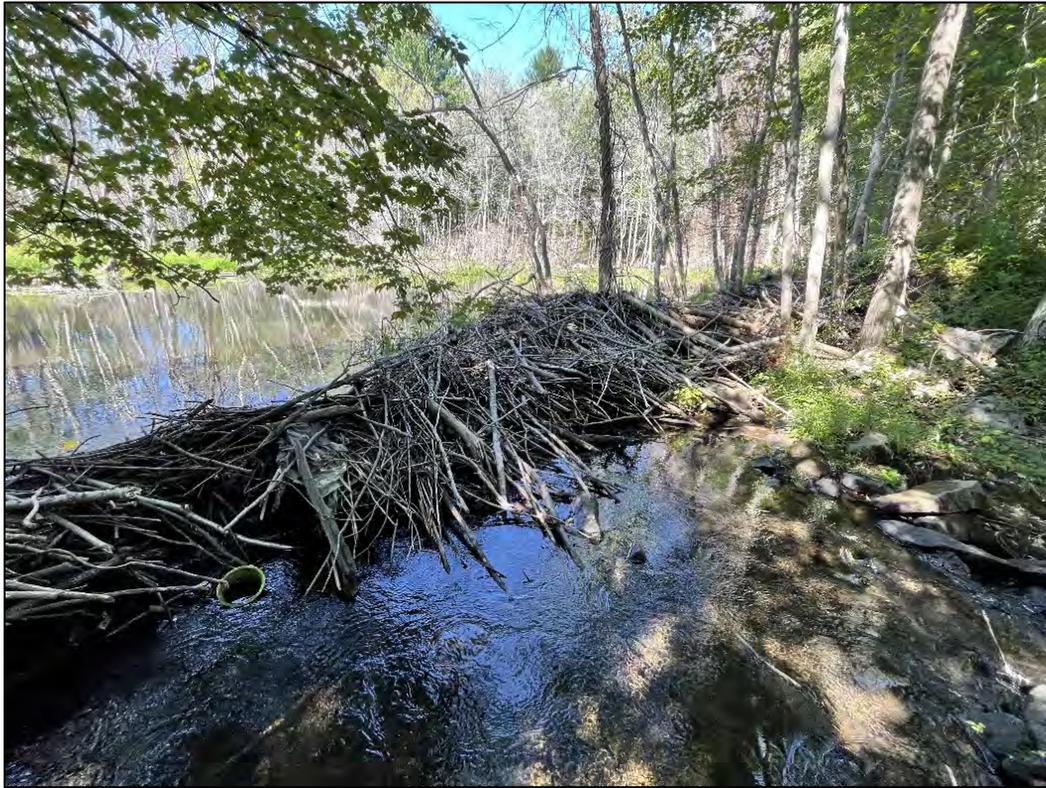
Photo No. 38.: Reach_C_#1 - Former Lower Tucker Pond Dam / Current Beaver Dam

Photo No. 39.: Reach_C_#1 - Former Lower Tucker Pond Dam / Current Beaver Dam

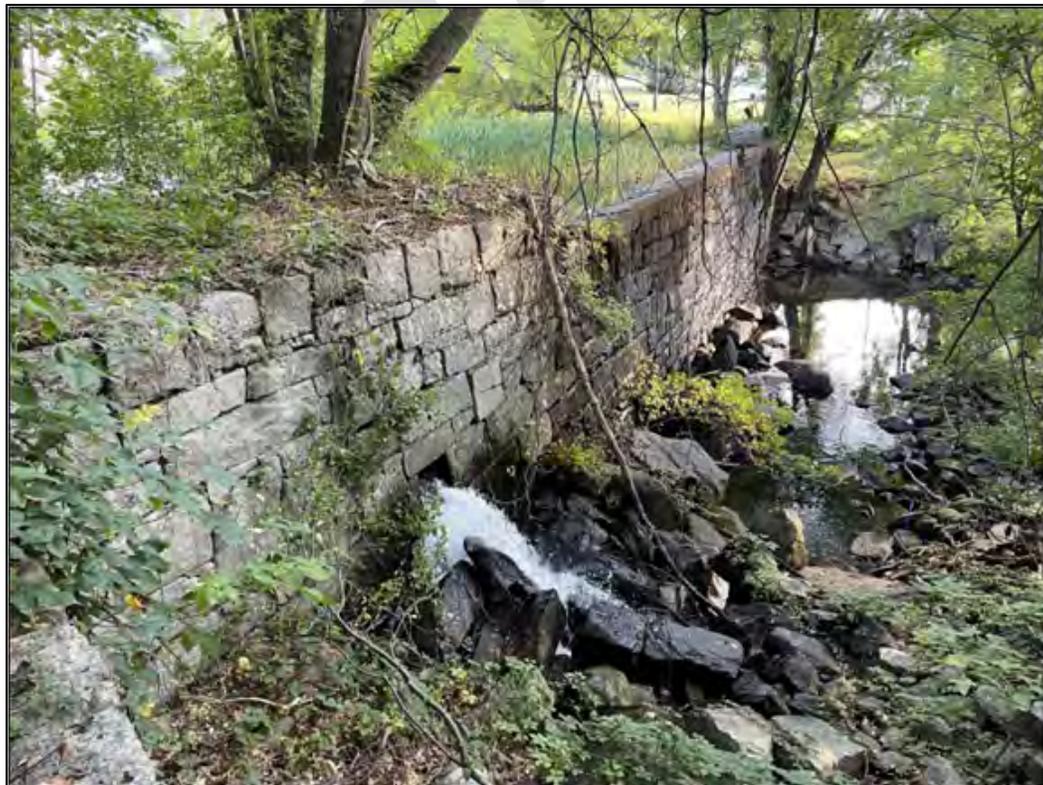
Photo No. 44.: Reach_C_#3 - Mill Pond Dam No.1 downstream face.

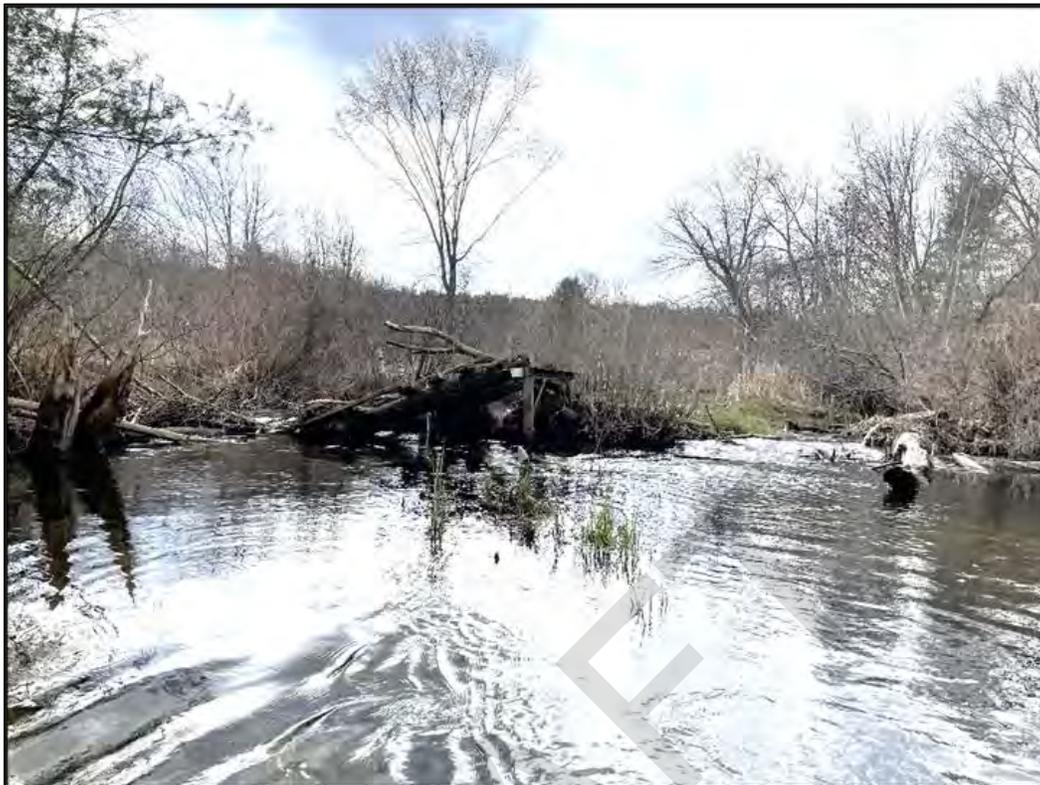
Photo No. 49.: Reach_C_ Beaver/Debris Location #10 – Construction debris along the Mumford River.

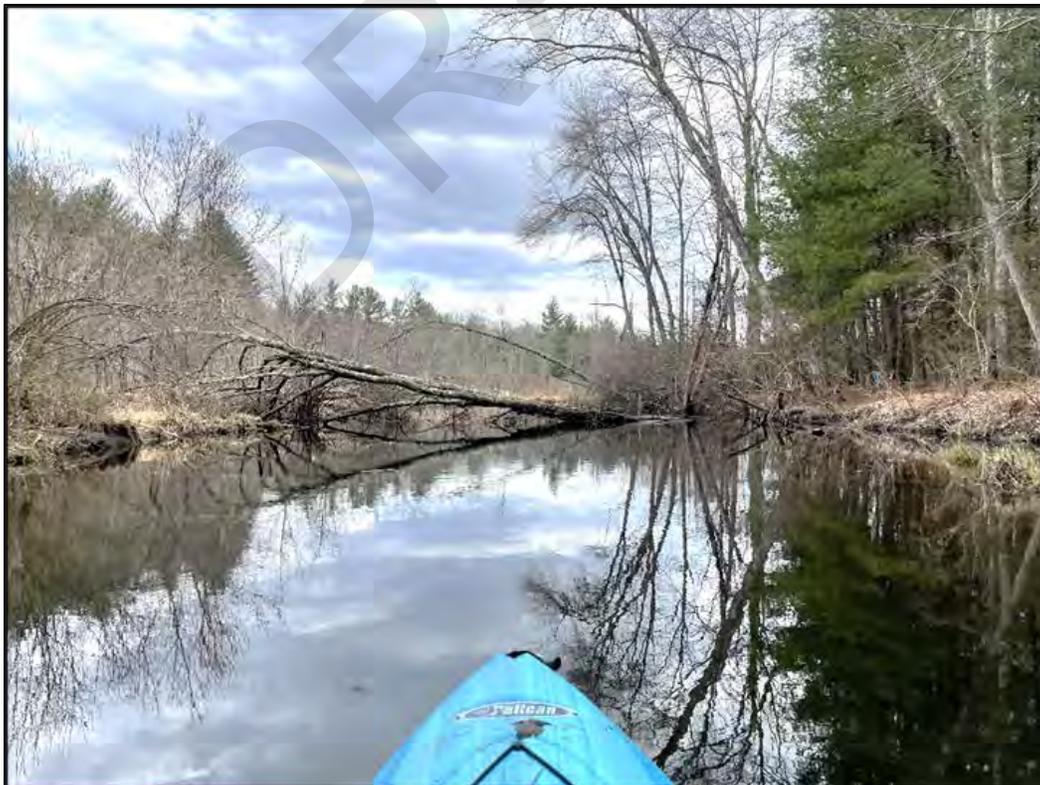
Photo No. 50.: Reach_C_ Beaver/Debris Location #11 – Fallen trees block a section of the Mumford River.

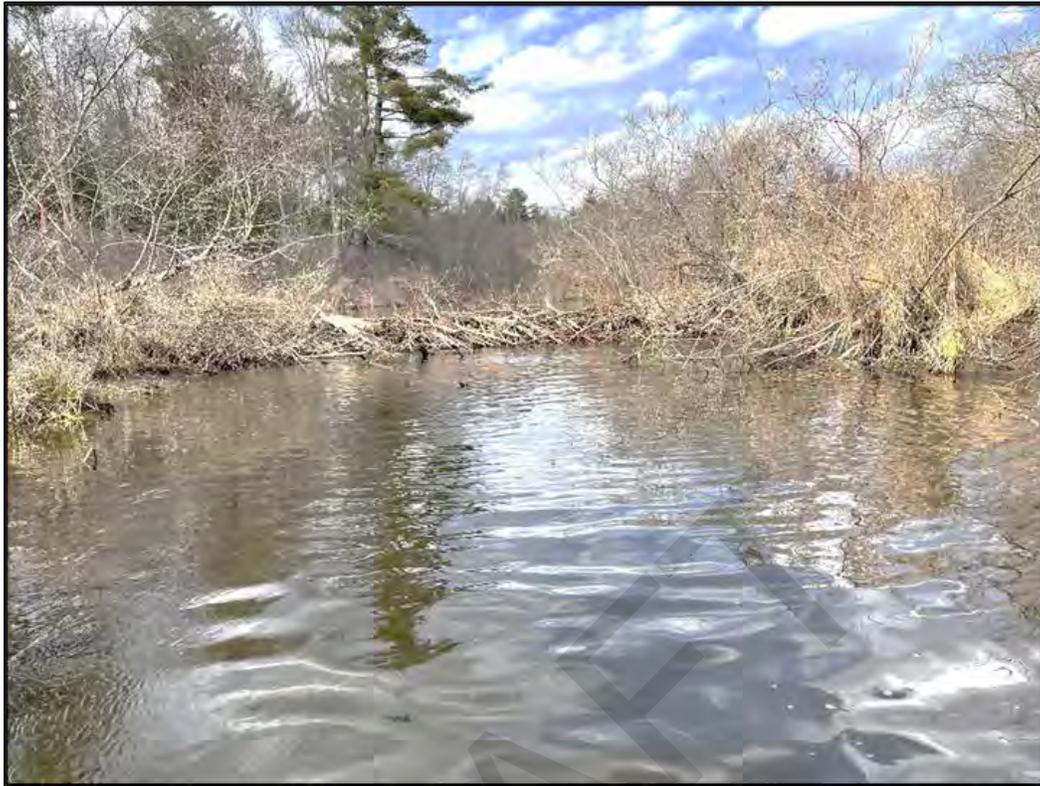
Photo No. 51.: Reach_C_ Beaver/Debris Location#12 – Beaver Dam along the Mumford River that creates a 2' head differential.

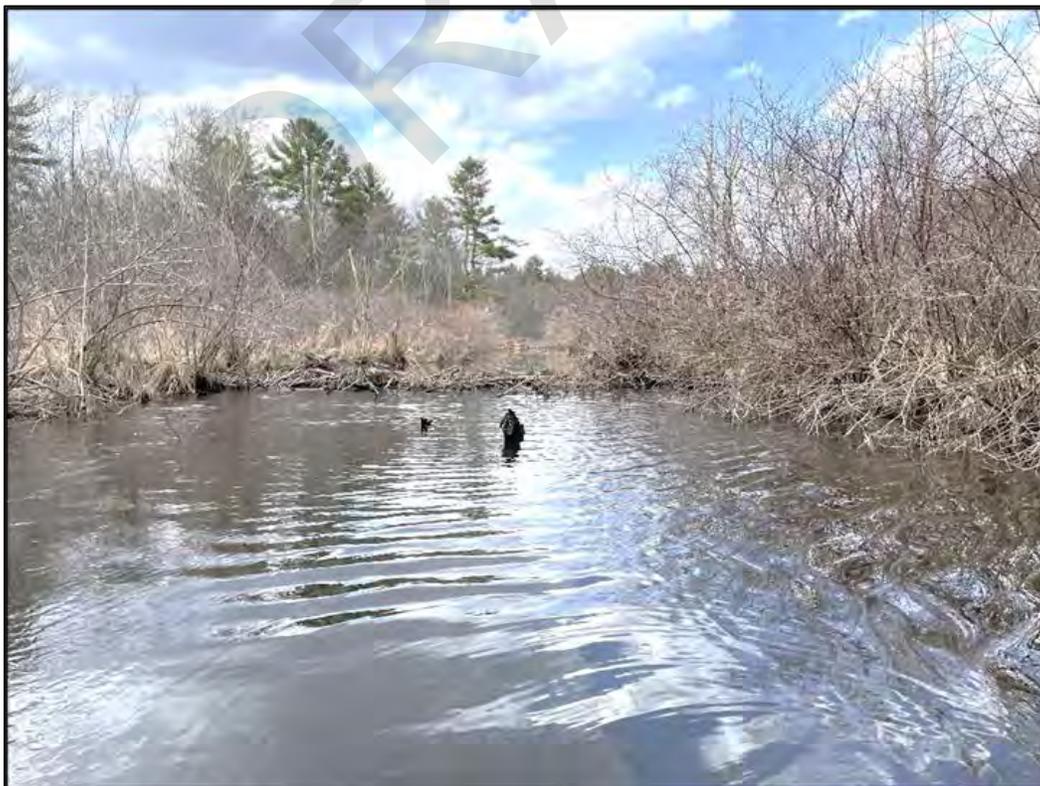
Photo No. 52.: Reach_C_ Beaver/Debris Location #13 – A second beaver dam located along the Mumford River, approximately 100 feet downstream of the beaver dam shown in the previous photo (No. 51).

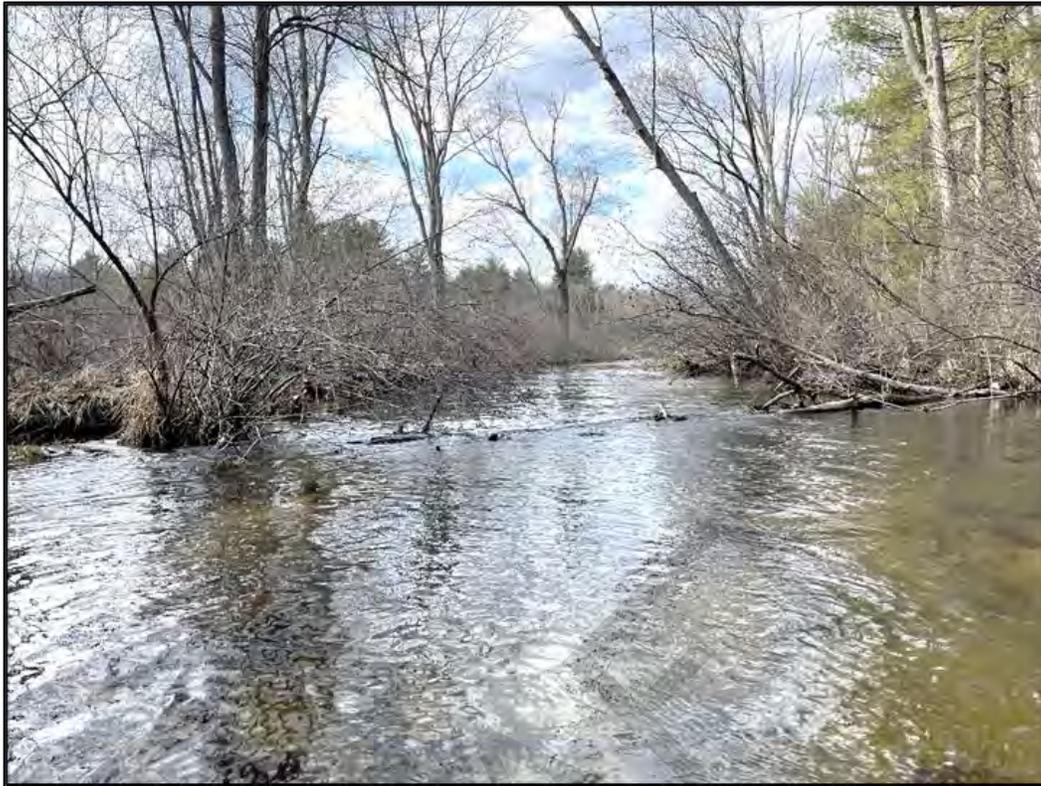
Photo No. 53.: Reach_C_ Beaver/Debris Location #14 – Tree Debris along the Mumford River.

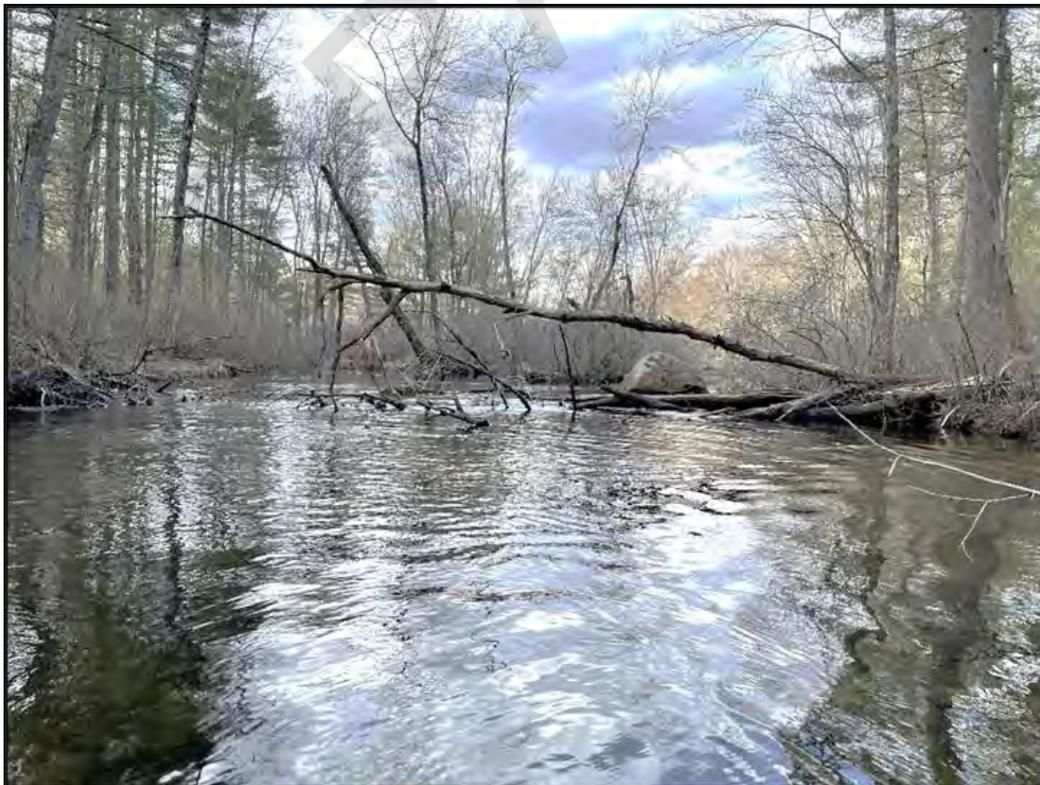
Photo No. 54.: Reach_C_ Beaver/Debris Location #15 – Tree debris along the Mumford River.

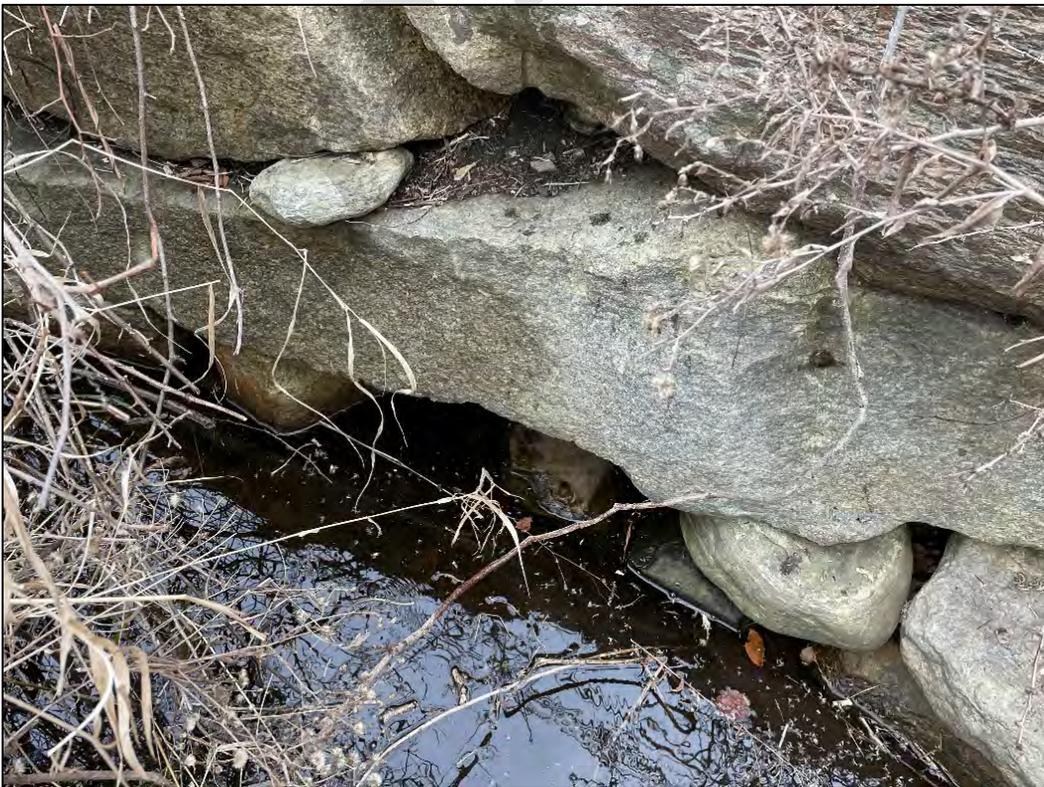
Photo No. 56.: Reach_C_#5.2 - Whitin Road west "culvert" downstream view. No visible culvert; possibly fully collapsed

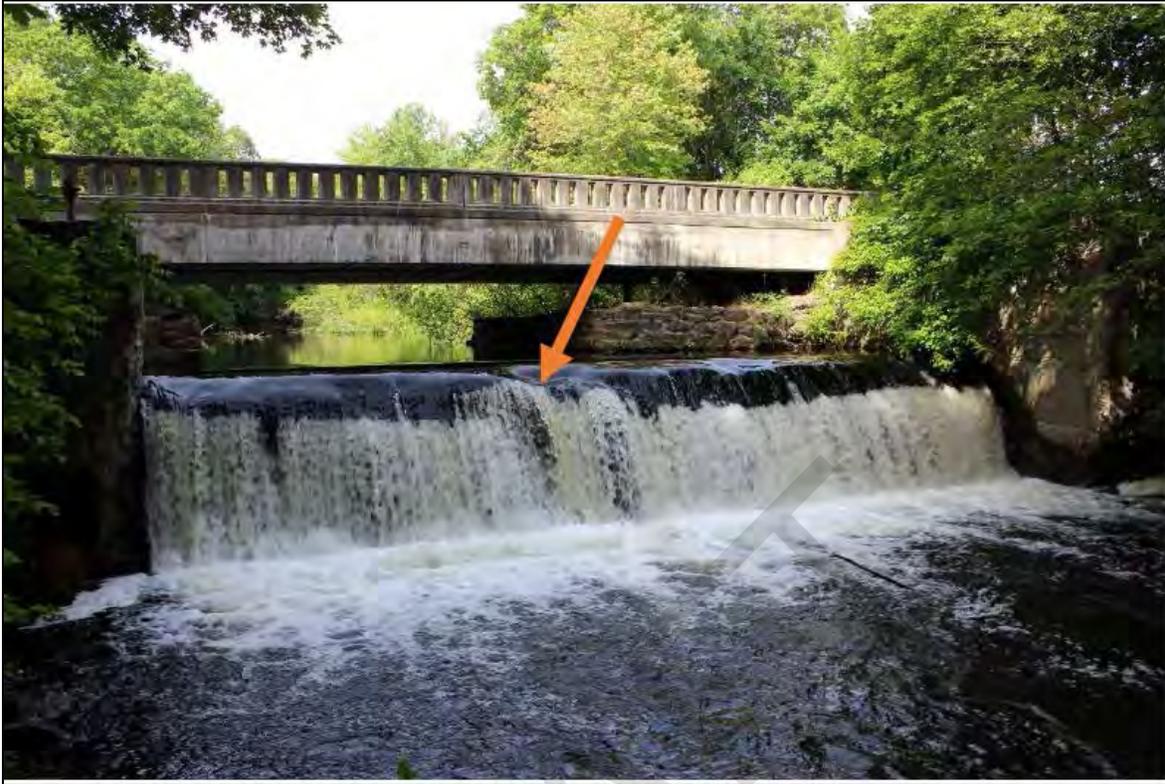
Photo No. 69.: Reach_D_#5 - Old Mill Pond Dam spillway (2021 Phase I - GZA)
