PREPARED FOR: TOWN OF SUTTON

MANCHAUG WATER RESOURCES RESILIENCY ACTION PLAN Sutton, Massachusetts

PREPARED BY:
PARE CORPORATION
10 LINCOLN ROAD, SUITE 210
FOXBORO, MASSACHUSETTS 02035
PARE PROJECT NUMBER 22153.00

DRAFT Report – May 2023

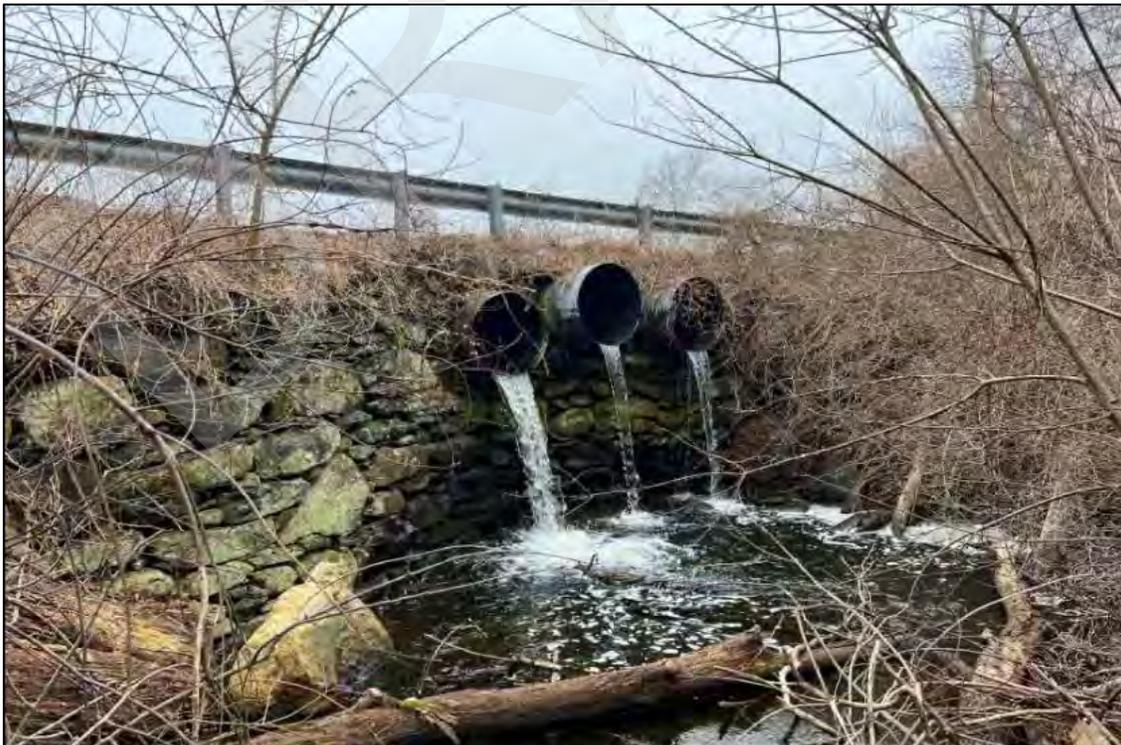
Photo No. 2.: Reach_A_#3 – Overview of the Number One Pond Dam (Town Farm Road) from downstream. (2022 Follow-up inspection – Tighe & Bond)

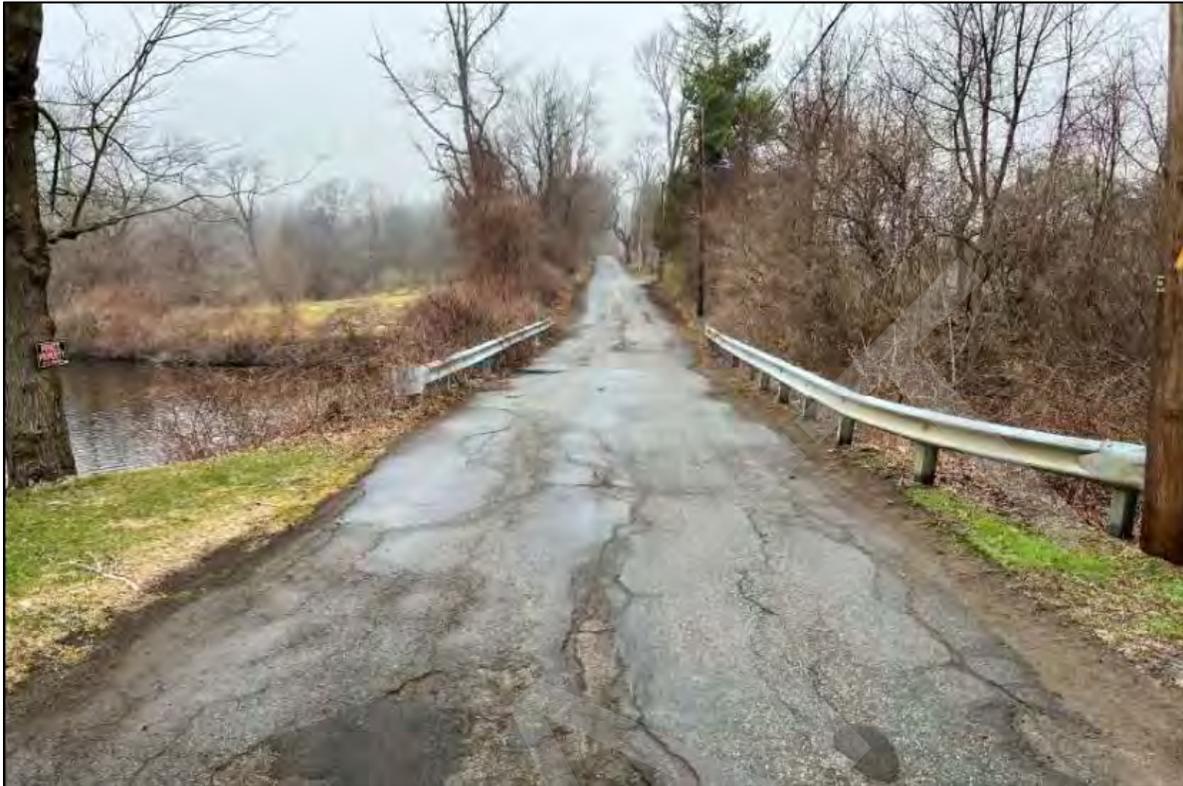
Photo No. 3.: Reach_A_#3 - Overview of Number One Pond Dam's crest, Town Farm Road, from the right abutment (2022 Follow-up inspection).

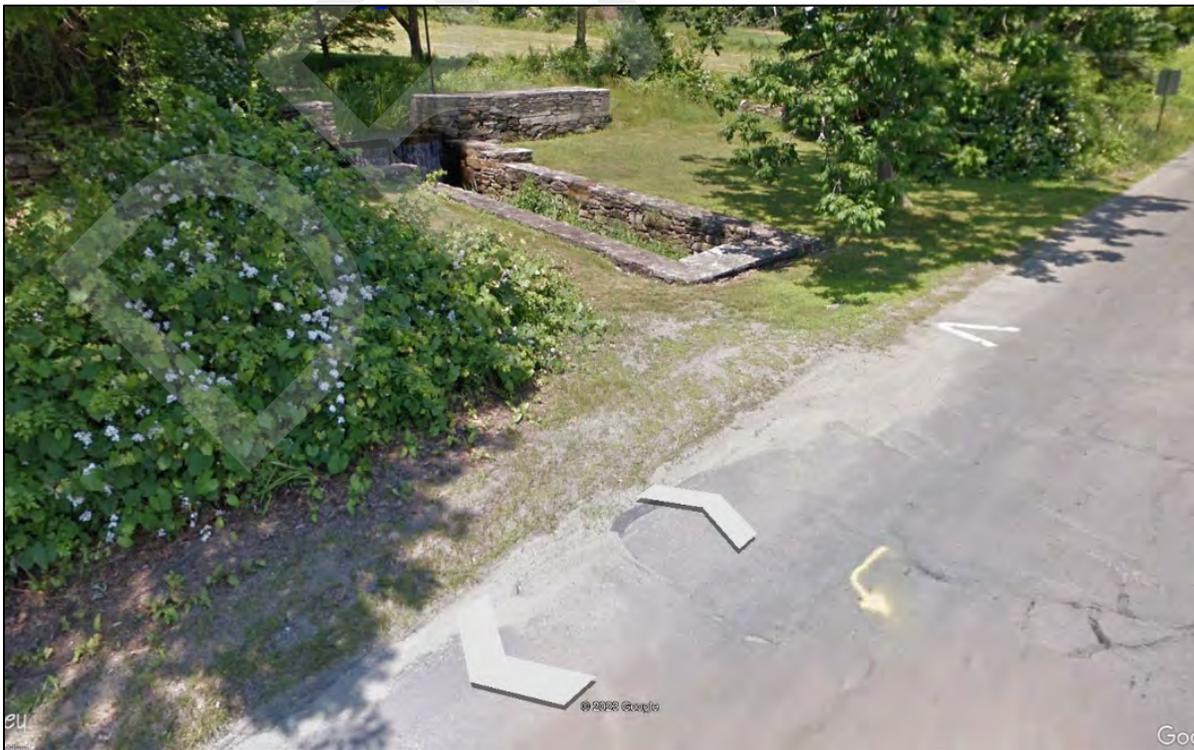
Photo No. 4.: Reach_A_#4 - West Sutton Road apparent dam upstream of the road crossing (Google Earth).

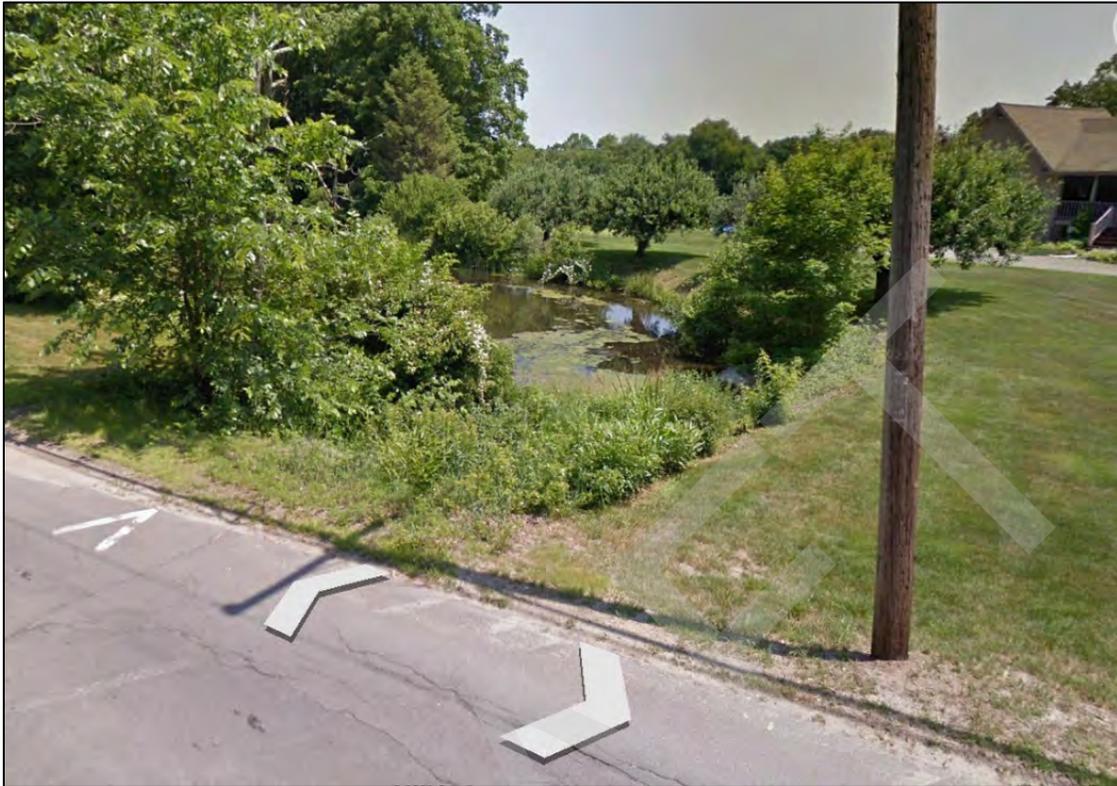
Photo No. 5.: Reach_A_#4 – Channel downstream of West Sutton Road (Google Earth)

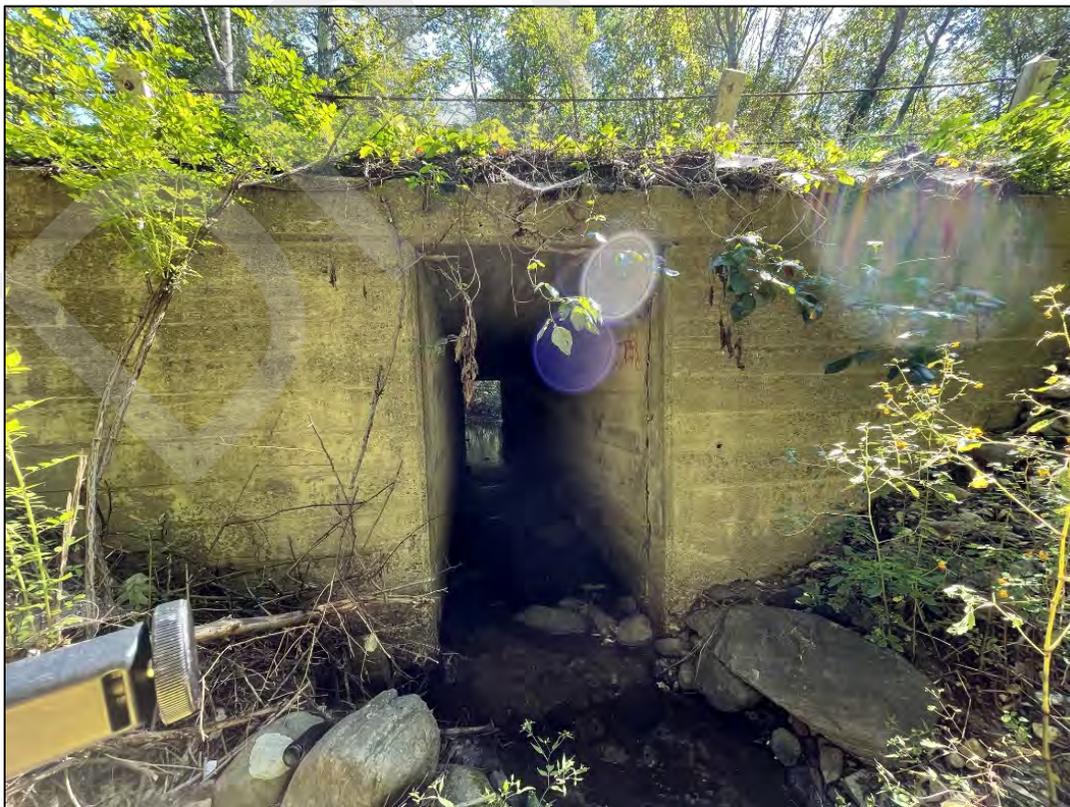
Photo No. 6.: Reach_A_#5 - Central Turnpike West Culvert upstream view.

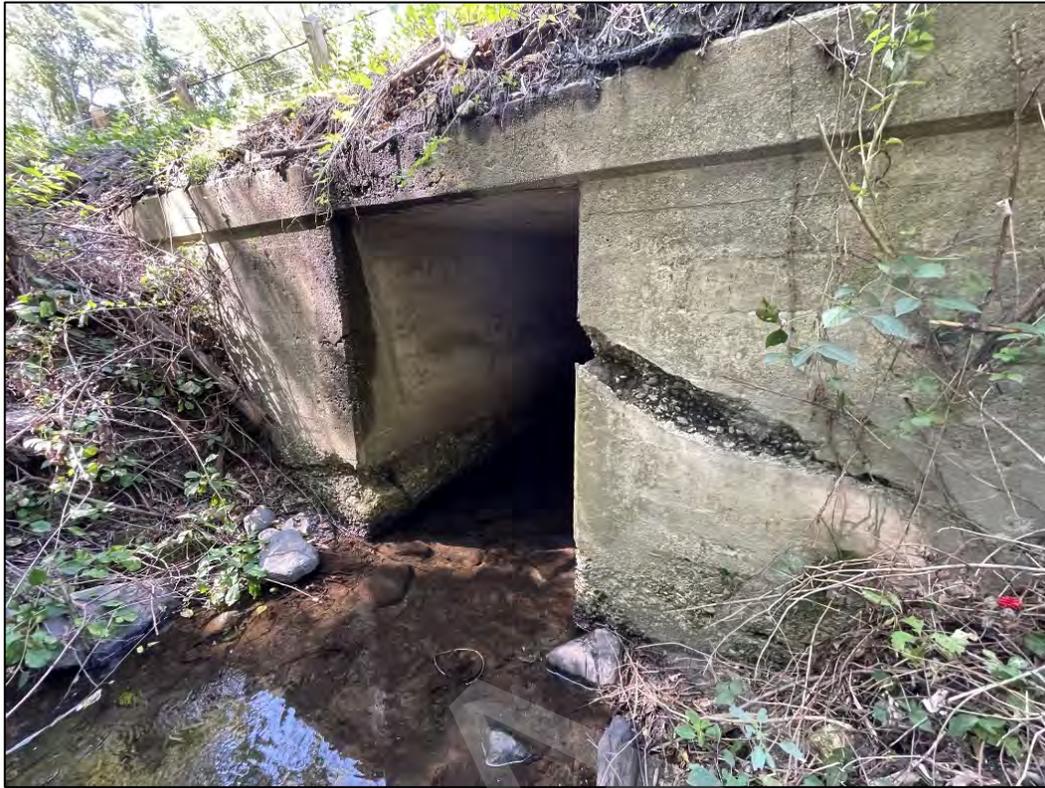
Photo No. 7.: Reach_A_#5 - Central Turnpike West culvert downstream face.

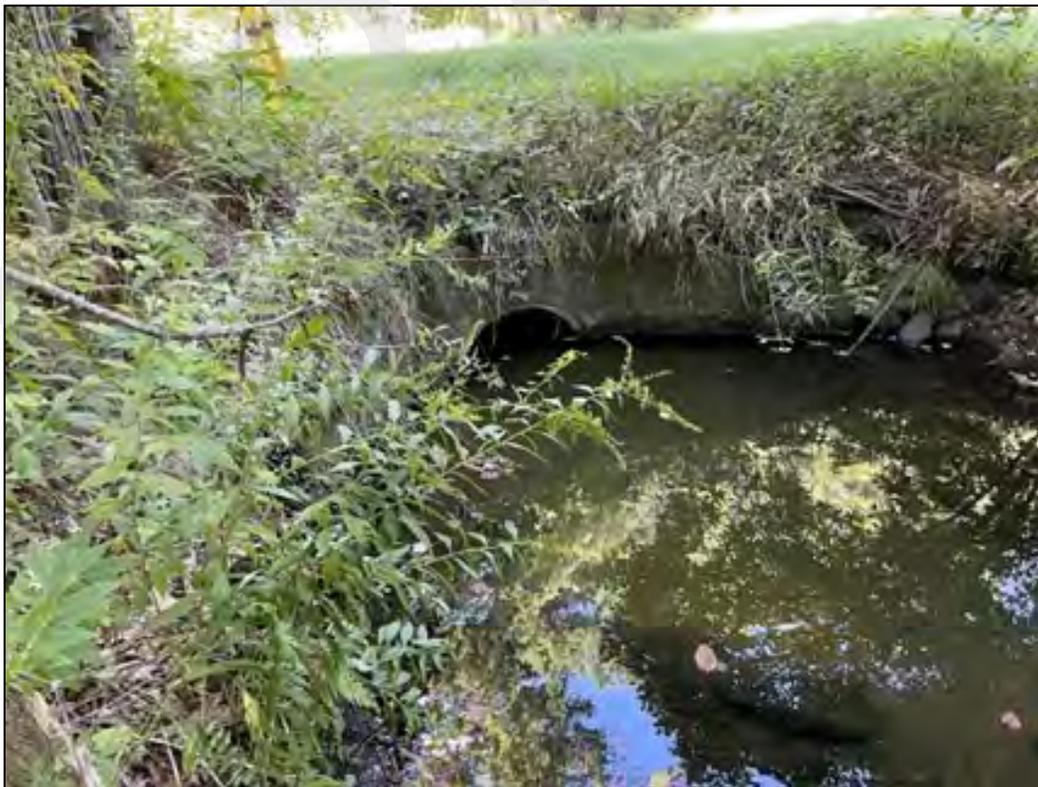
Photo No. 8.: Reach_A_#5.1 - Central Turnpike East culvert downstream face.

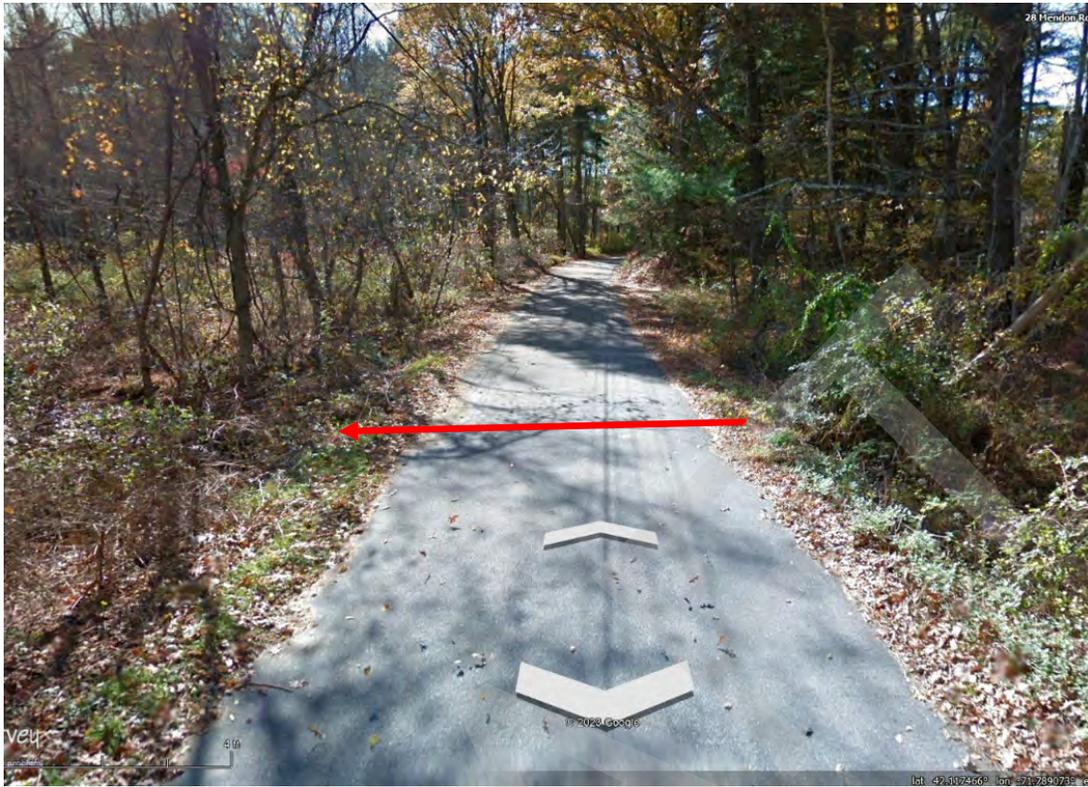
Photo No. 9.: Reach_A_ #6 – Mendon Road looking right; note approximate location of culvert crossing identified with red line (arrow pointing downstream). (Google Earth)

6*	1.4	+1	1.7	Mendon Road	4' high roadway embankment	Town	Crossing provides no attenuation; not modeled	-	-
7	1.6	+1	2.3	Manchaug Road	9' high roadway embankment with 6' CMP conduit	Town	Crossing provides some attenuation; Split flow condition upstream sends a portion of the flow to a second crossing located 1,400' southeast - 4' high embankment with 1.5' pipe; Capacity of main culvert is fine (100-yr), but capacity of east culvert is limited (5-yr)	5-yr	2-yr
8*	1.9	-	2.4	MA02899 Homes Pond Dam	7' high partially breached dam embankment	Private	Non-Jurisdictional Dam that appears to be partially breached; Likely no attenuation, not modeled	-	-

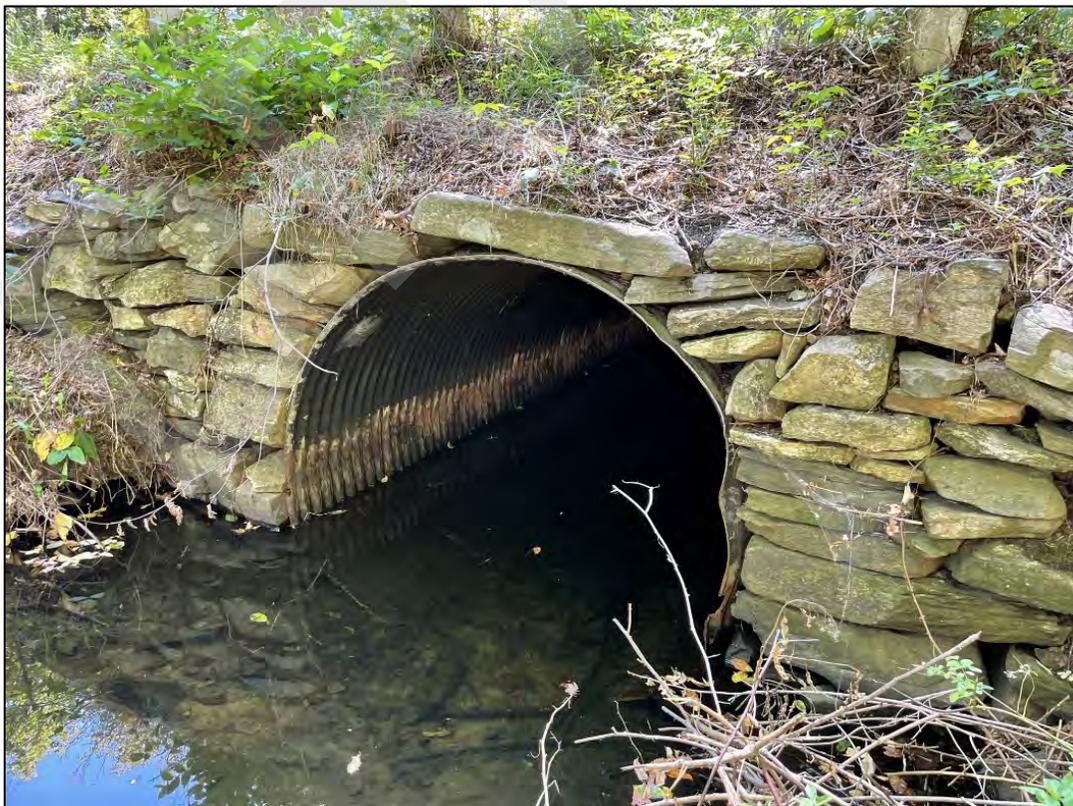
Photo No. 10.: Reach_A_ #7 - Manchaug Road main culvert, upstream view.

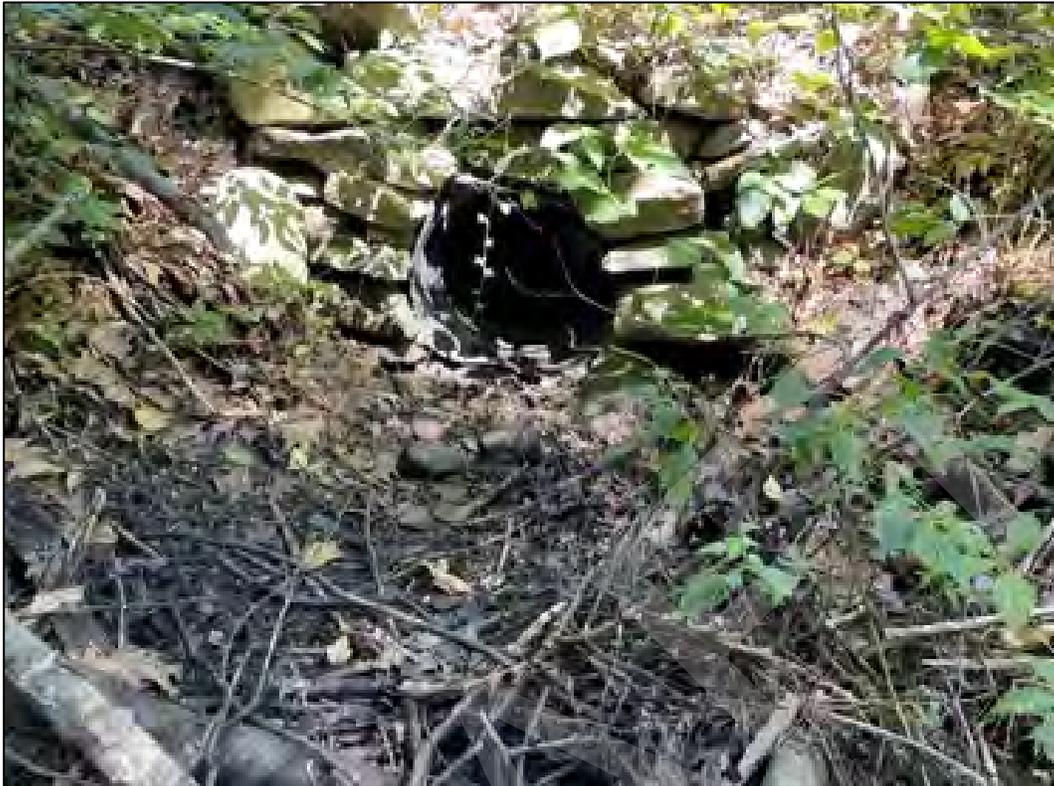
Photo No. 11.: Reach_A_#7.1 – Manchaug Road east culvert, downstream view.

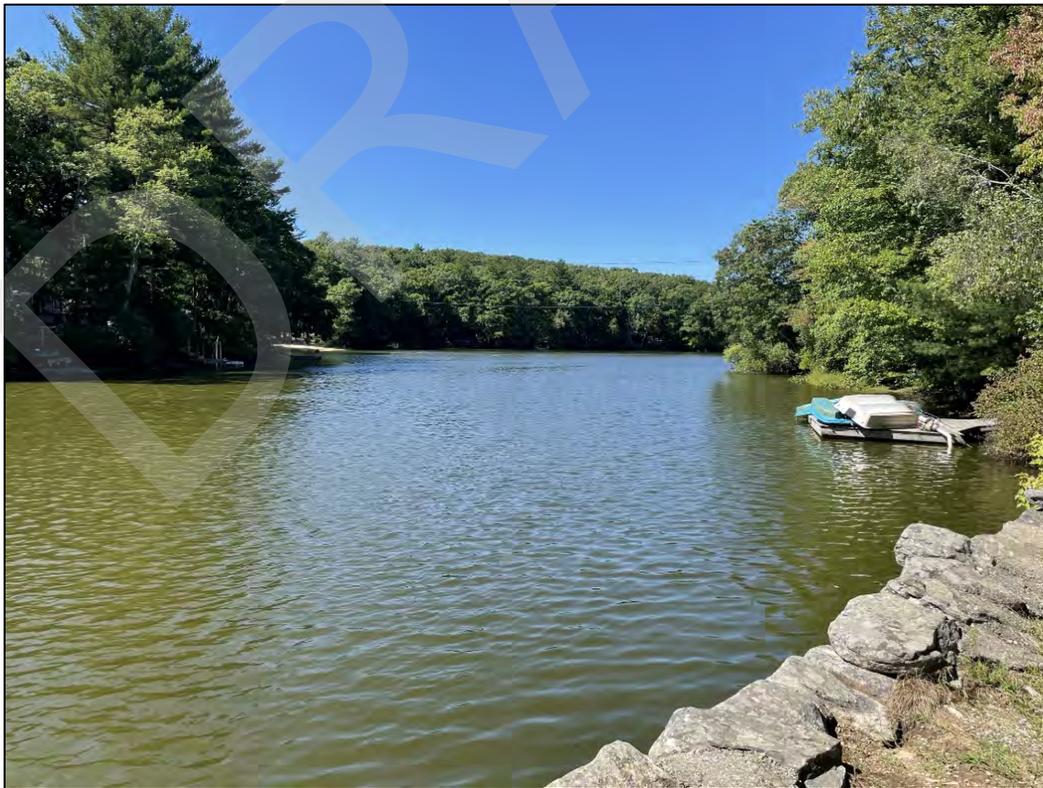
Photo No. 12.: Reach_A_#9.1 - Sutton Falls Pond.

9.1	2.0	-	2.8	Sutton Falls Pond	Impoundment	Private	9' deep impoundment with 3' of freeboard	10-yr	5-yr
9.2	2.3	-	2.8	MA00956 Sutton Falls Pond Dam (Aldrich Lane)	12' high dam embankment with 19' long spillway	Private	Significant Hazard Dam in Fair Condition; Little attenuation provided by impoundment and dam; >10-year storm will overtop the dam; SDF for dam is 100-year - not SDF compliant	10-yr	5-yr

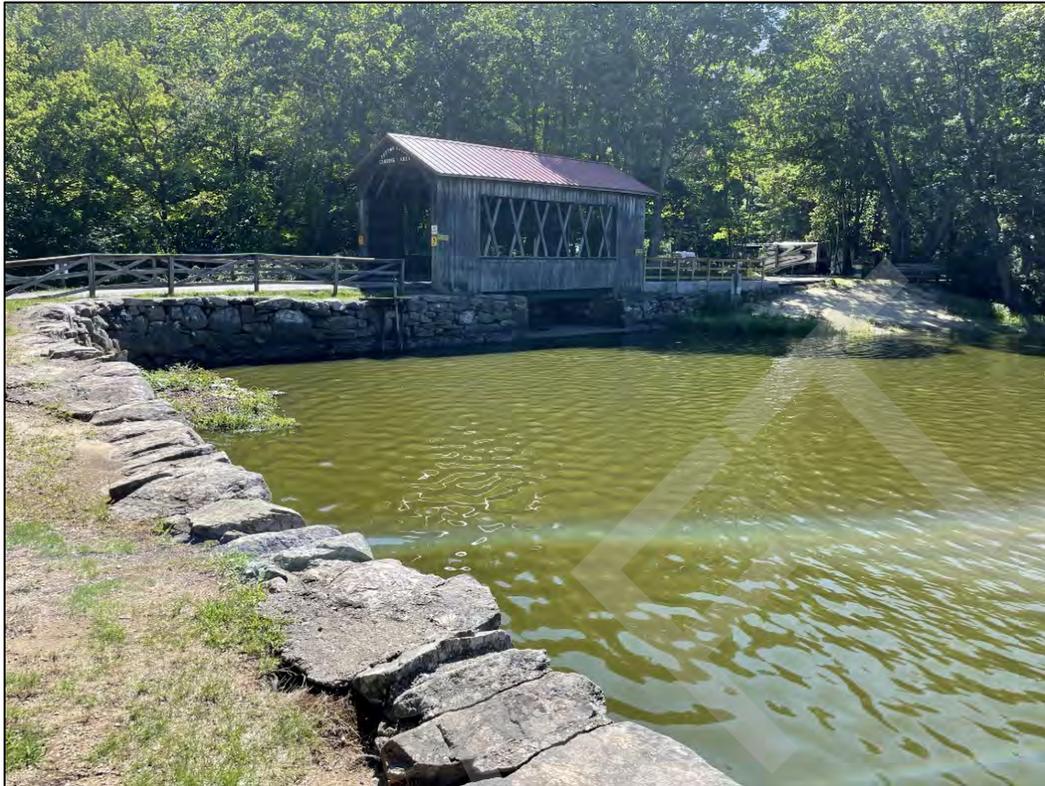
Photo No. 13.: Reach_A_#9.2 - Sutton Falls Dam upstream view.

- **9.1 & 9.2: Sutton Falls Pond Dam**, a Significant Hazard Dam in Fair Condition, provides very little to no flood attenuation and has limited hydraulic capacity; expected to overtop during storm events in excess of the 10-year event, far less than its required spillway design flood (SDF), the 100-year event. Failure of the dam would most likely have generally low to moderate impacts aside from making Aldrich Lane (the camp site access way that runs along the dam) impassible and potential flooding of the Sutton Falls Camping Area Intake Building.

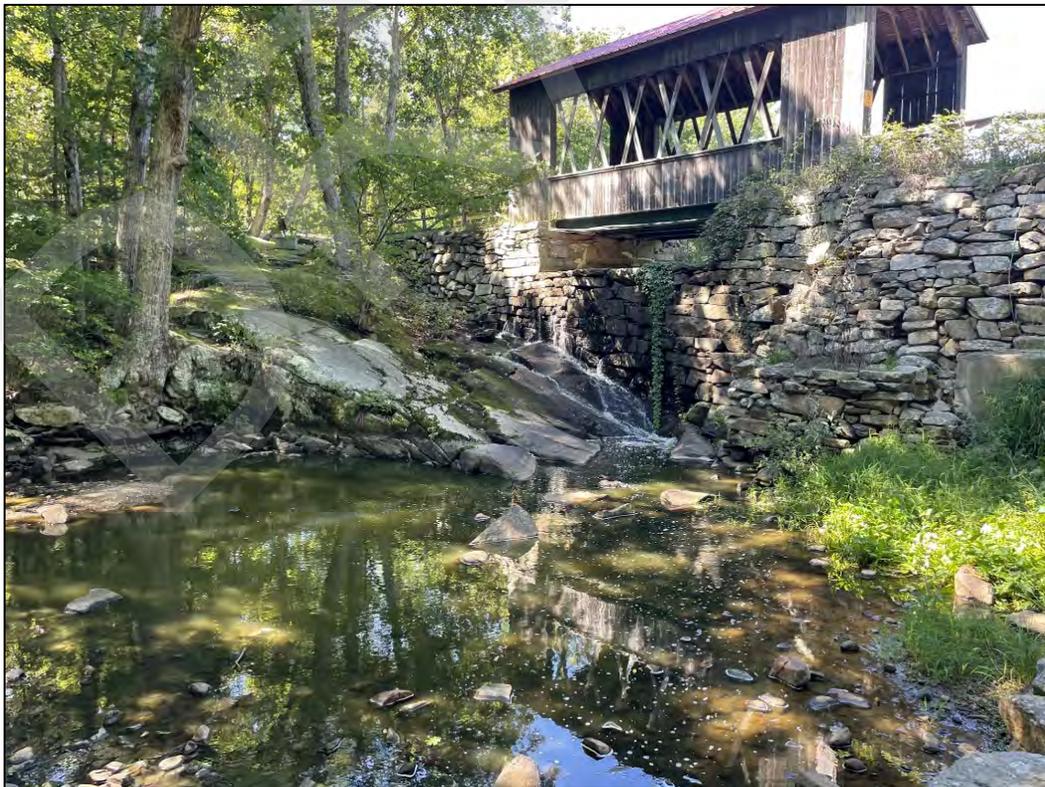
Photo No. 14.: Reach_A_#9.2 - Sutton Falls Dam's downstream view.

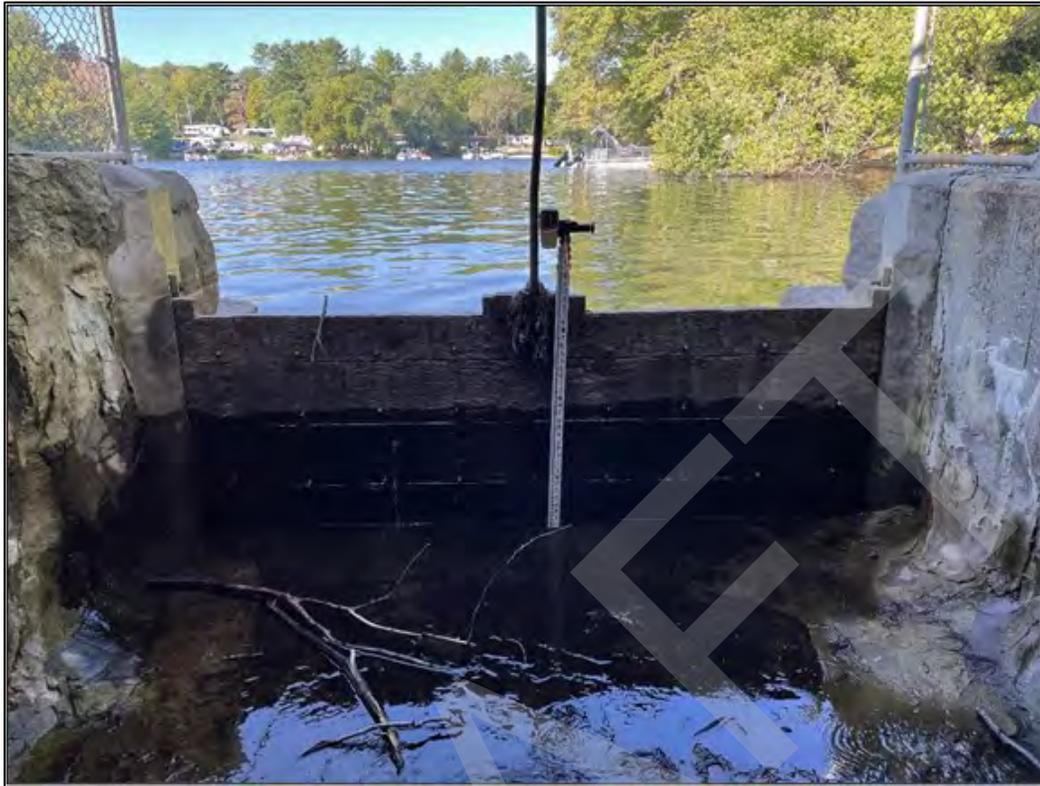
Photo No. 15.: Reach_A_#10.1 – Manchaug Pond and spillway controls of Manchaug Pond Dam

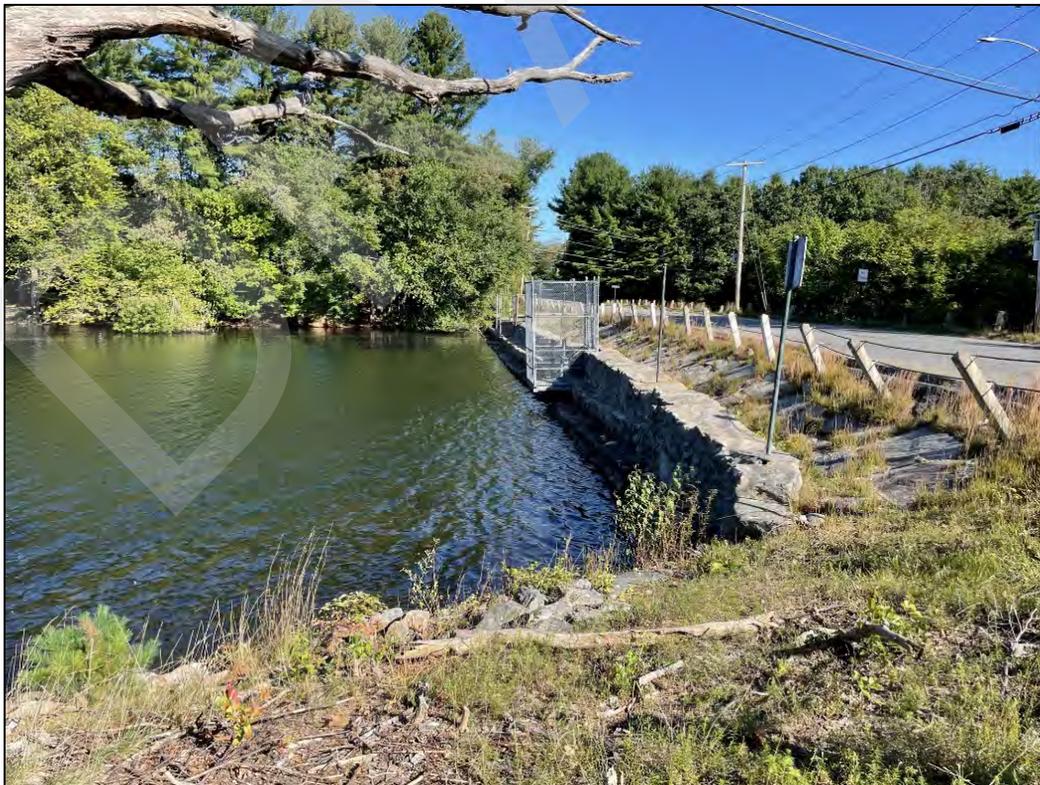
Photo No. 16.: Reach_A_#10.2 - Manchaug Pond Dam

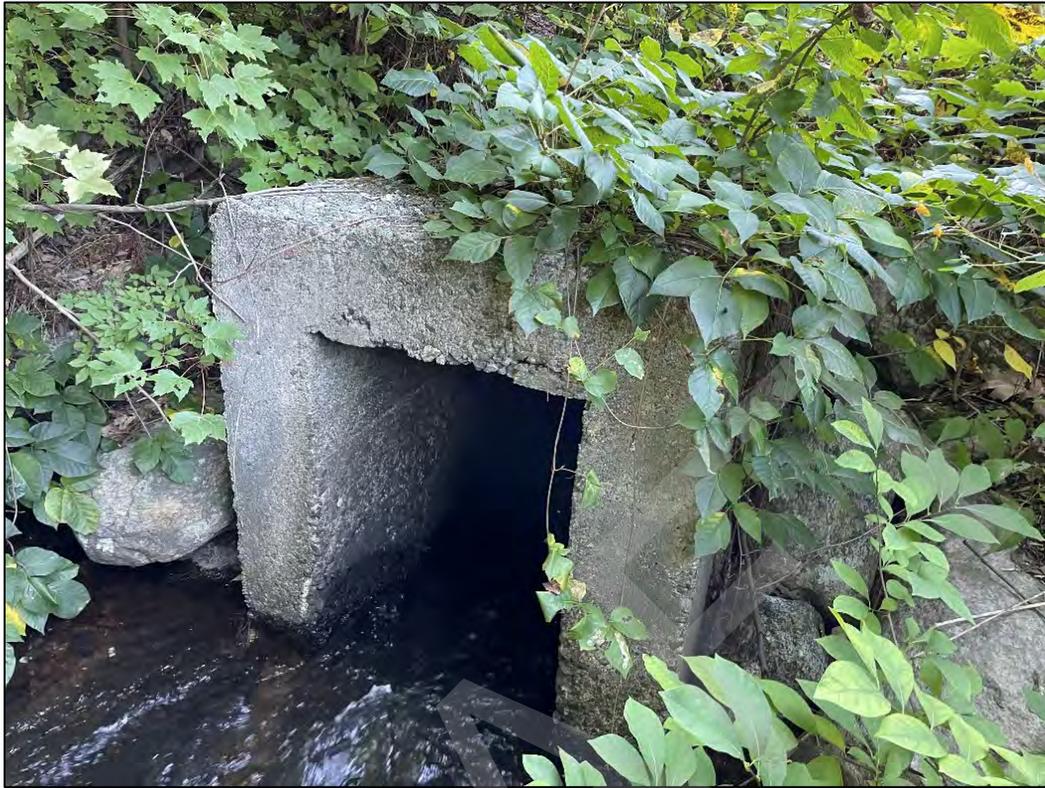
Photo No. 17.: Reach_A_#10.2 - Manchaug Pond Dam Low-level Outlet.

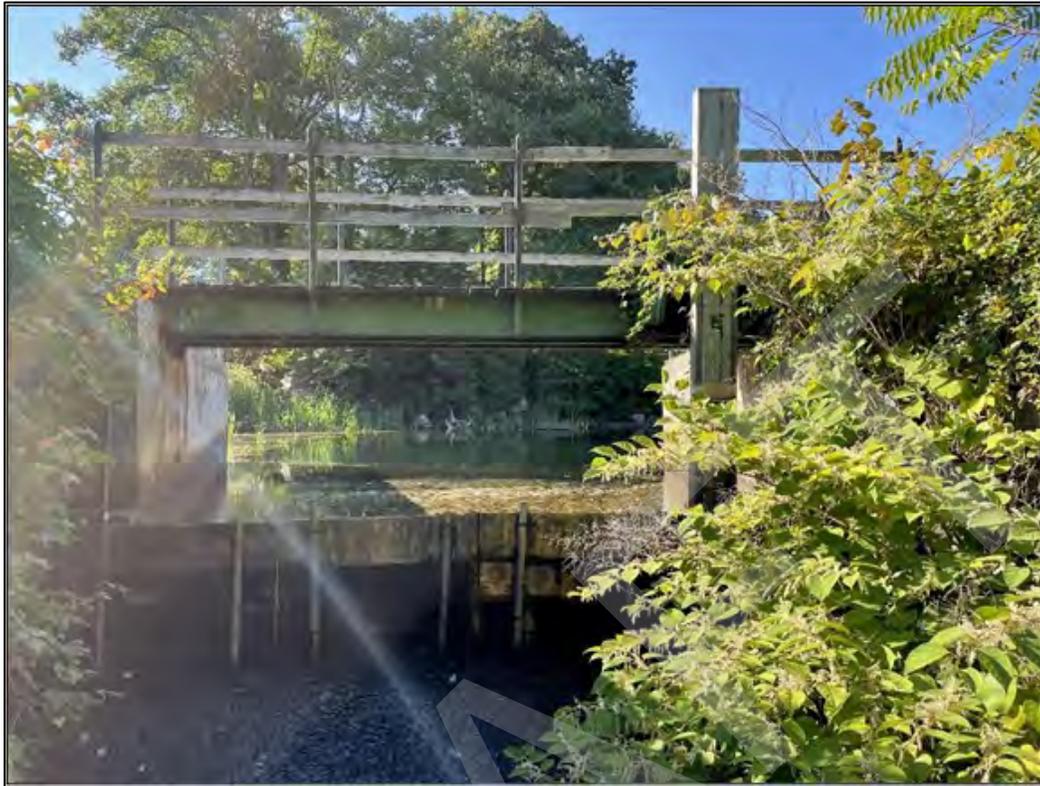
Photo No. 19.: Reach_A_#11.2 - Overview of the Stevens Pond Dam's spillway.

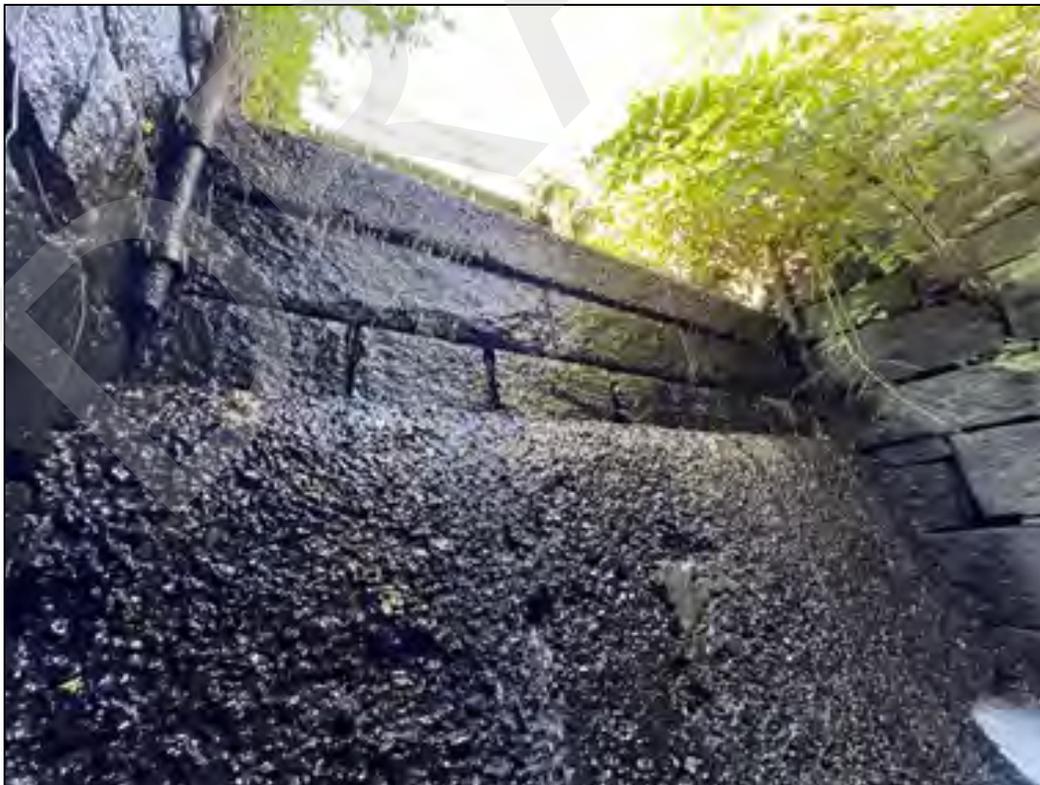
Photo No. 20.: Reach_A_#11.2 - Stevens Pond Dam's spillway. Note the LLO discharging at the base of the spillway (photo bottom right).

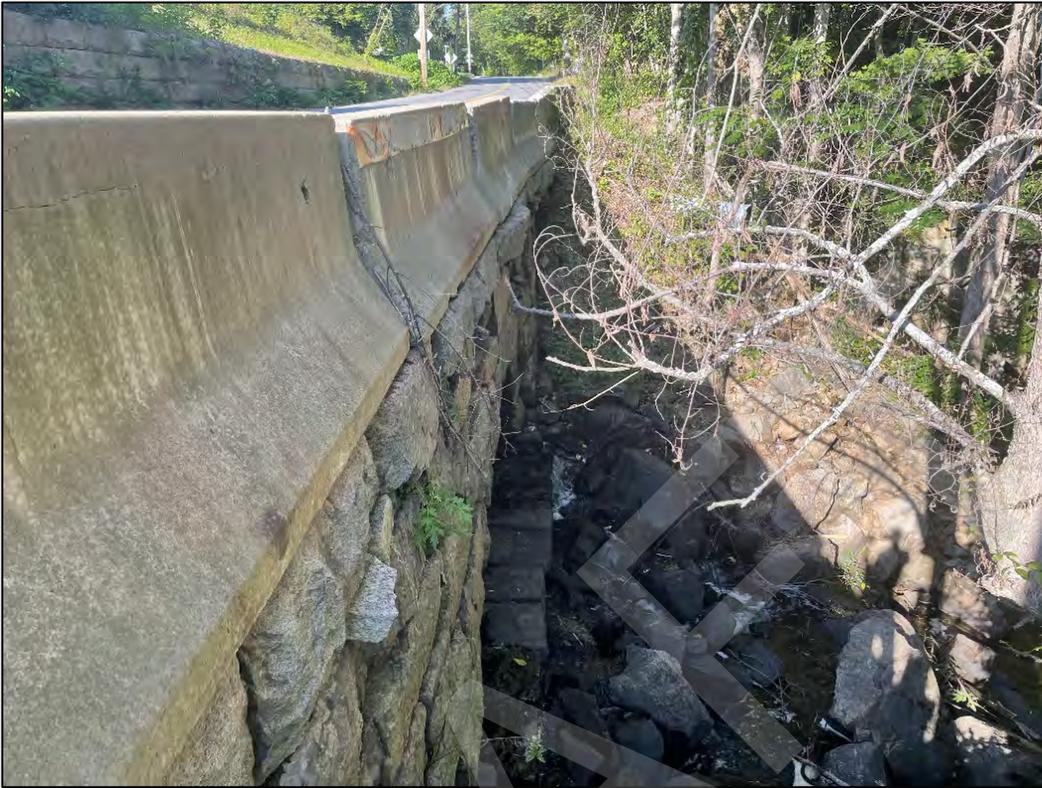
Photo No. 21.: Reach_A_#11.2 – Downstream face of the Manchaug Road embankment located downstream of Stevens Pond Dam.

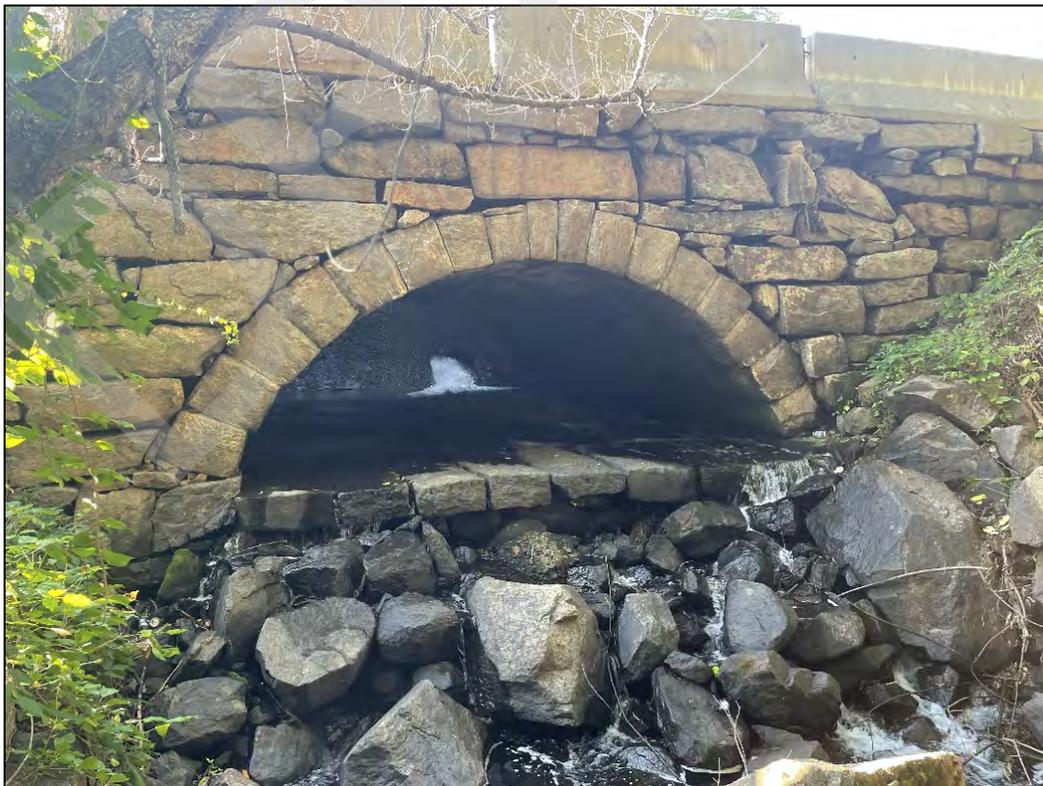
Photo No. 22.: Reach_A_#11.2 – View of the stone arch culvert of the Manchaug Road crossing downstream of Stevens Pond Dam.

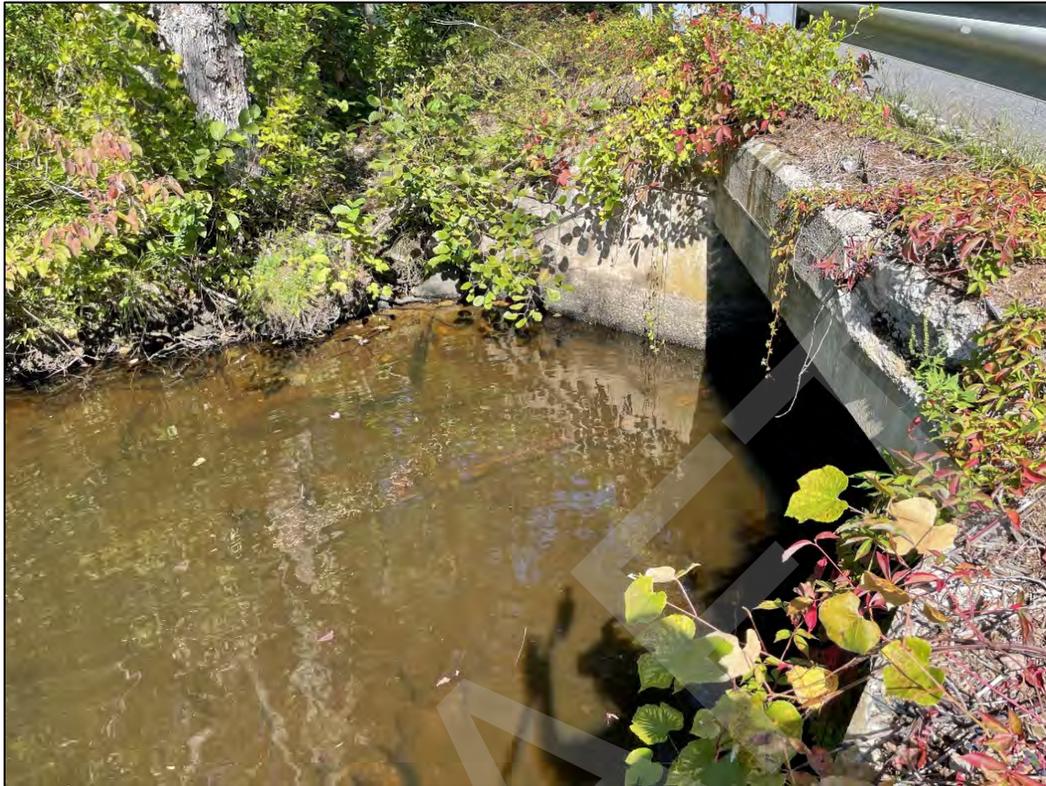
Photo No. 25.: Reach_B_#9 - Putnam Hill Road culvert downstream end.

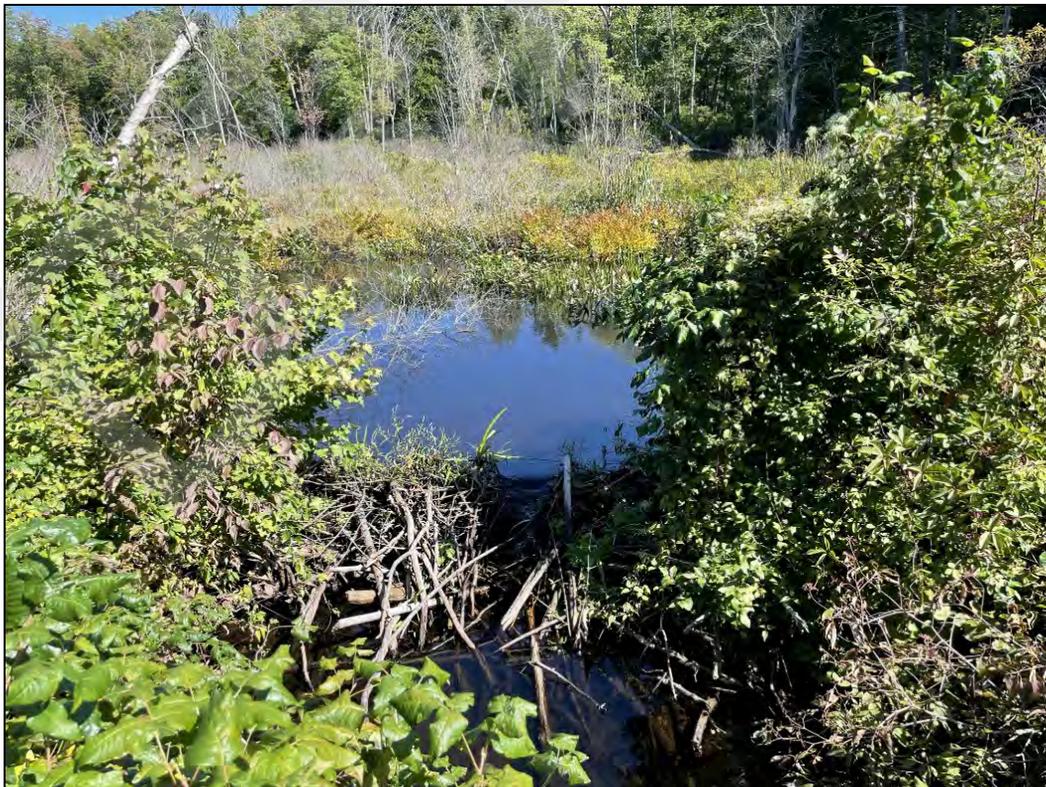
Photo No. 26.: Reach_B_#9 - Beaver Dam upstream of Putnam Hill Road culvert.

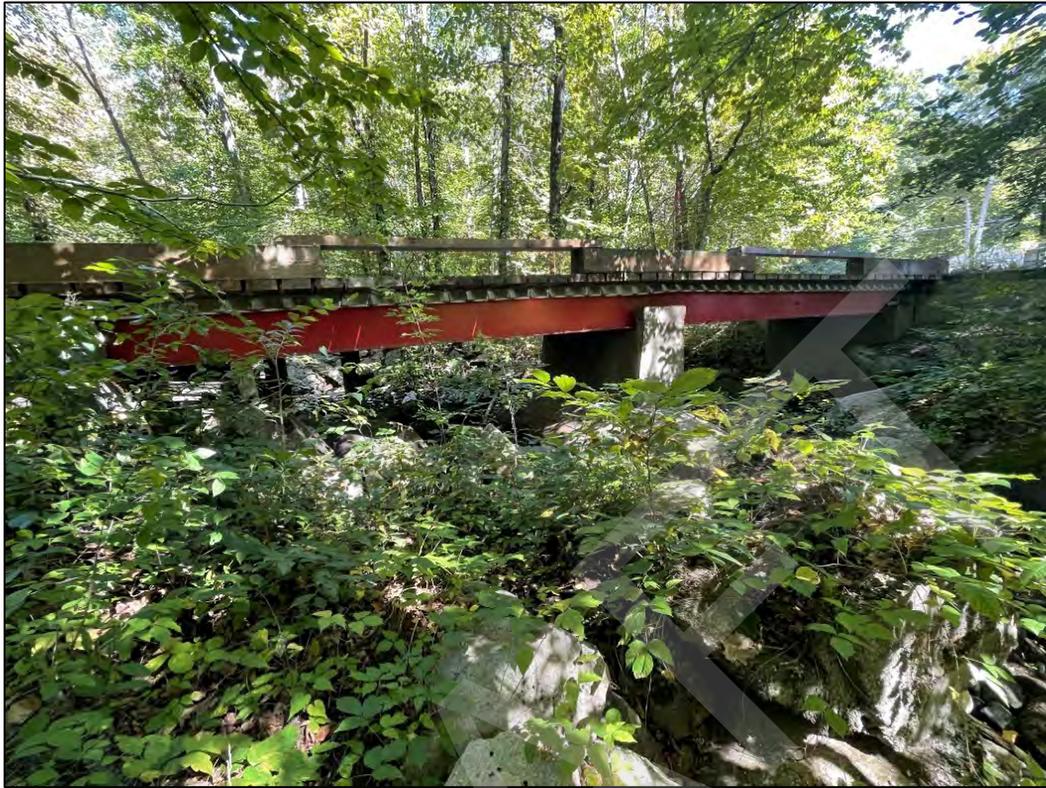
Photo No. 27.: Reach_B_#10 - Tucker Lane bridge crossing

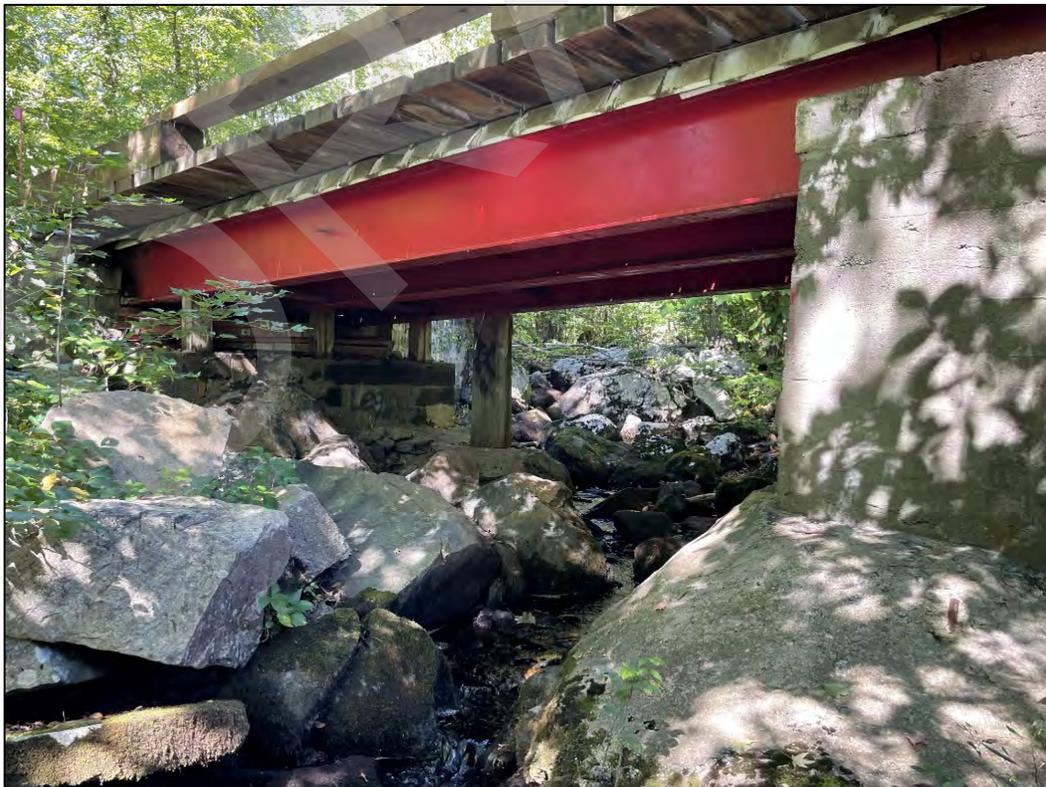
Photo No. 28.: Reach_B_#10 - Downstream view of Tucker Lane bridge.

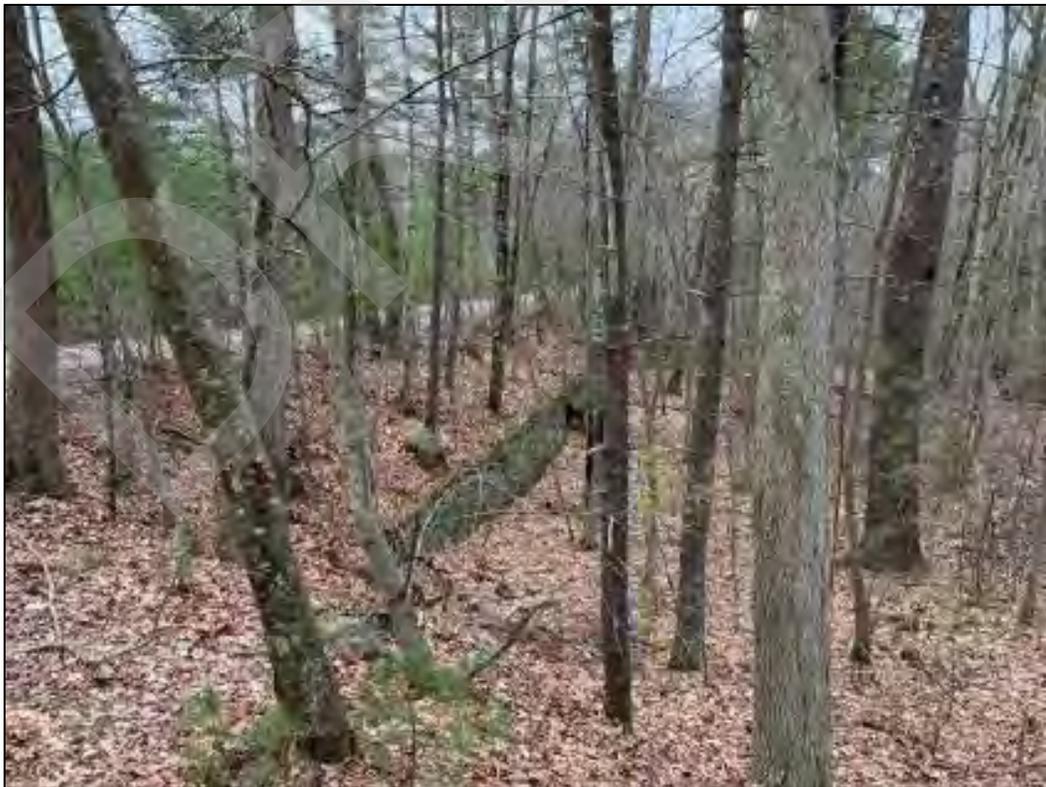
Photo No. 30.: Reach_B_#11.2 - Overview of the UTP South Dam (Cote Lane) embankment. (2022 Phase I Inspection – Tighe & Bond)

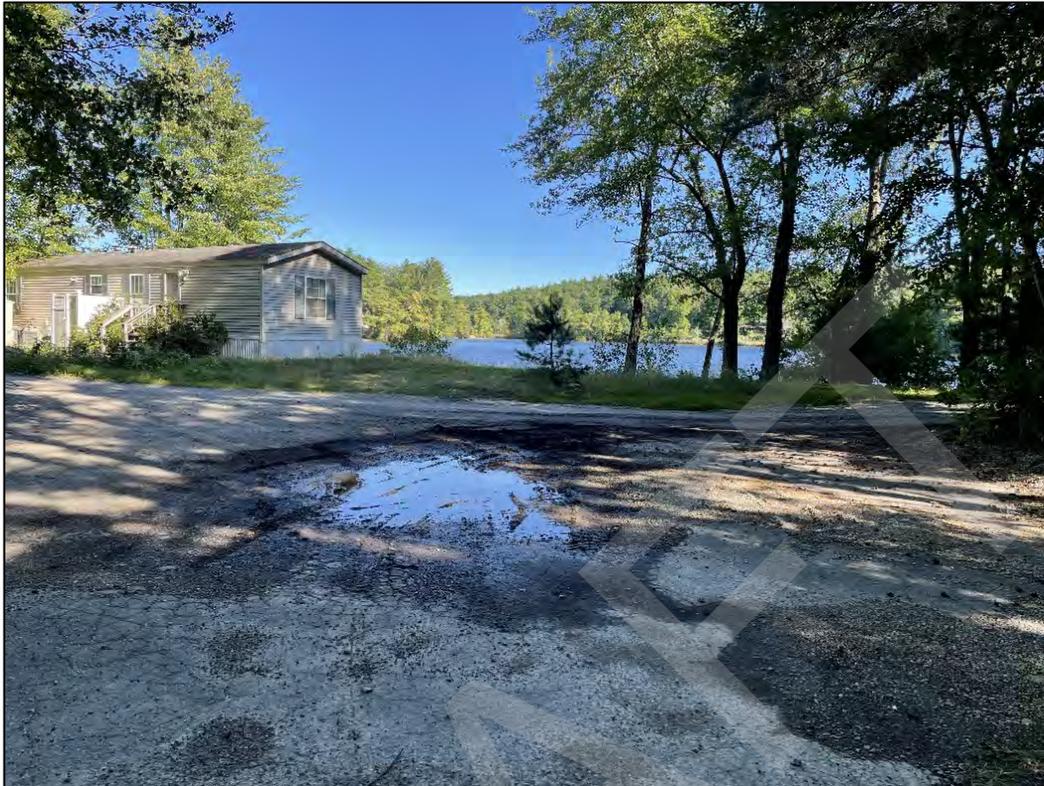
Photo No. 31.: Reach_B_#11.2 - Low right abutment area of the UTP South Dam (Cote Lane).
