PREPARED FOR: TOWN OF SUTTON

MANCHAUG WATER RESOURCES RESILIENCY ACTION PLAN Sutton, Massachusetts

PREPARED BY:
PARE CORPORATION
10 LINCOLN ROAD, SUITE 210
FOXBORO, MASSACHUSETTS 02035
PARE PROJECT NUMBER 22153.00

DRAFT Report – May 2023

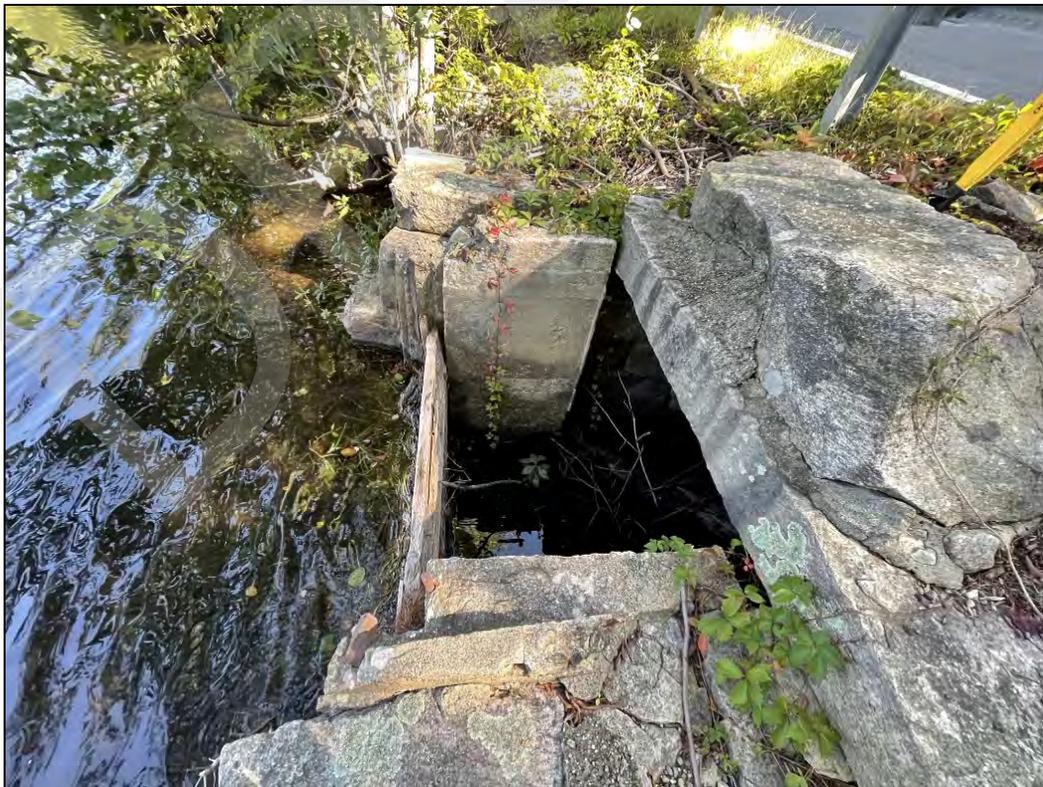
Photo No. 32.: Reach_B_#11.3 - UTP East Dam spillway controls.

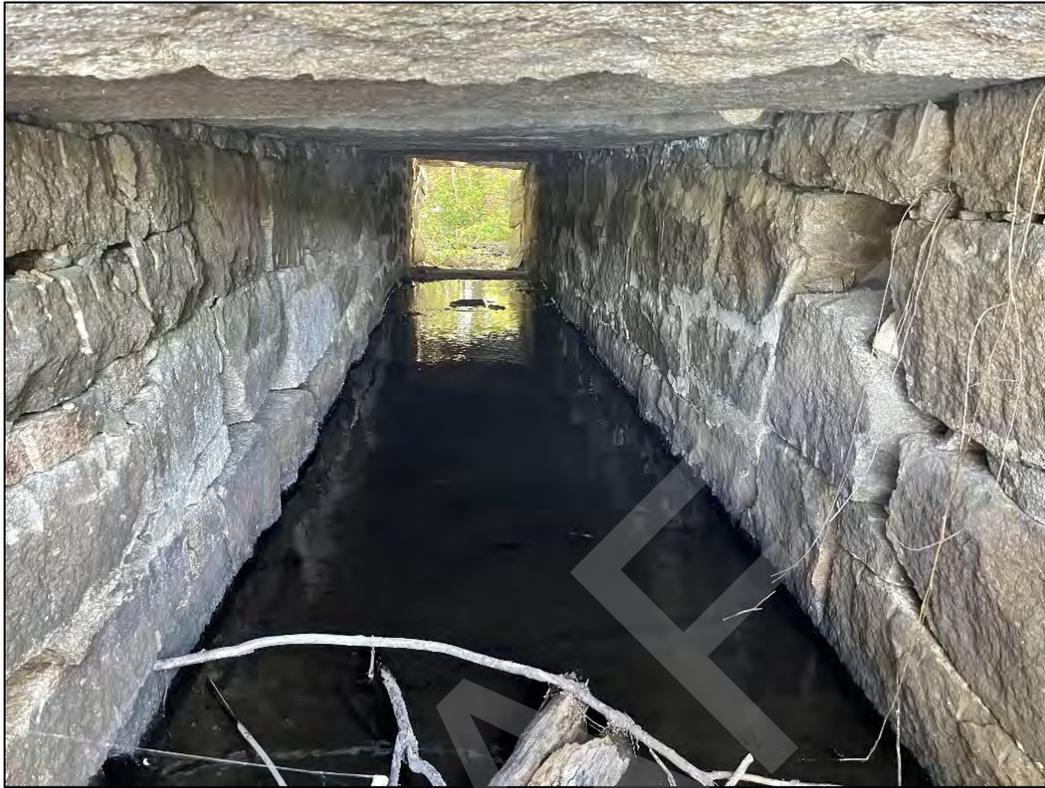
Photo No. 33.: Reach_B_#11.3 – Interior of the Putnam Hill Road culvert downstream of the UTP East Dam spillway controls.

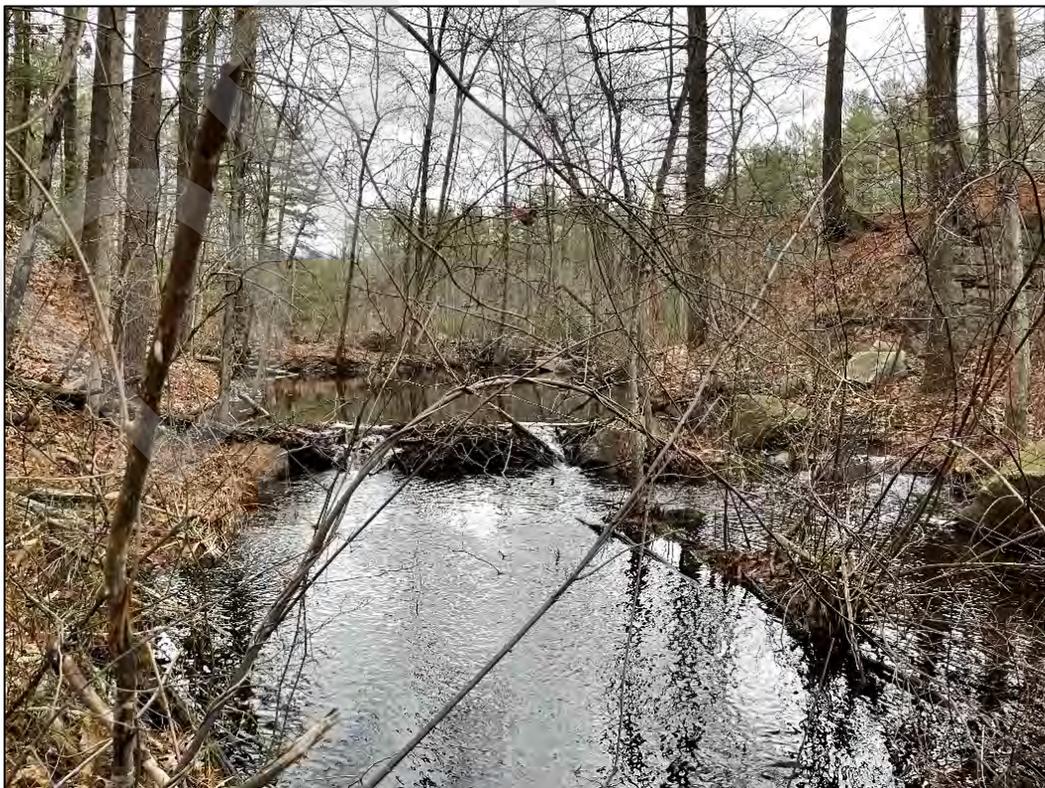
Photo No. 34.: Reach_B_#12 - Former Upper Tucker Pond Dam / Current Beaver Dam.

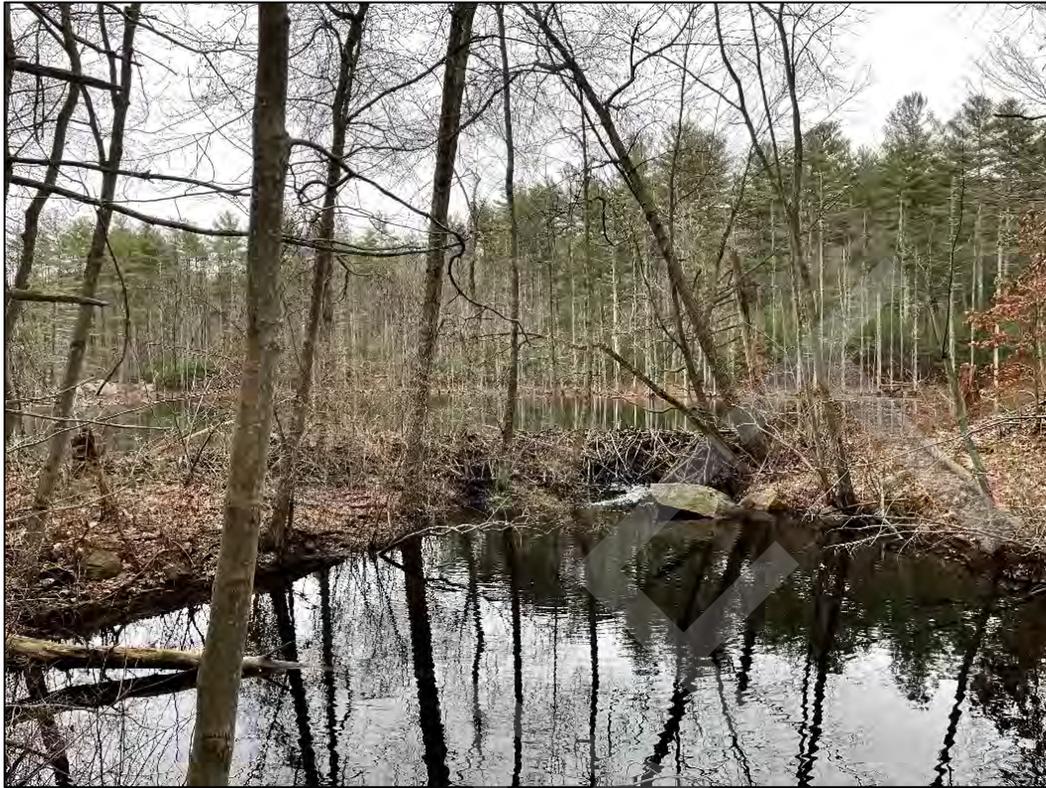
Photo No. 35.: Reach_B_#12 - Former Upper Tucker Pond Dam / Current Beaver Dam

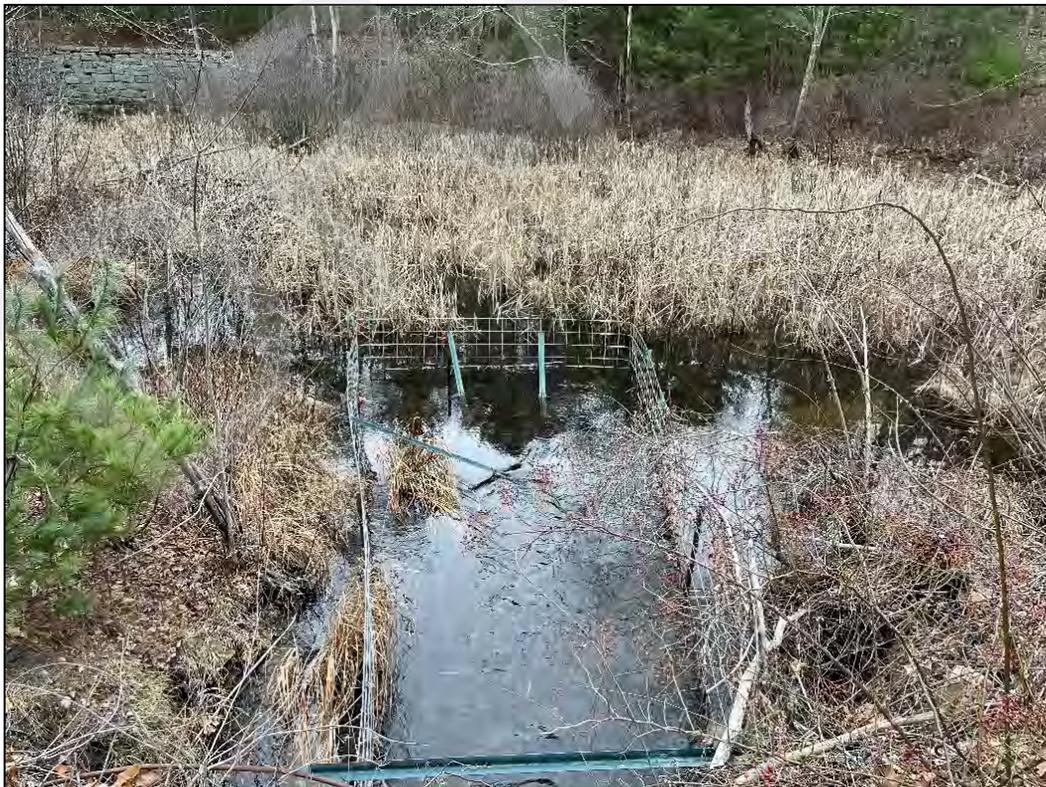
Photo No. 36.: Reach_B_#13 – Beaver deceiver installed upstream of the Putnam Hill Road culvert.

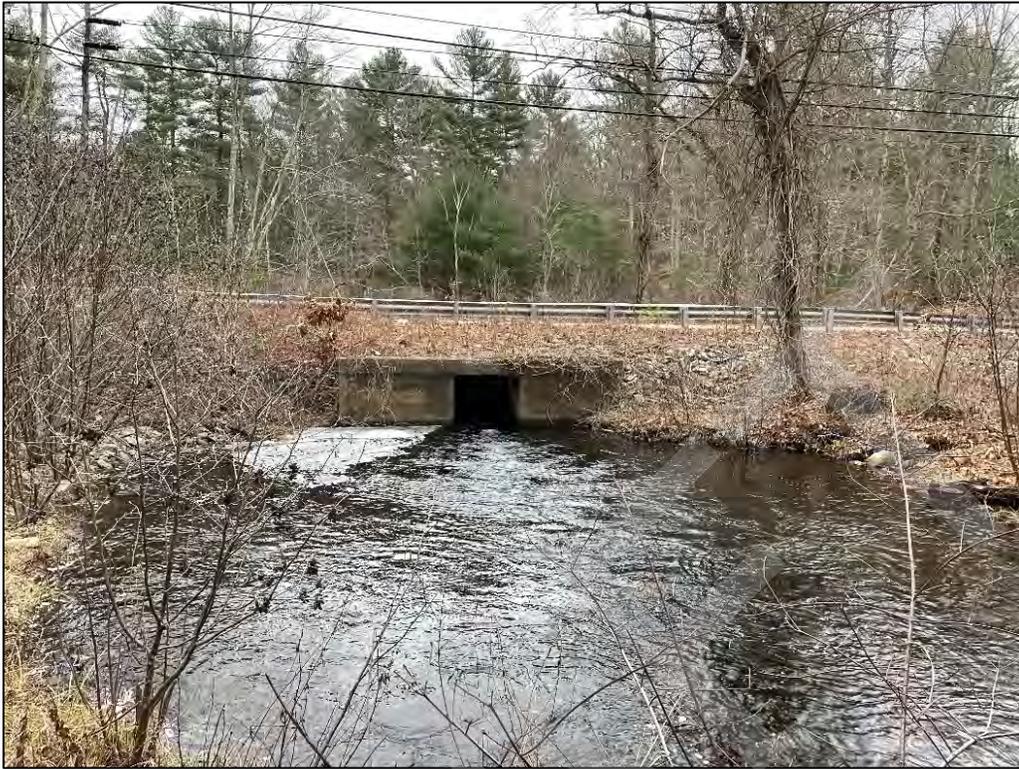
Photo No. 37.: Reach_B_#13 - Putnam Hill Road culvert from the downstream channel looking upstream.

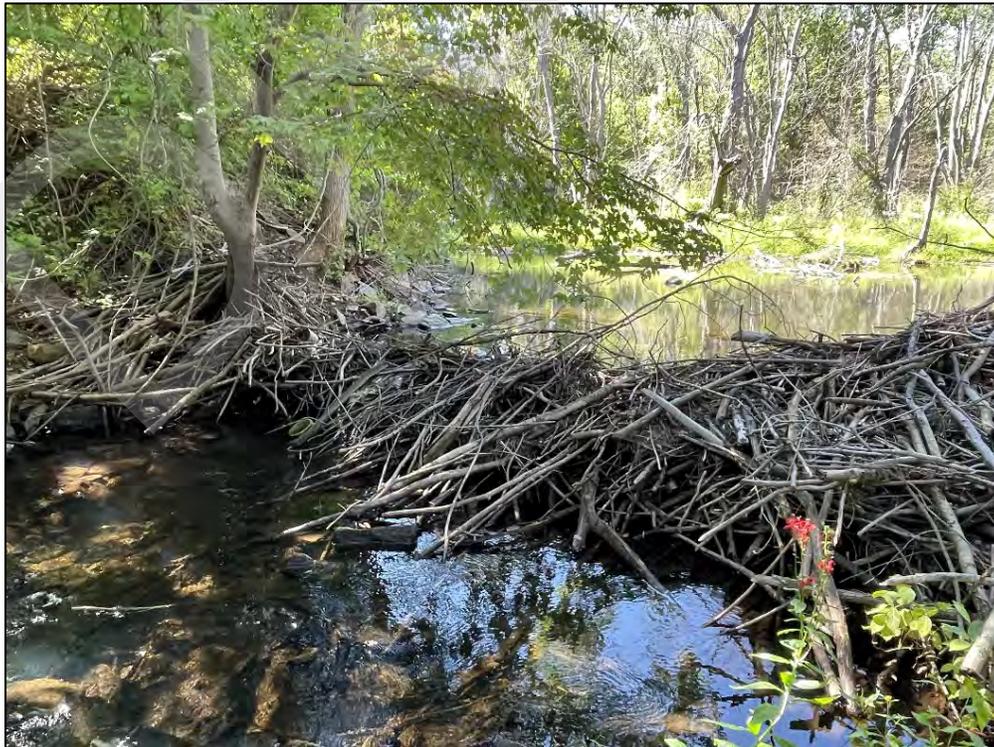
Photo No. 38.: Reach_C_#1 - Former Lower Tucker Pond Dam / Current Beaver Dam

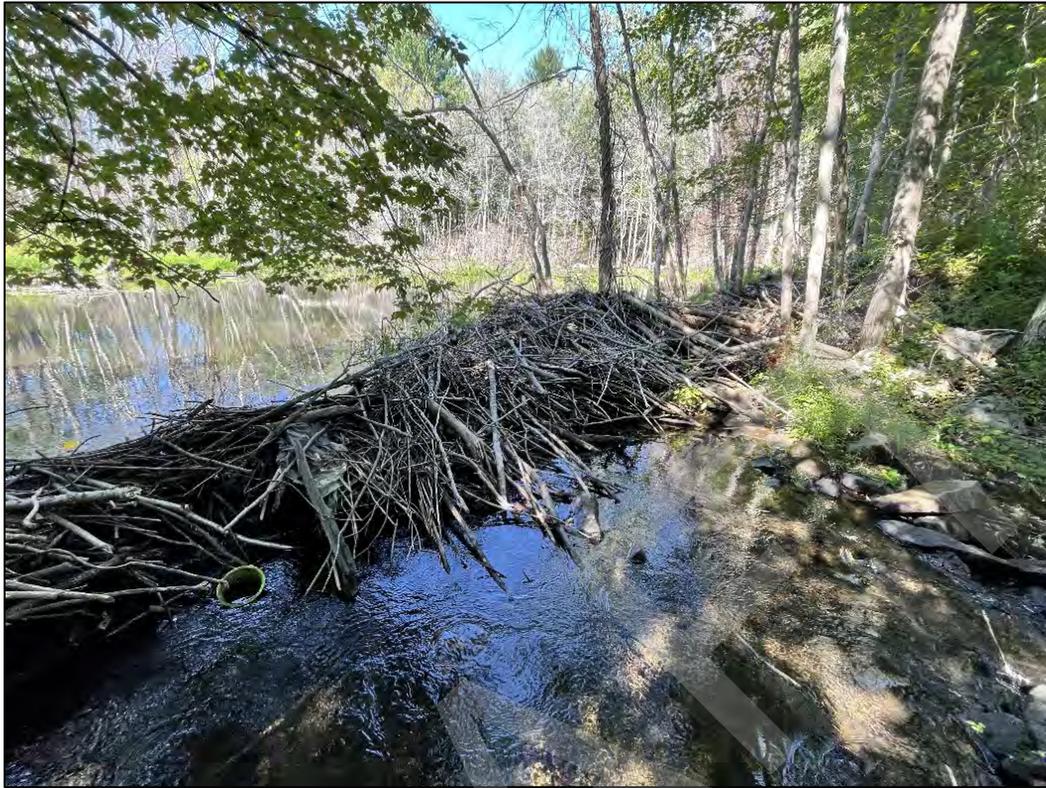
Photo No. 39.: Reach_C_#1 - Former Lower Tucker Pond Dam / Current Beaver Dam

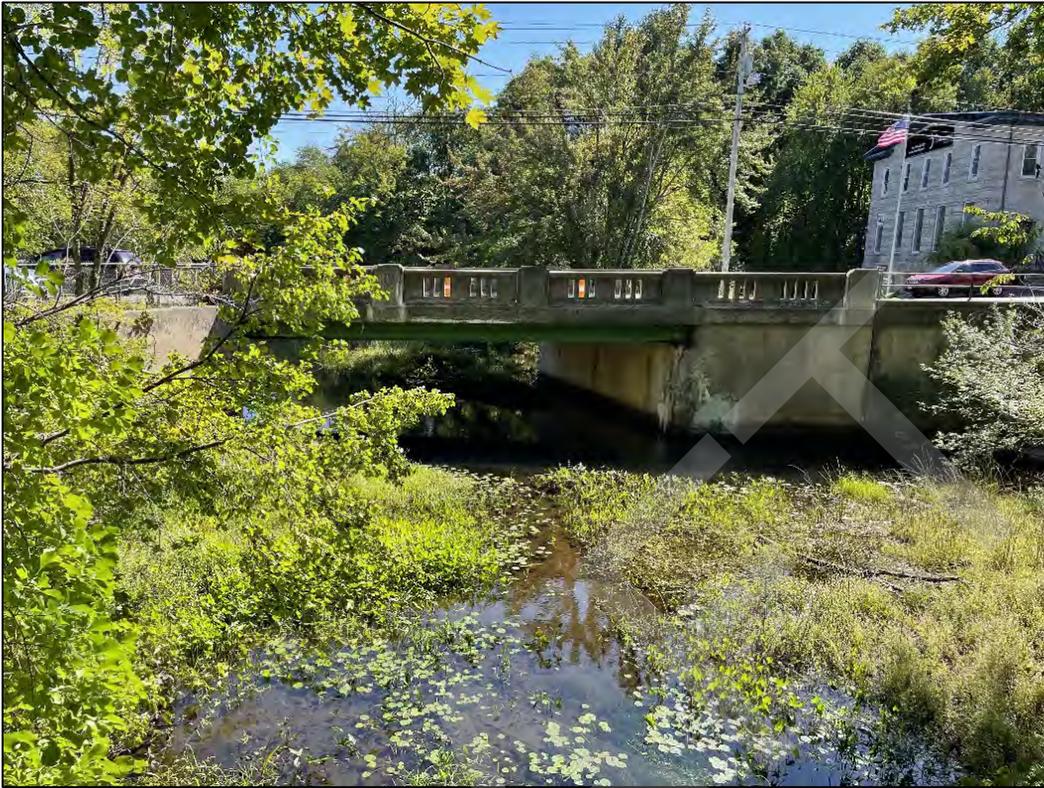
Photo No. 41.: Reach_C_#2 - Manchaug Road bridge from 200 feet upstream looking downstream.

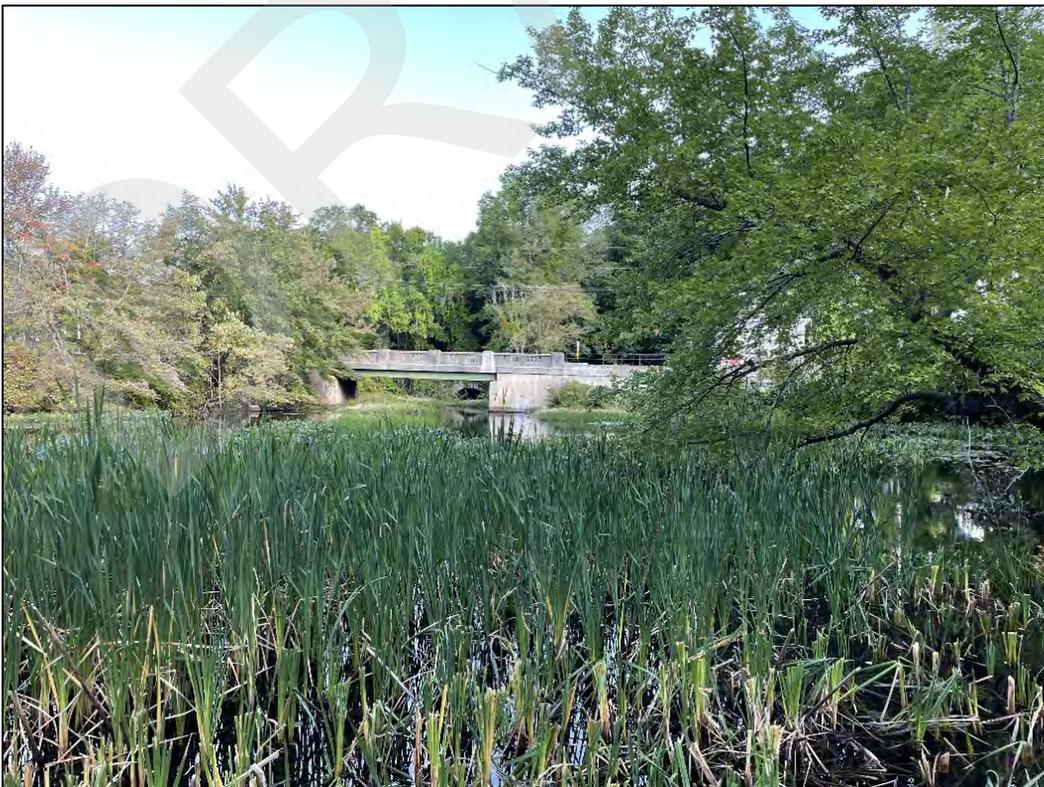
Photo No. 42.: Reach_C_#2 - Manchaug Road bridge from Mill Pond Dam looking upstream.

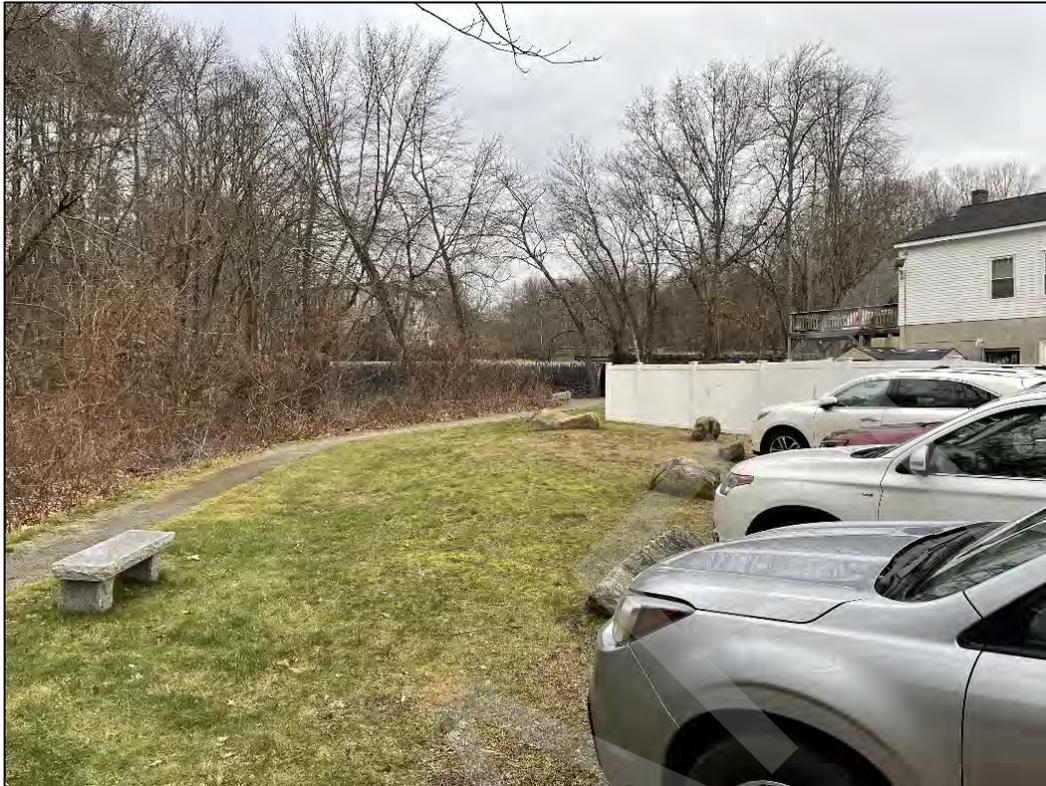
Photo No. 43.: # Reach_C_3 - Mill Pond Dam No.1 from 300 feet downstream looking upstream.

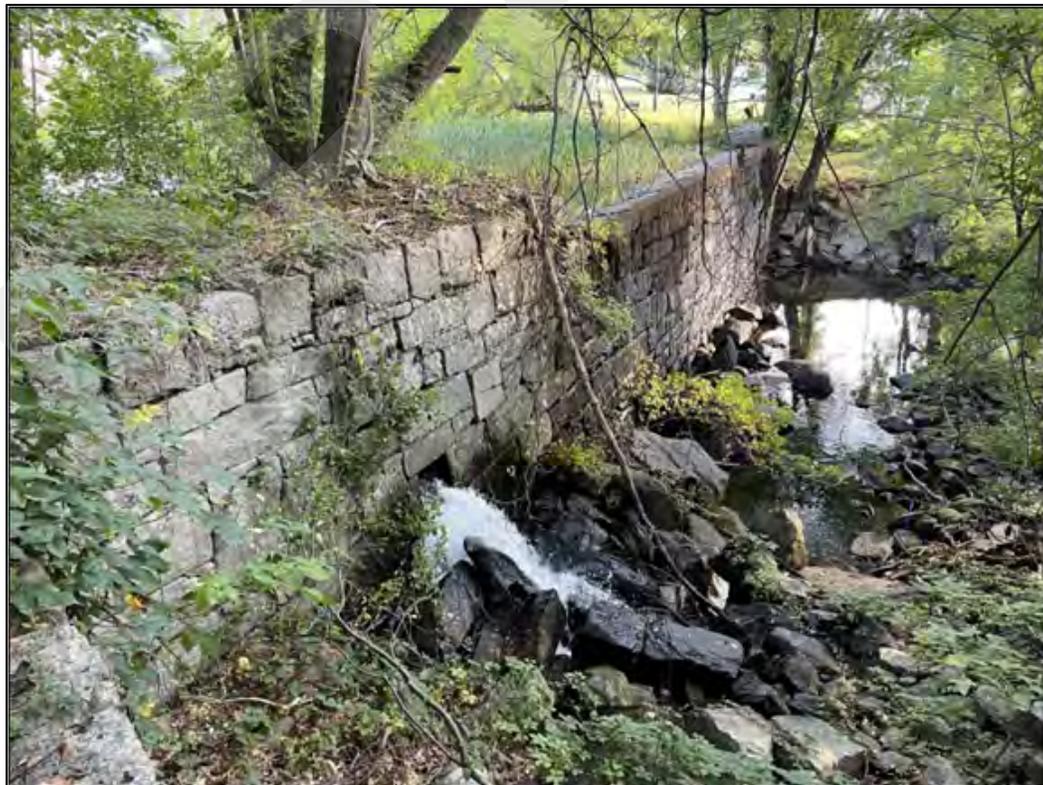
Photo No. 44.: Reach_C_#3 - Mill Pond Dam No.1 downstream face.

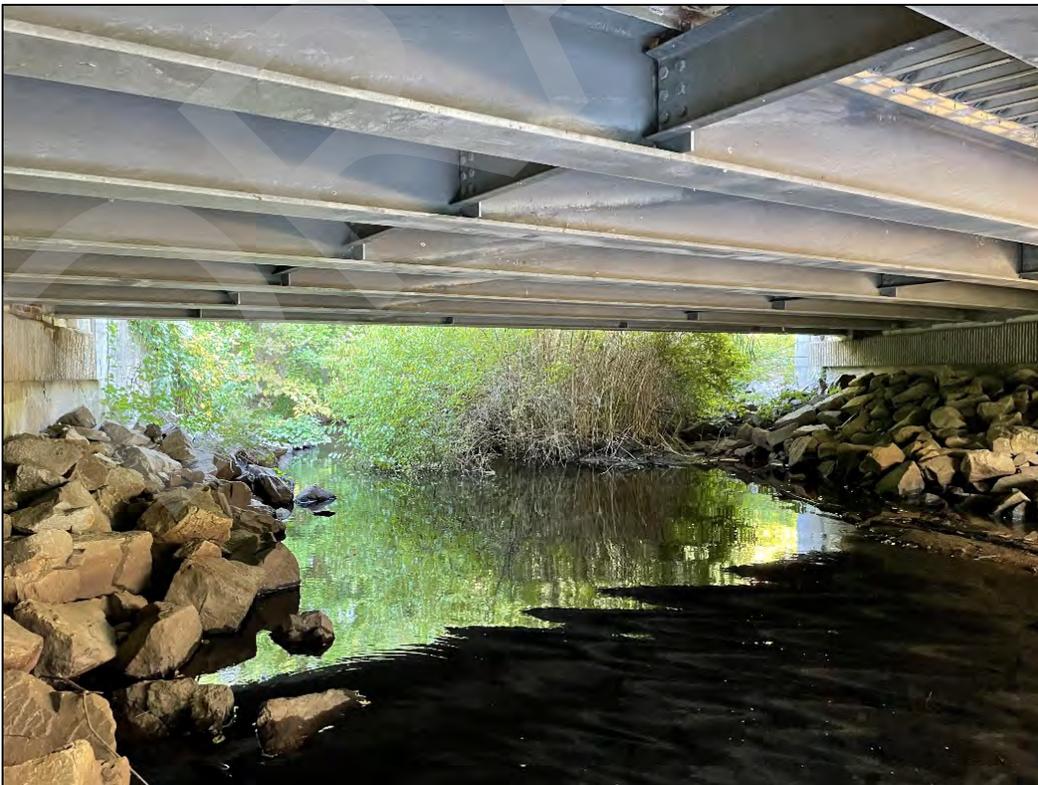
Photo No. 46.: Reach_C_#4 - Main Street bridge from under the bridge looking upstream.

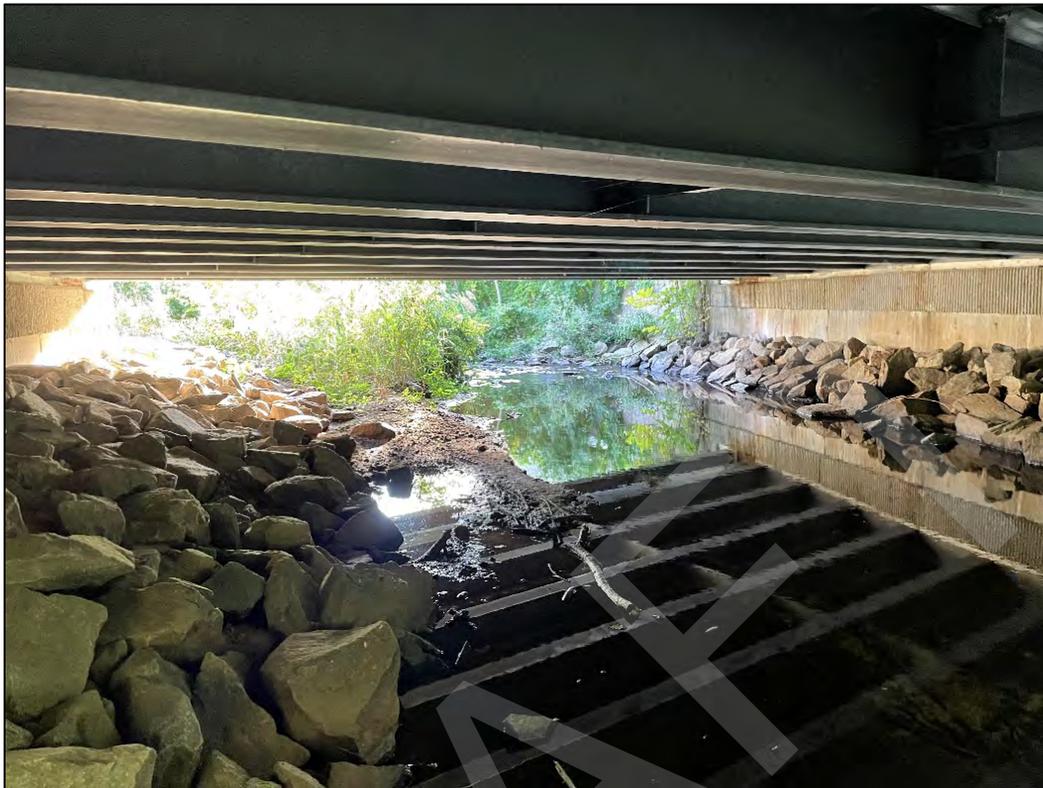
Photo No. 47.: Reach_C_#5 – Main Street bridge from under the bridge looking downstream.

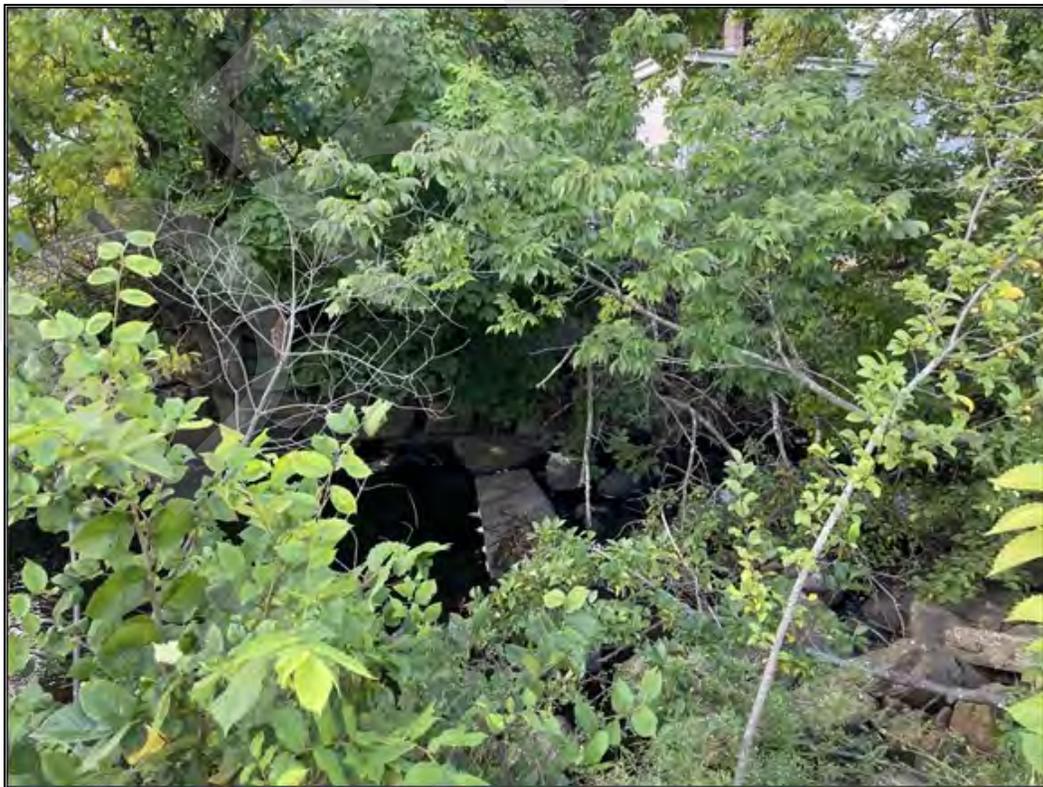
Photo No. 48.: Reach_C_#5 - Stone weir downstream of Main Street.

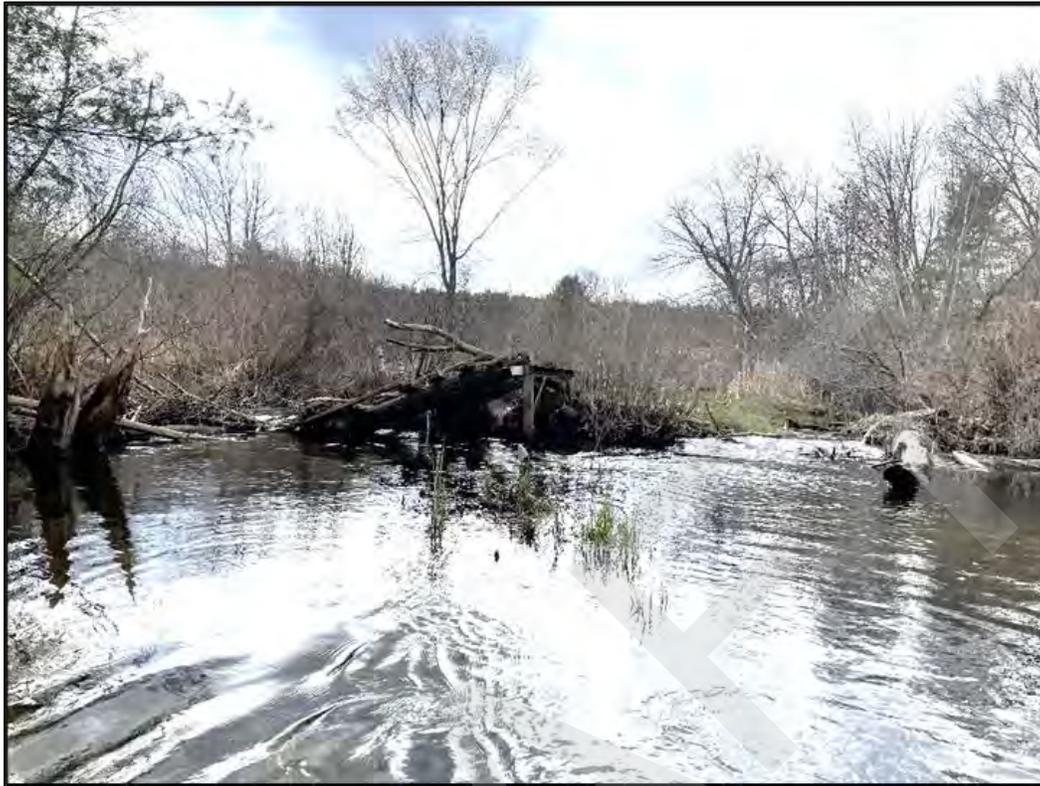
Photo No. 49.: Reach_C_ Beaver/Debris Location #10 – Construction debris along the Mumford River.

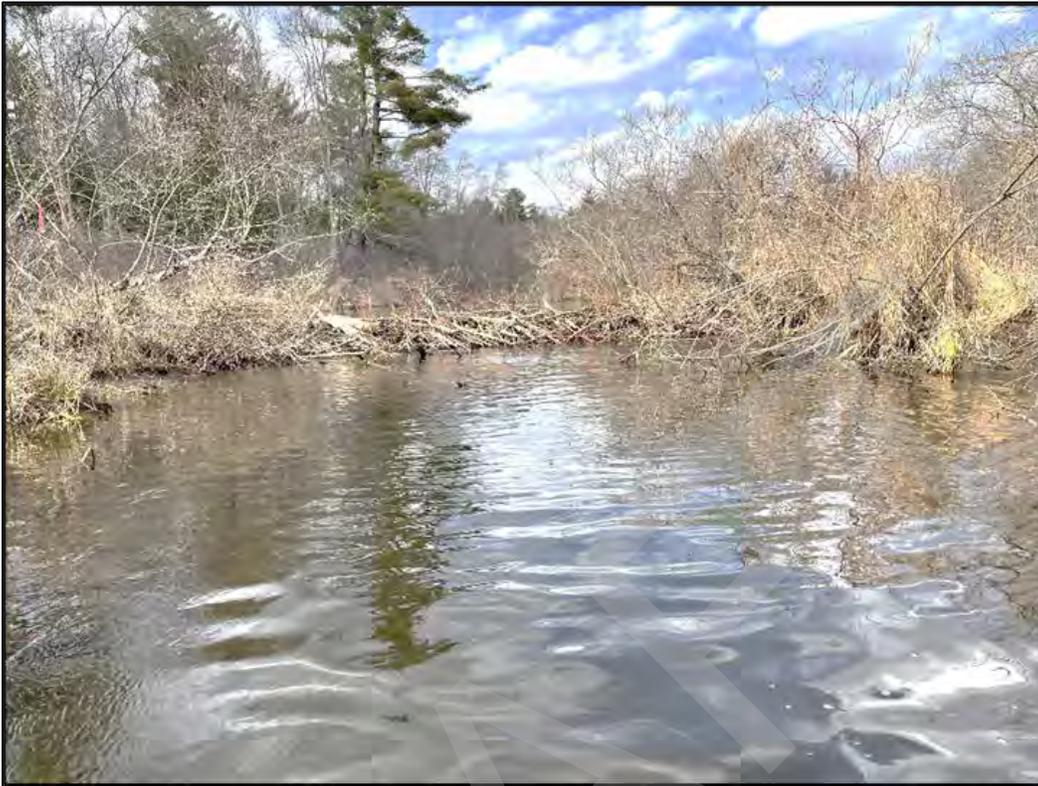
Photo No. 51.: Reach_C_ Beaver/Debris Location#12 – Beaver Dam along the Mumford River that creates a 2' head differential.

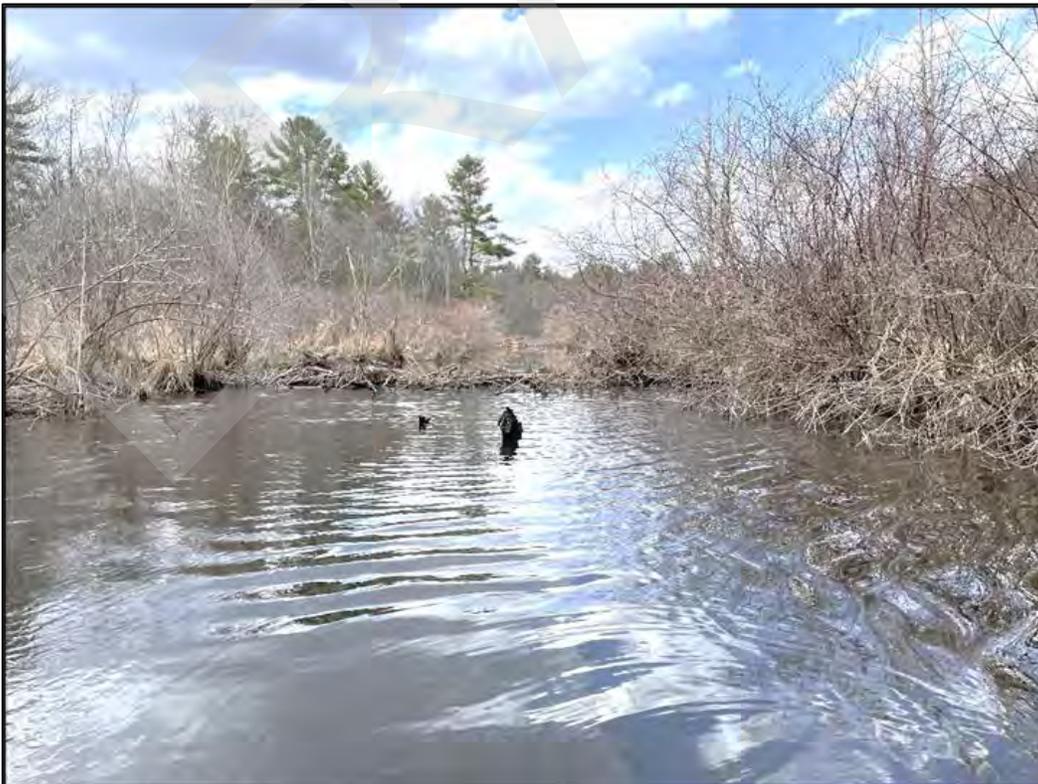
Photo No. 52.: Reach_C_ Beaver/Debris Location #13 – A second beaver dam located along the Mumford River, approximately 100 feet downstream of the beaver dam shown in the previous photo (No. 51).

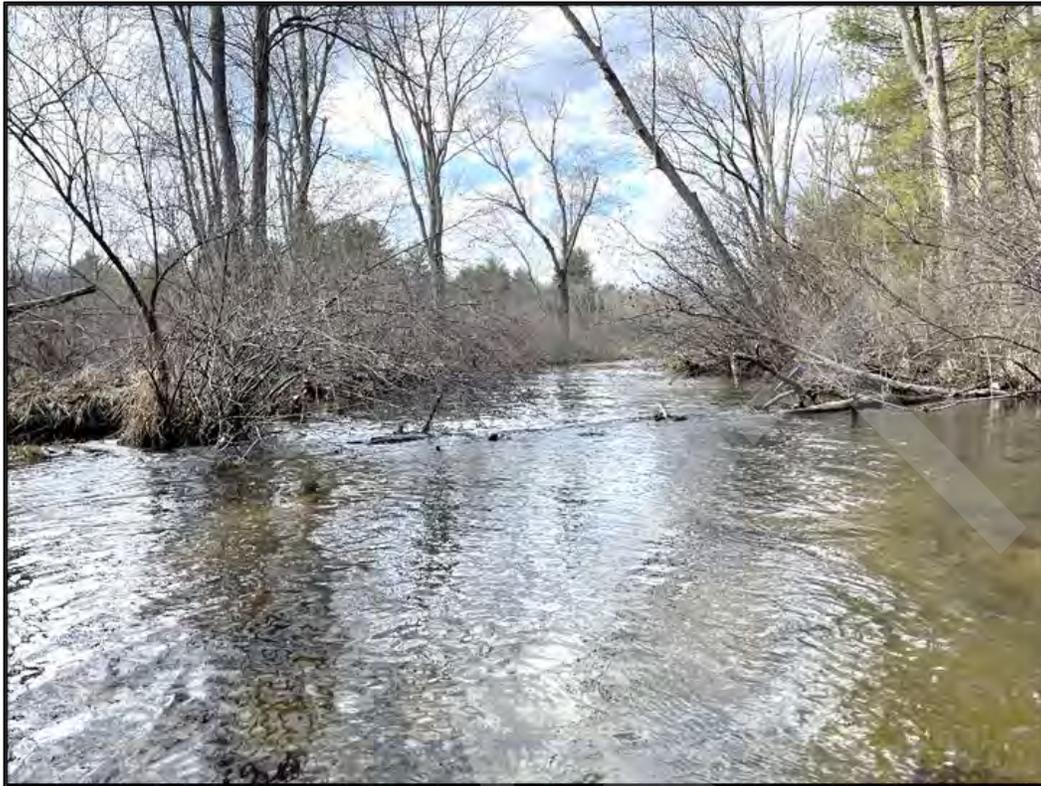
Photo No. 53.: Reach_C_ Beaver/Debris Location #14 – Tree Debris along the Mumford River.

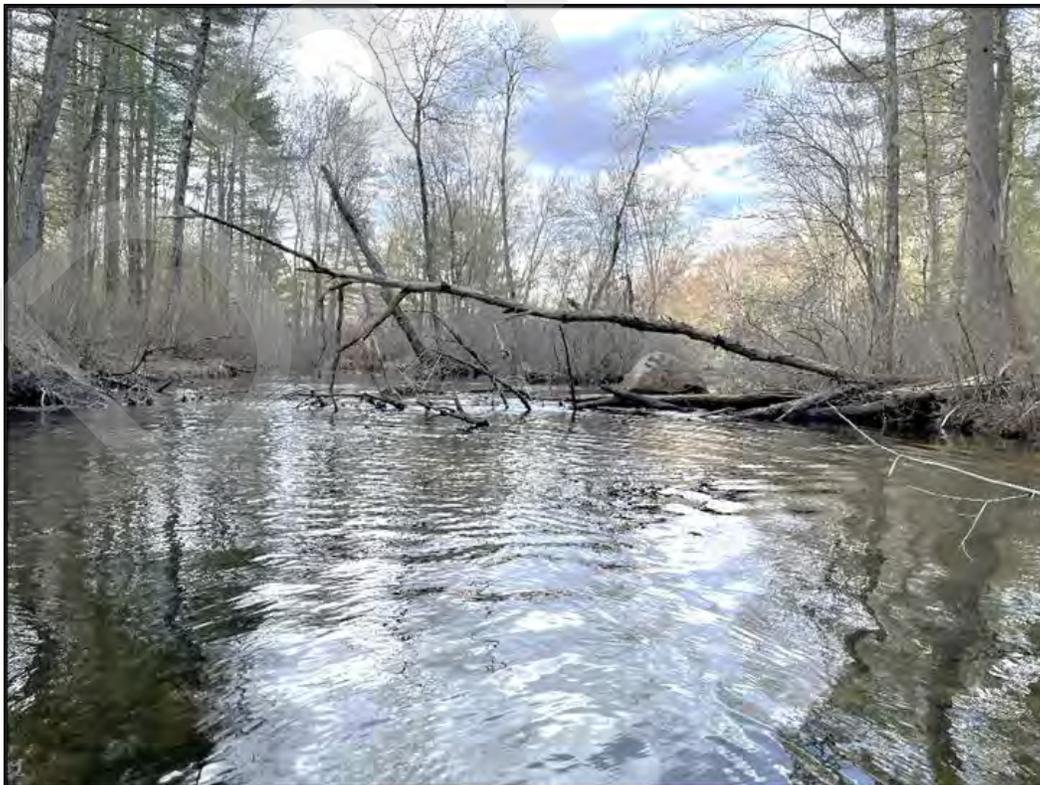
Photo No. 54.: Reach_C_ Beaver/Debris Location #15 – Tree debris along the Mumford River.

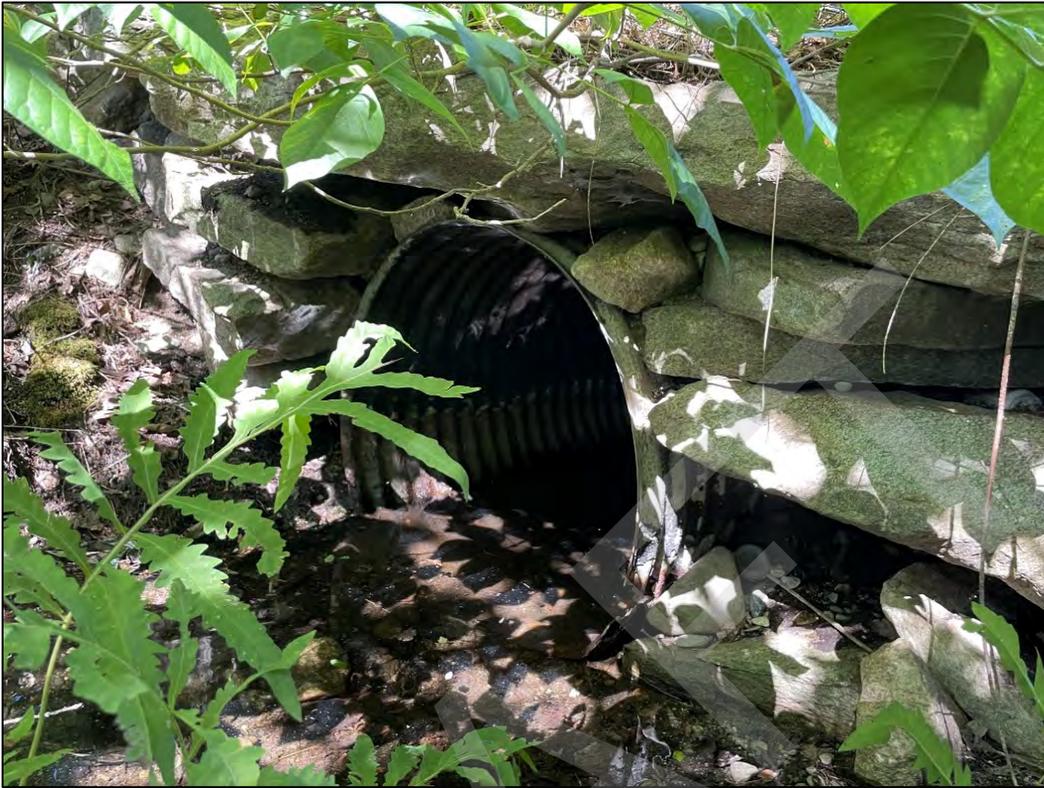
Photo No. 55.: Reach_C_#5.1 - Whitin Road east culvert upstream view.

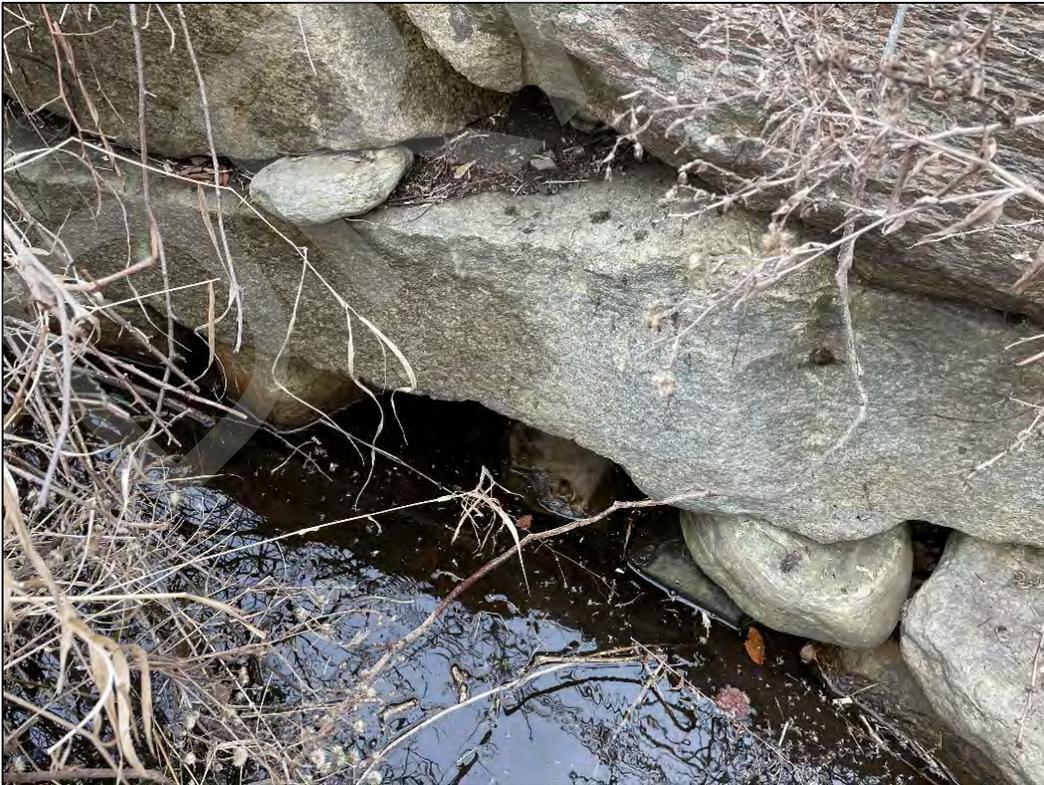
Photo No. 56.: Reach_C_#5.2 - Whitin Road west "culvert" downstream view. No visible culvert; possibly fully collapsed

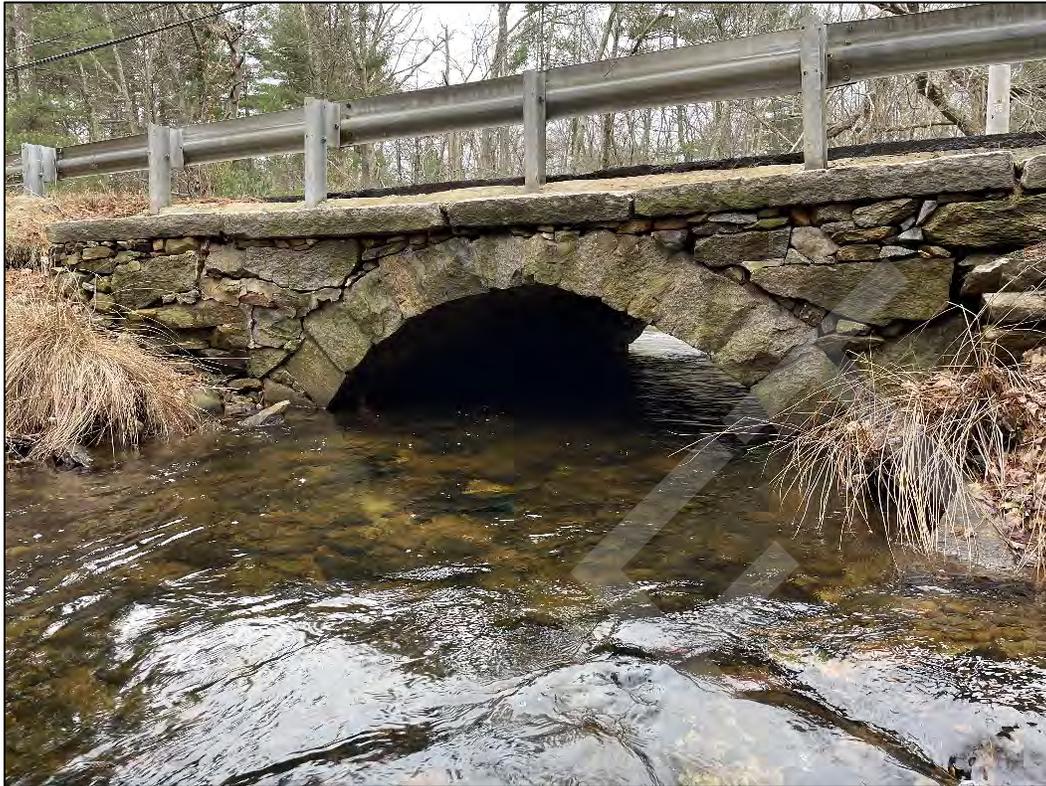
Photo No. 57.: Reach_C_#6.1 – Main Street main culvert downstream view; along tributary from Whitins Reservoir Dam.

22	C	6.1-6.3	Main Street	State	Crossing Replacements (3EA)	8.3.2	Replace 8' arch with 19' bridge; Other two pipes with 6'w culverts	Increased capacity of crossing, reduction in river levels upstream, reduction in frequency of road overtopping, improved stream connectivity	50-200	1,000	25-50	500	\$ 3,000	\$ 5,000	MADER
23	C	8-9	Potter Road Dam & Bridge	Town, Private	Dam Removal/Modification and Crossing Replacement	8.3.1.2	(Douglas) Remove or modify dam, replace bridge with 40' span	Reduction in river levels upstream, reduction in frequency of dam, driveway, and road overtopping, improved stream connectivity	10	200	5	50	\$ 2,000	\$ 4,000	EOEEA, MADER, MassDOT
24	C	6.4	Mumford Street	Town	Crossing Replacement	8.3.2	(Douglas) Replace twin 4'pipes with 20x6 culvert	Increased capacity of crossing, reduction in river levels upstream, reduction in frequency of road overtopping, improved stream connectivity	10	500	5	100	\$ 2,000	\$ 3,000	MassDOT, MADER

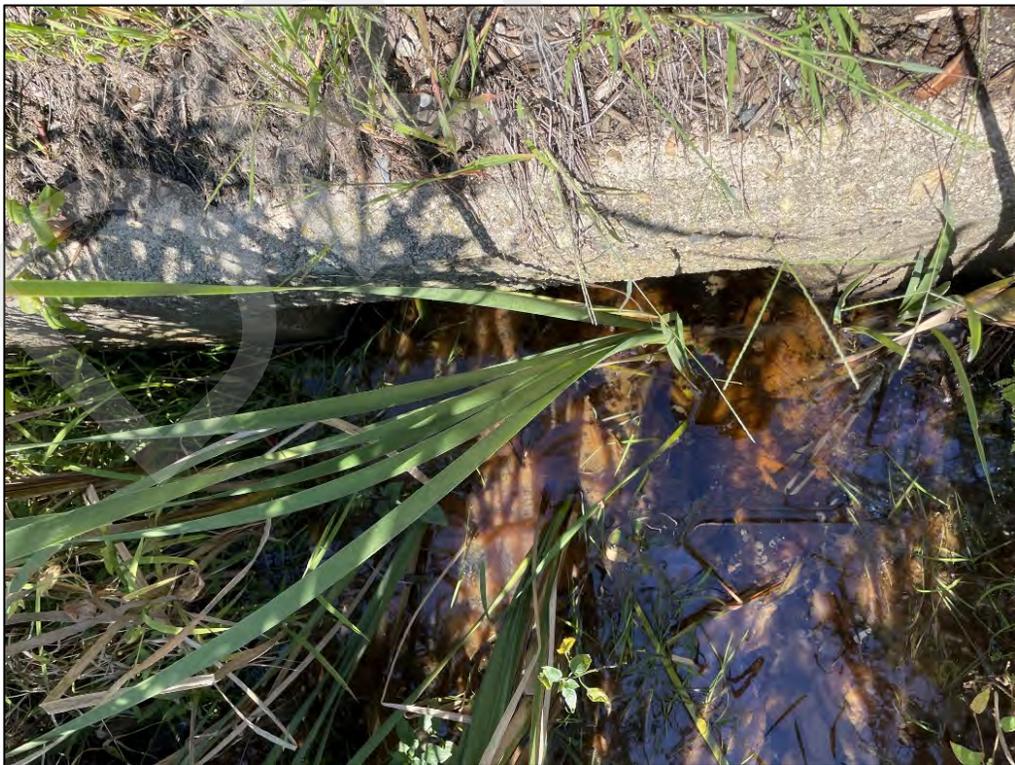
Photo No. 58.: Reach_C_#6.2 - Main Street west culvert upstream view.

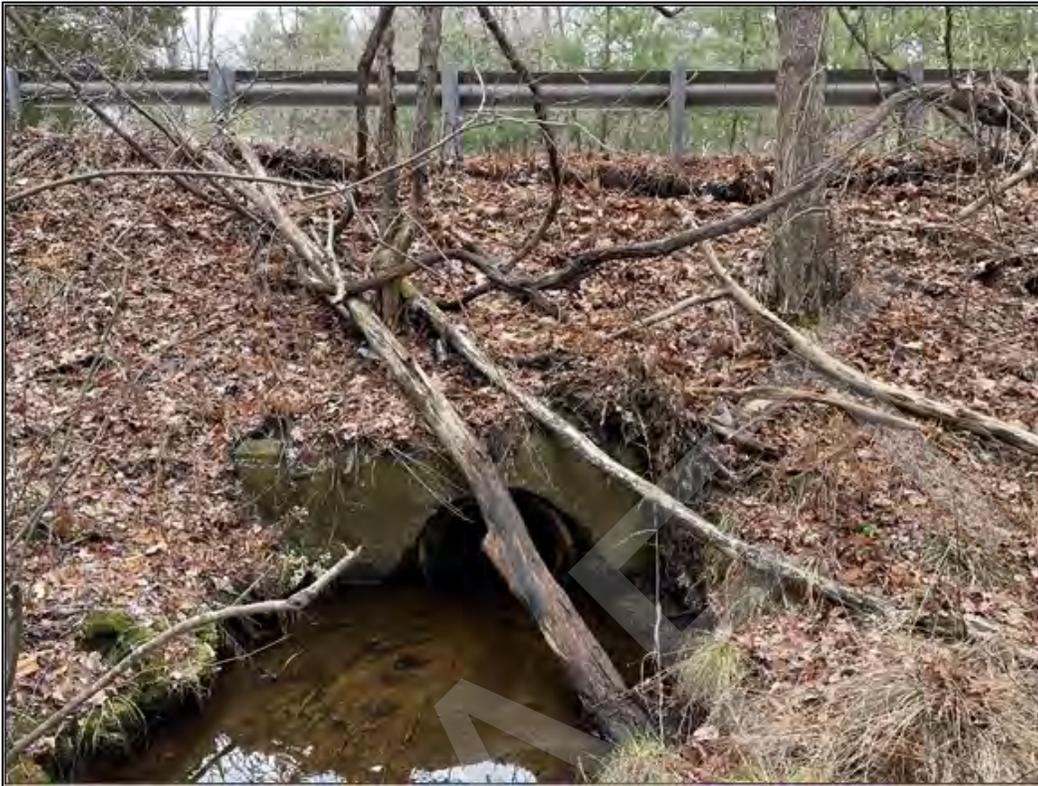
Photo No. 59.: Reach_C_#6.3 - Main Street east culvert upstream view.

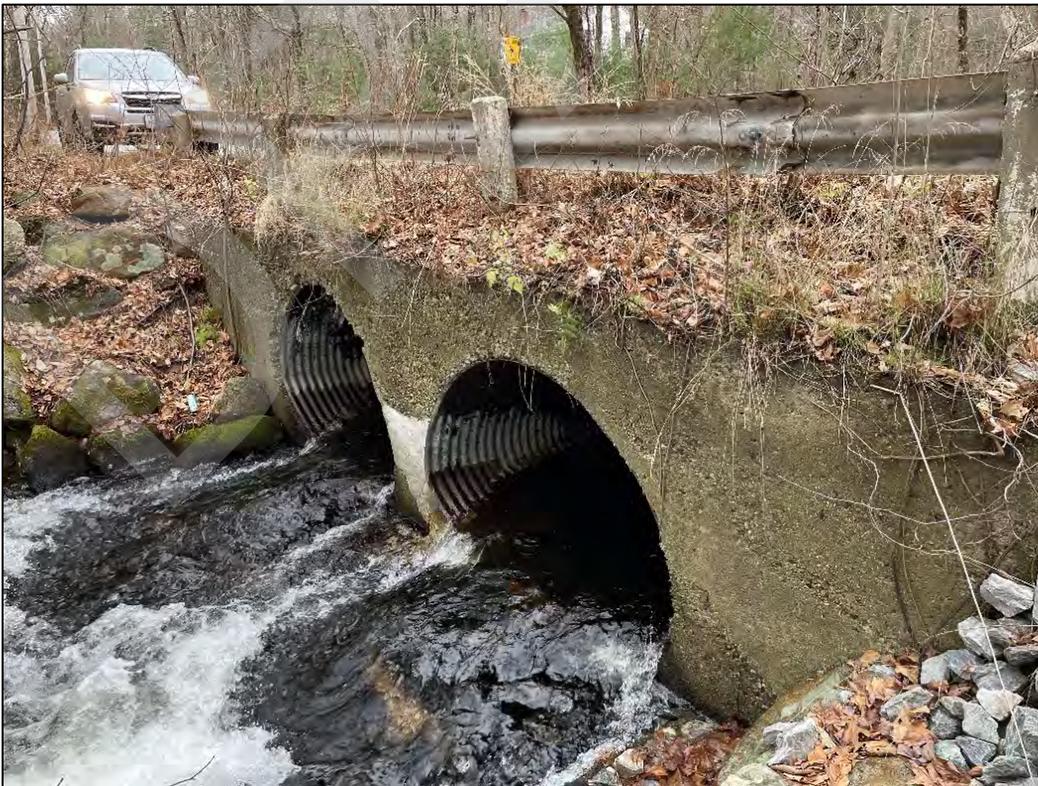
Photo No. 60.: Reach_C_#6.4 - Mumford Street crossing downstream view.

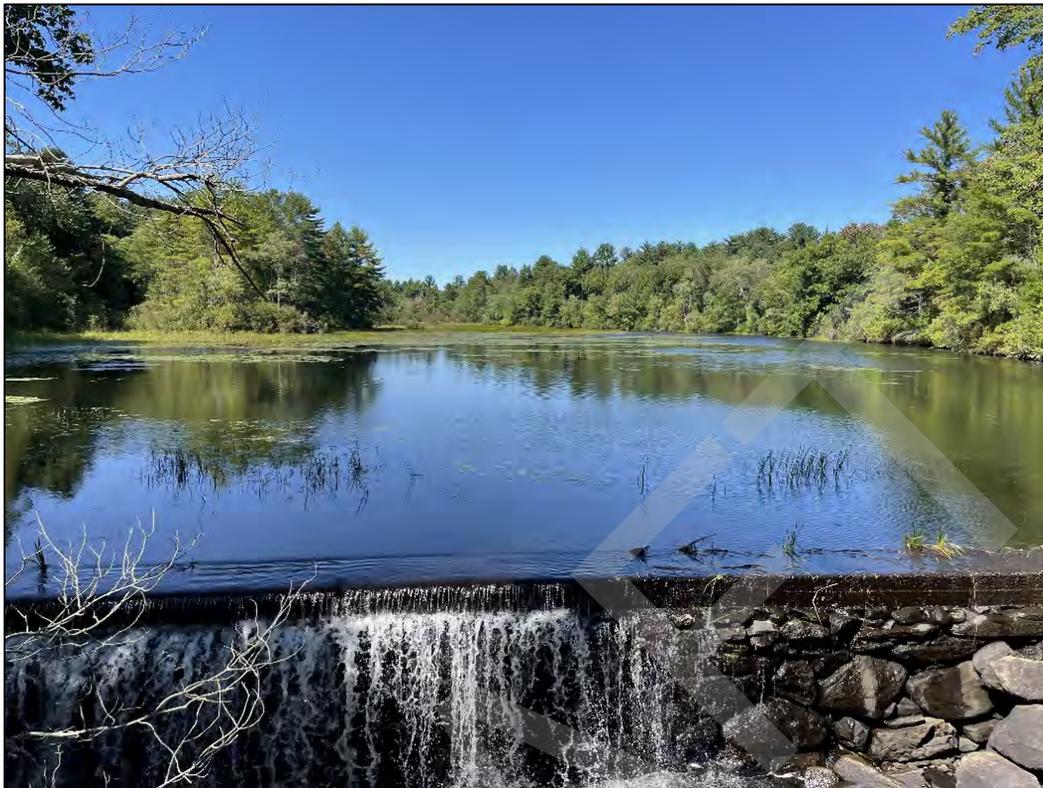
Photo No. 61.: Reach_C_#7 - Potter Road Dam and impoundment.
