PREPARED FOR: TOWN OF SUTTON

MANCHAUG WATER RESOURCES RESILIENCY ACTION PLAN Sutton, Massachusetts

PREPARED BY:
PARE CORPORATION
10 LINCOLN ROAD, SUITE 210
FOXBORO, MASSACHUSETTS 02035
PARE PROJECT NUMBER 22153.00

DRAFT Report – May 2023

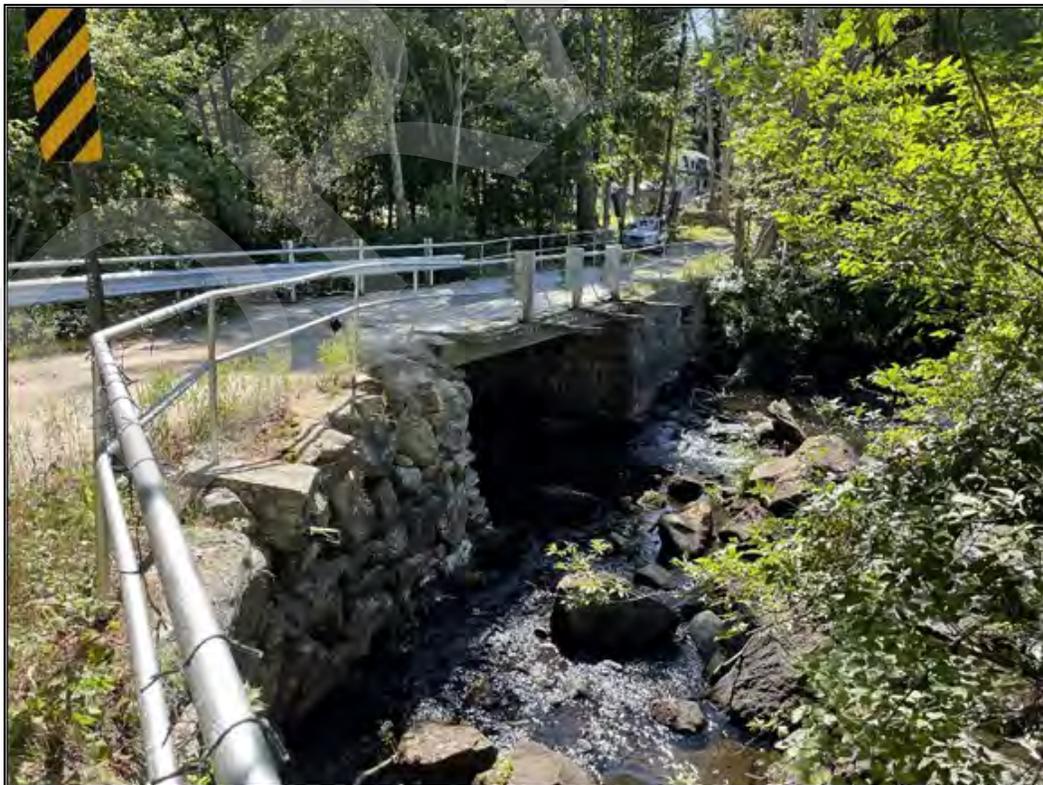
Photo No. 62.: Reach_C_#8 - Potter Road bridge upstream view.

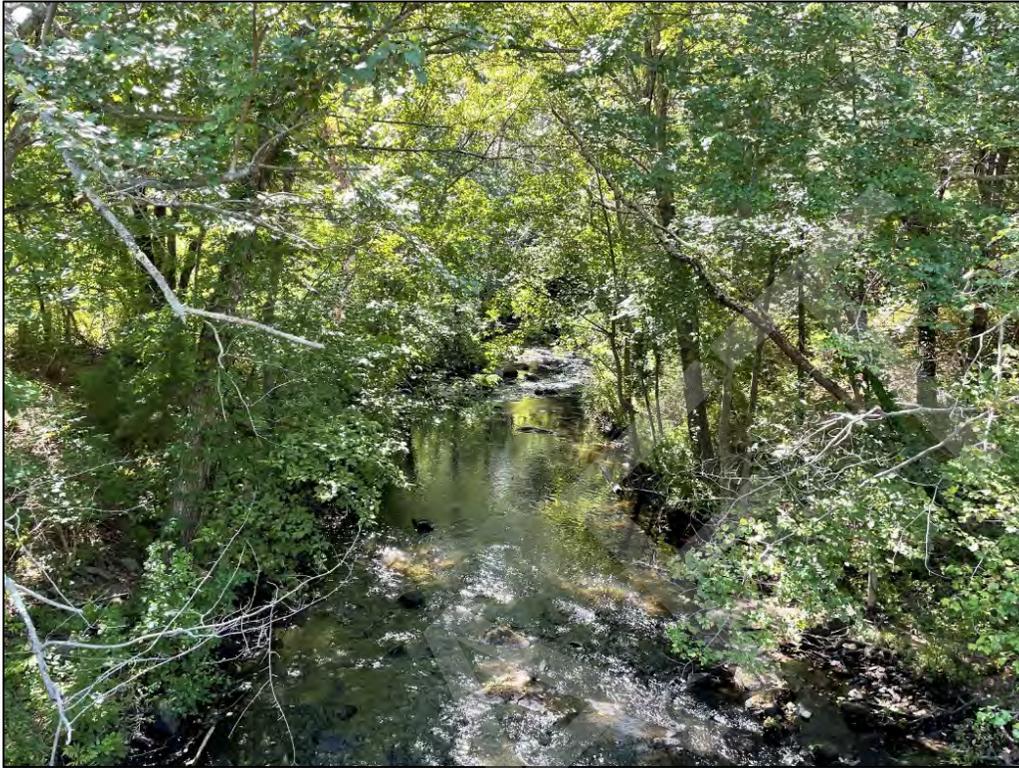
Photo No. 63.: Reach_D_#1 – Channel downstream of Potter Road; Note, confluence with Caswell Brook is located 200 feet downstream of Potter Road.

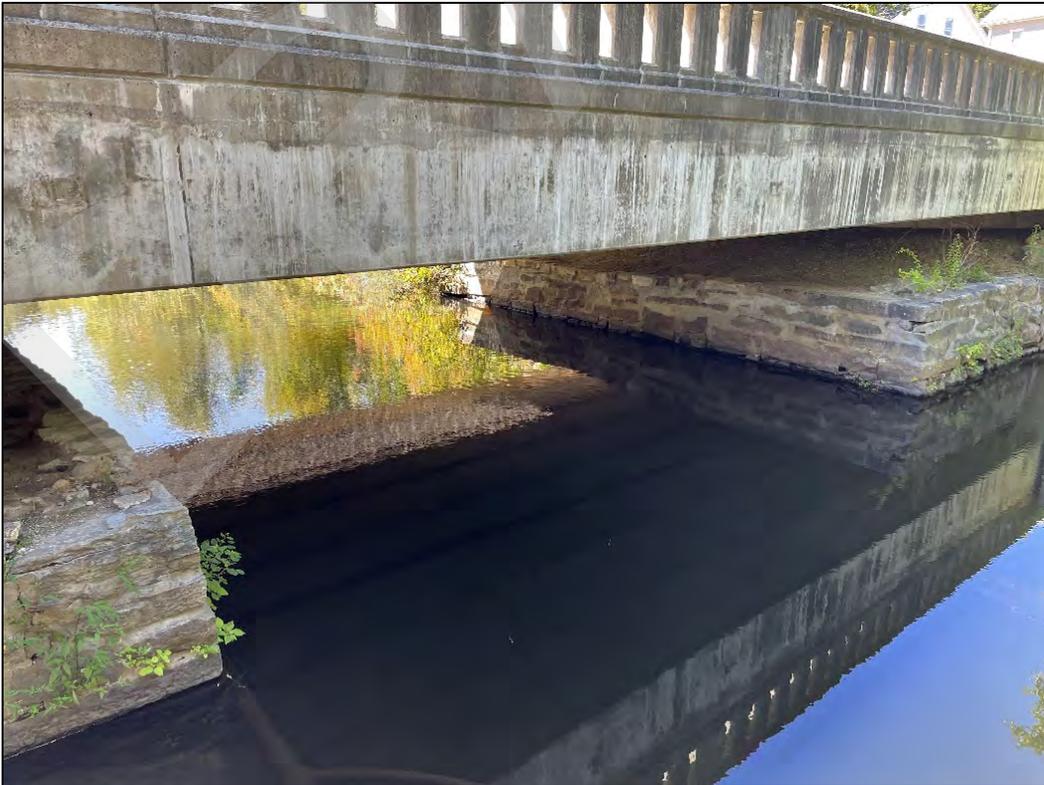
Photo No. 68.: Reach_D_#4 - Cook Street bridge downstream view.

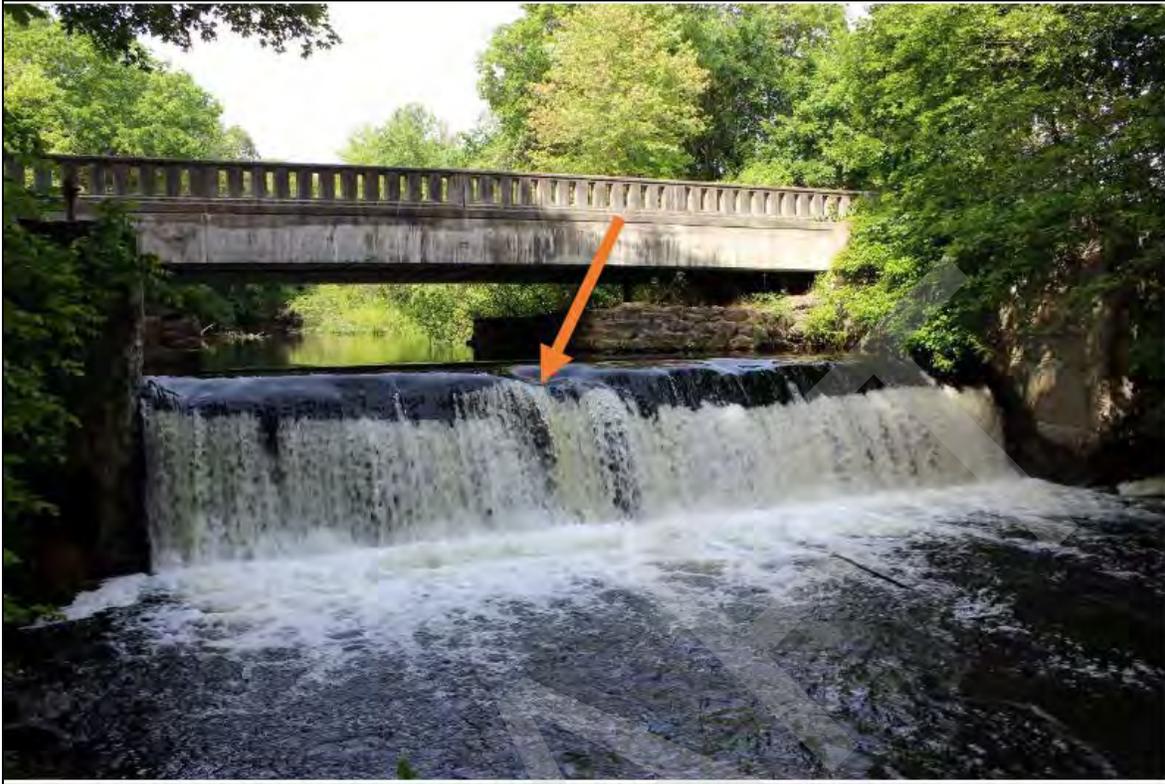
Photo No. 69.: Reach_D_#5 - Old Mill Pond Dam spillway (2021 Phase I - GZA)

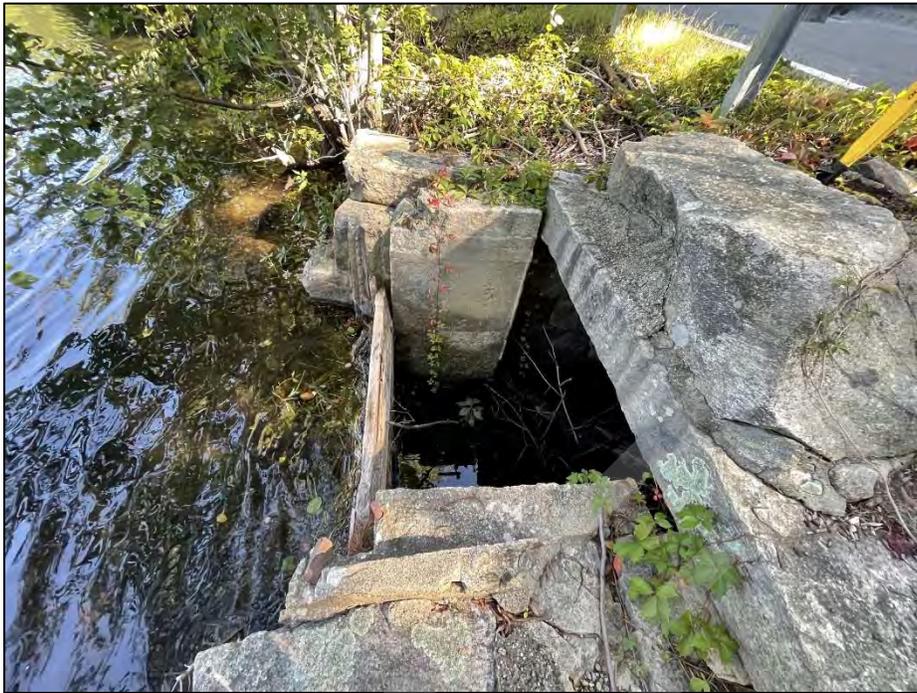
Photo No. 1.: Upper Tucker Pond East Dam spillway controls (a.1)

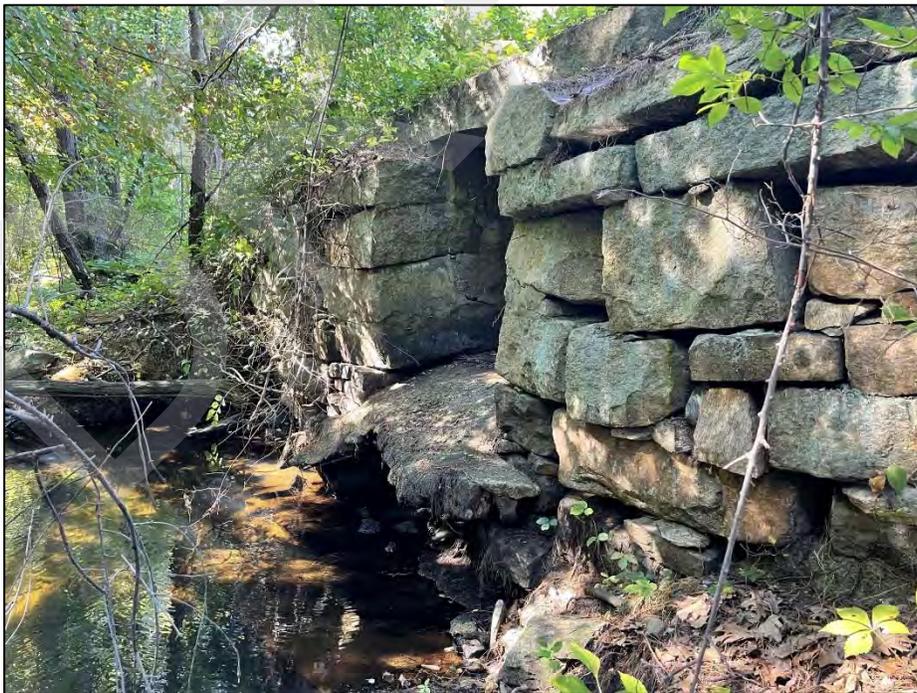
Photo No. 2.: Upper Tucker Pond East Dam discharge end of spillway culvert (a.1)

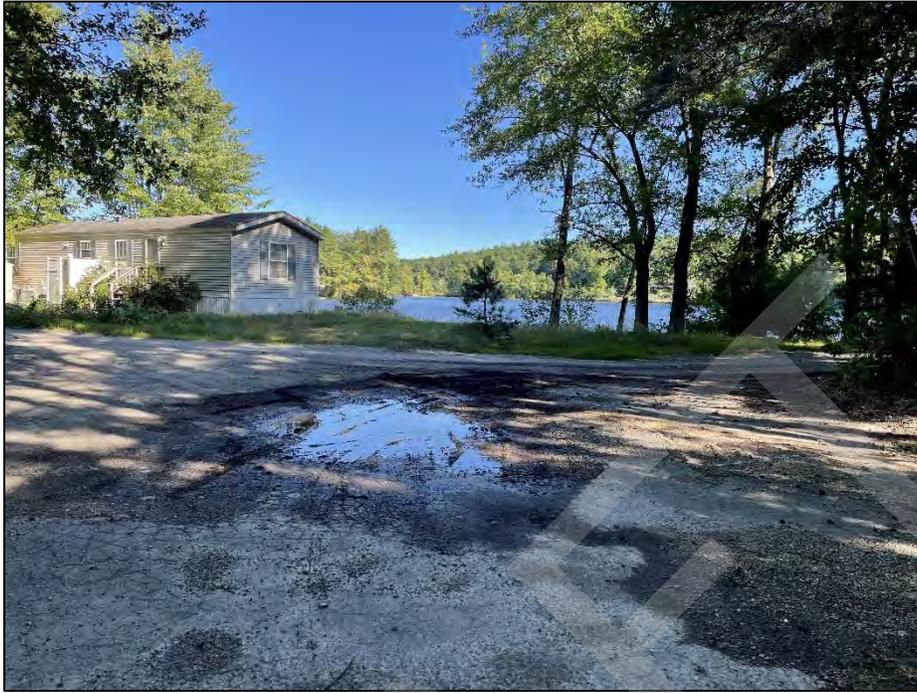
Photo No. 3.: Upper Tucker Pond South Dam low area at right end of dam that serves as informal auxiliary spillway (a.2)

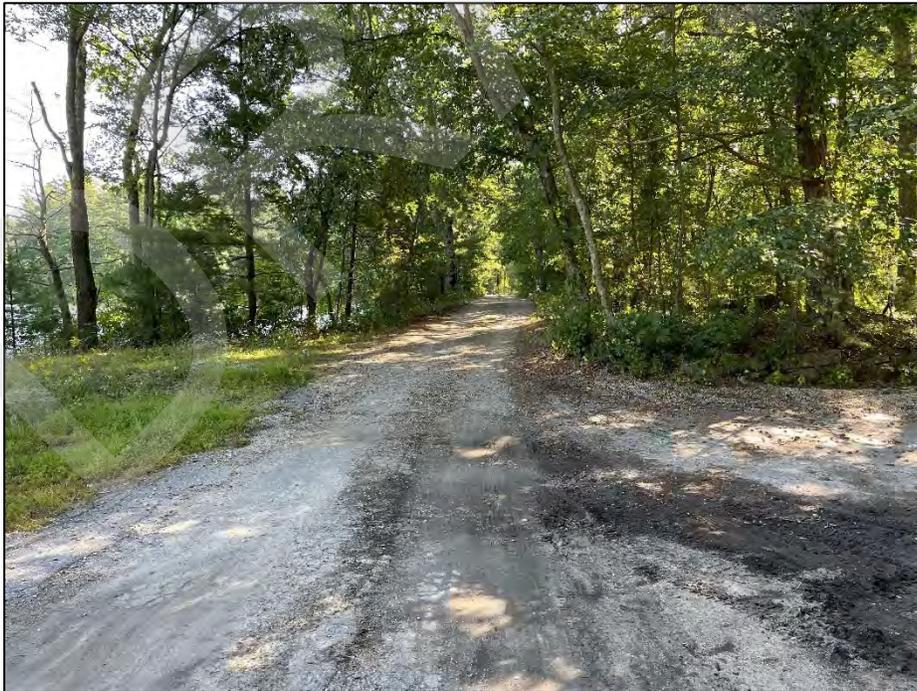
Photo No. 4.: Upper Tucker Pond South Dam from low area looking left (a.2)

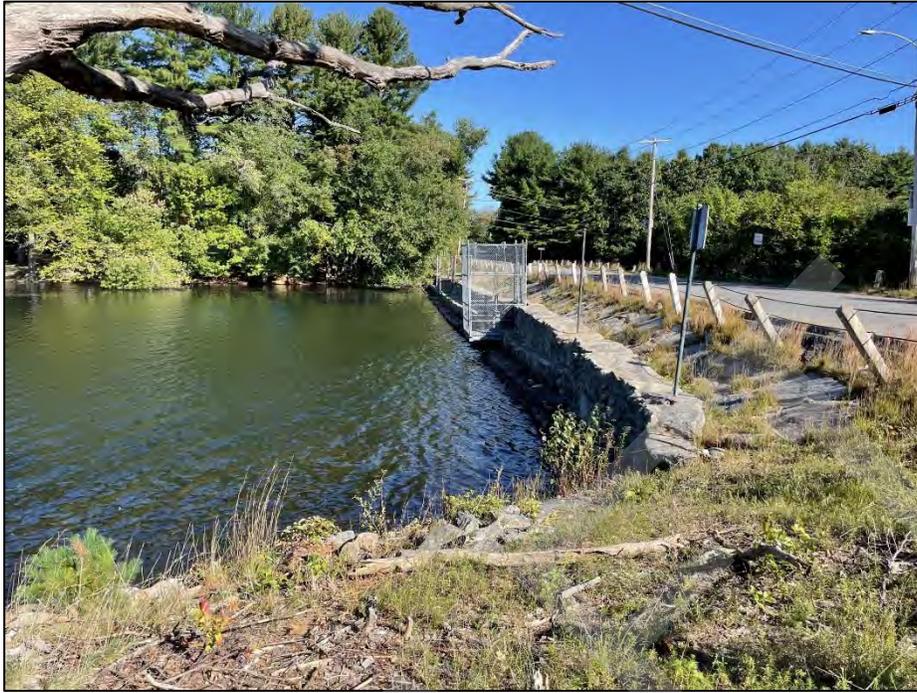
Photo No. 5.: Manchaug Pond Dam upstream face (b)

10.2	4.4	-	6.7	MA00955 Manchaug Pond Dam (Torrey Road)	29' high dam/roadway embankment with 10' wide stop log controlled spillway culvert and 2' square gated LLO conduit	Town	High Hazard Dam in Fair Condition; Dam provides extensive attenuation; Dam can accommodate all recurrent storm events; Cannot accommodate its SDF, the 1/2 PMF; therefore, dam is not SDF compliant	>1,000-yr	200-yr

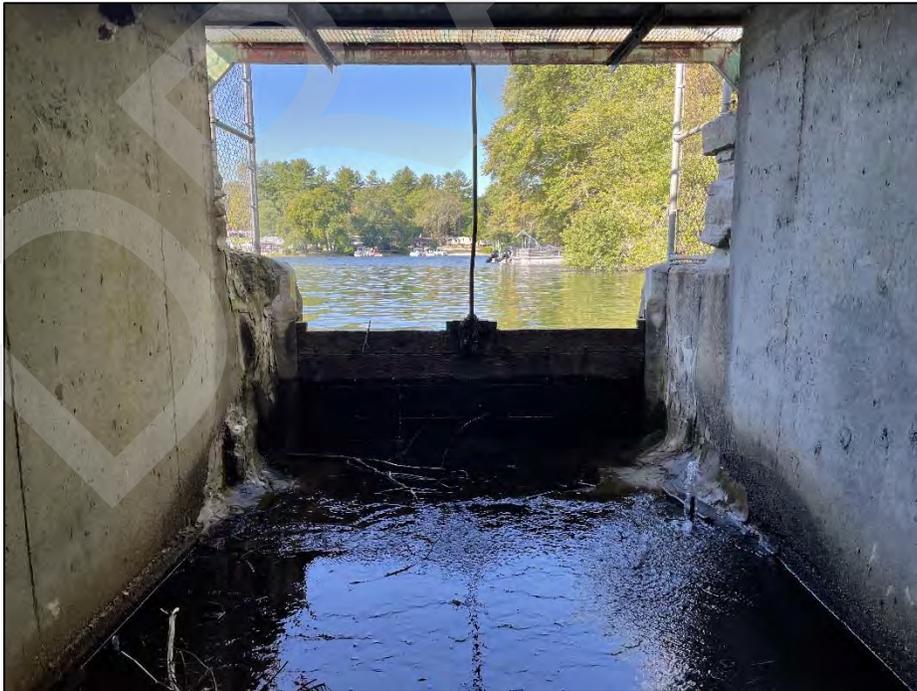
Photo No. 6.: Manchaug Pond Dam spillway controls (b)

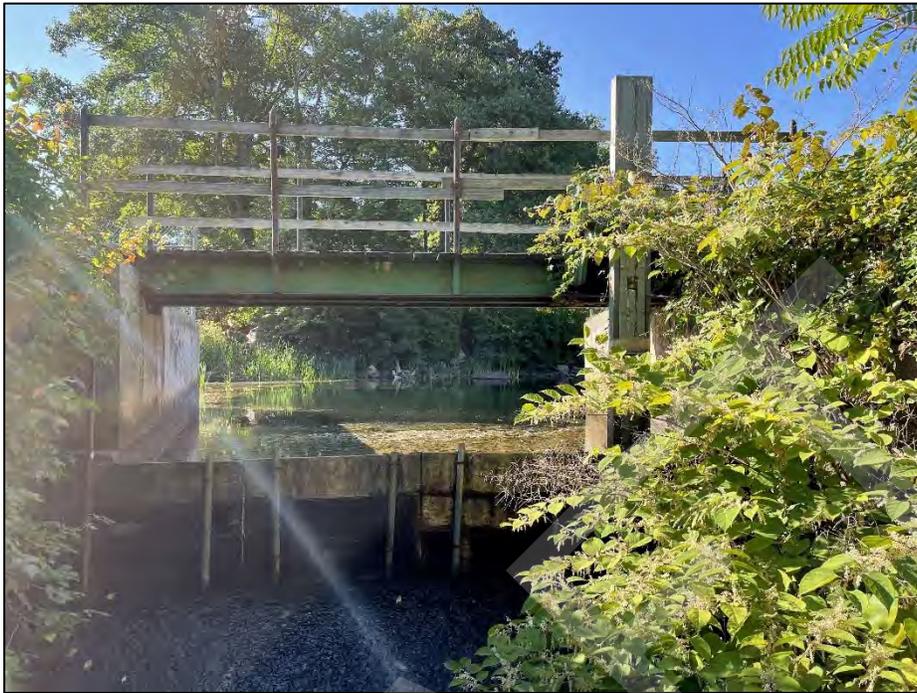
Photo No. 7.: Stevens Pond Dam spillway controls (c)

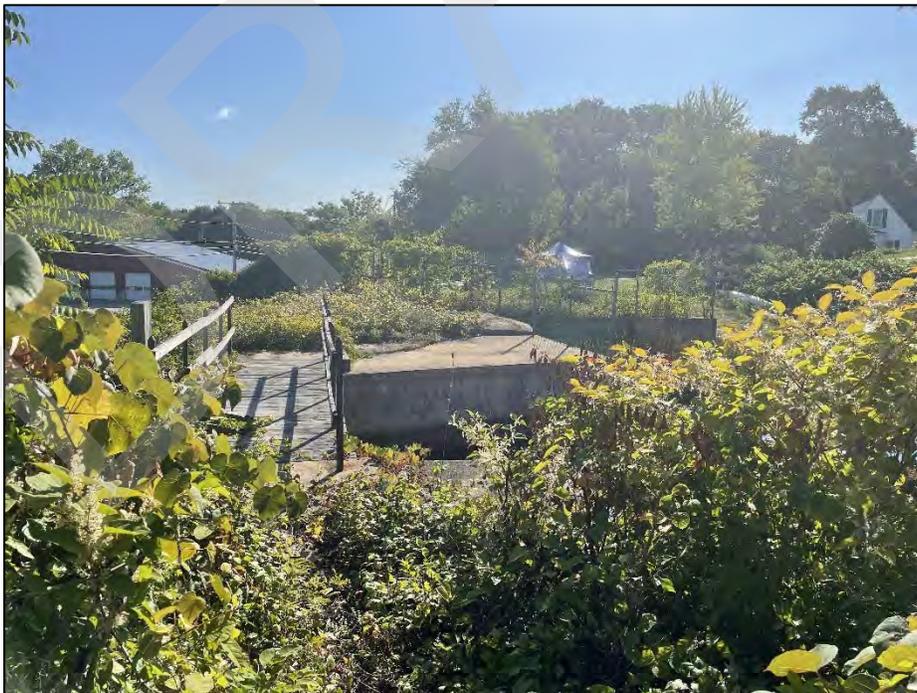
Photo No. 8.: Stevens Pond Dam crest overview (c)

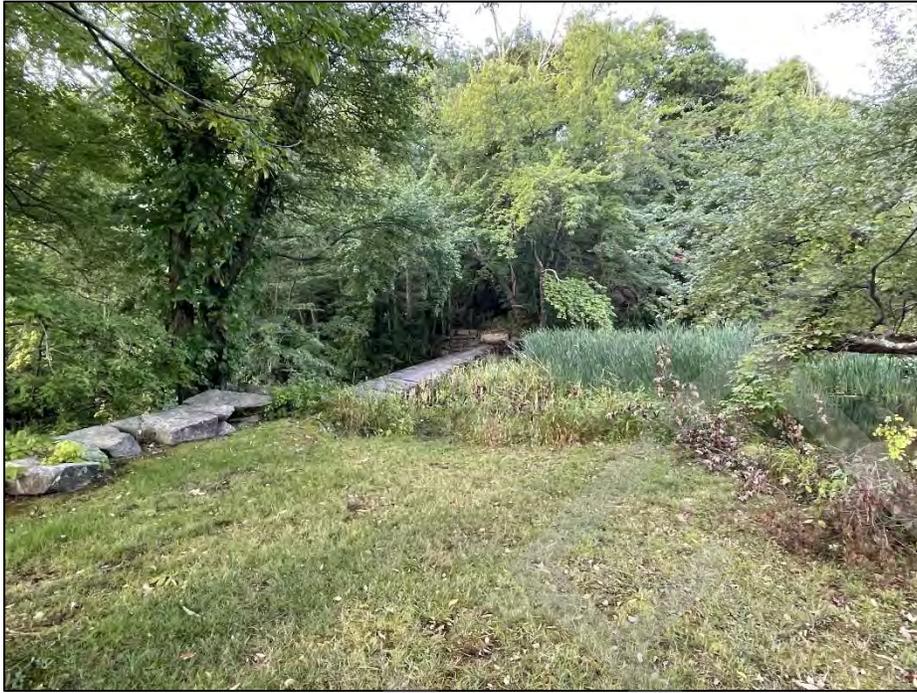
Photo No. 9.: Mill Site #2 Dam upstream face. (d)

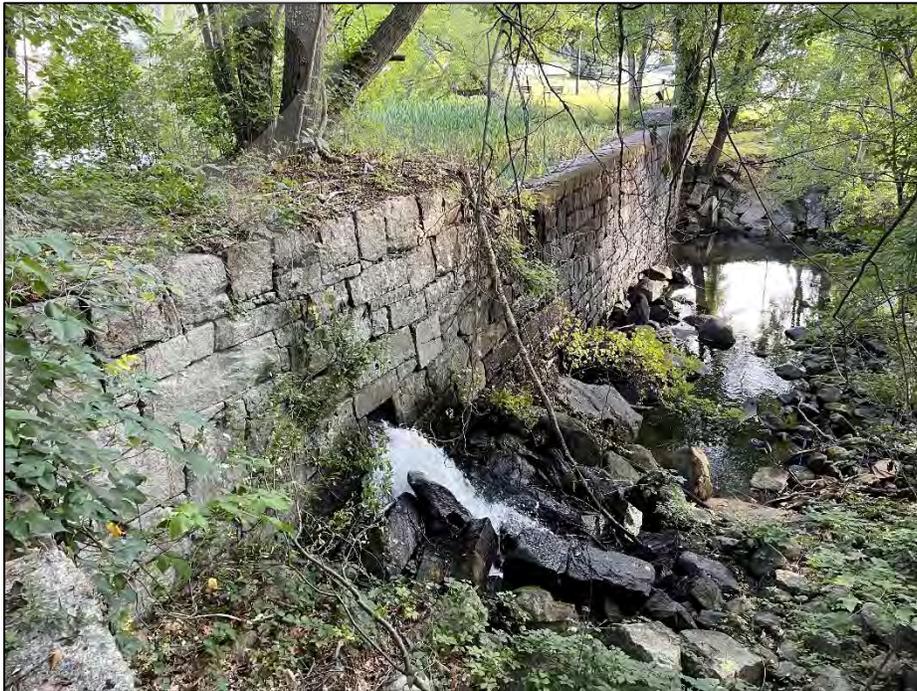
Photo No. 10.: Mill Site #2 Dam downstream face (d)

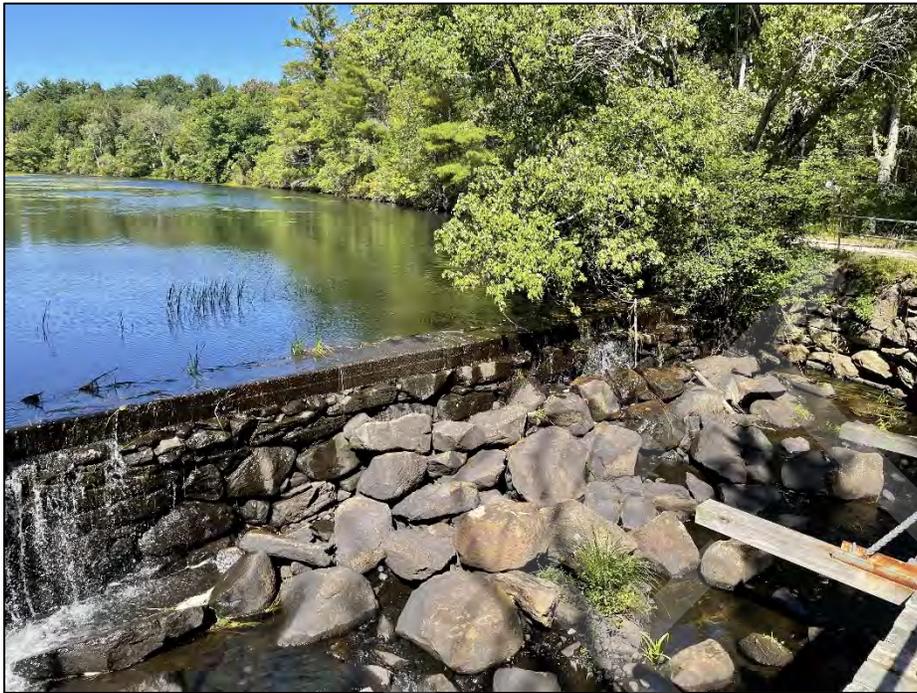
Photo No. 11.: Potter Road Dam downstream face left (e)

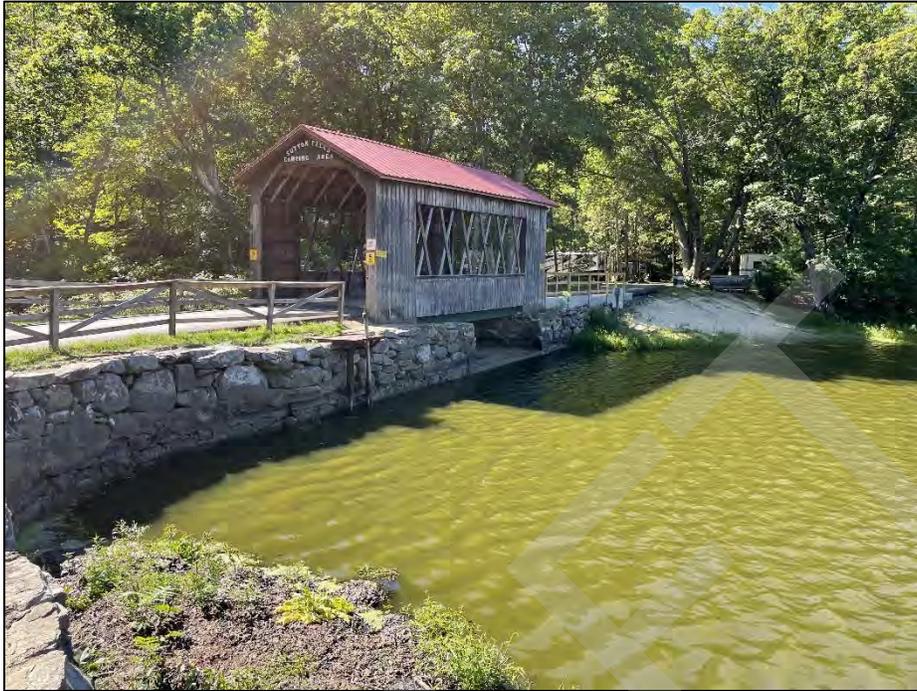
Photo No. 13.: Sutton Falls Dam upstream face (f)

9.1	2.0	-	2.8	Sutton Falls Pond	Impoundment	Private	9' deep impoundment with 3' of freeboard	10-yr	5-yr
9.2	2.3	-	2.8	MA00956 Sutton Falls Pond Dam (Aldrich Lane)	12' high dam embankment with 19' long spillway	Private	Significant Hazard Dam in Fair Condition; Little attenuation provided by impoundment and dam; >10-year storm will overtop the dam; SDF for dam is 100-year - not SDF compliant	10-yr	5-yr

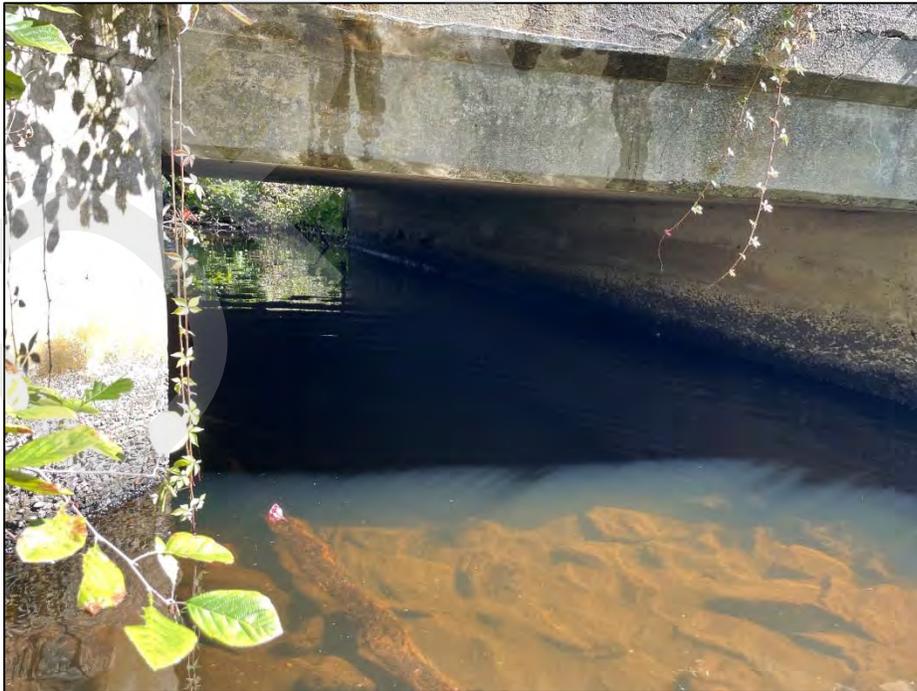
Photo No. 16.: Putnam Hill Road bridge crossing looking upstream (1.1)

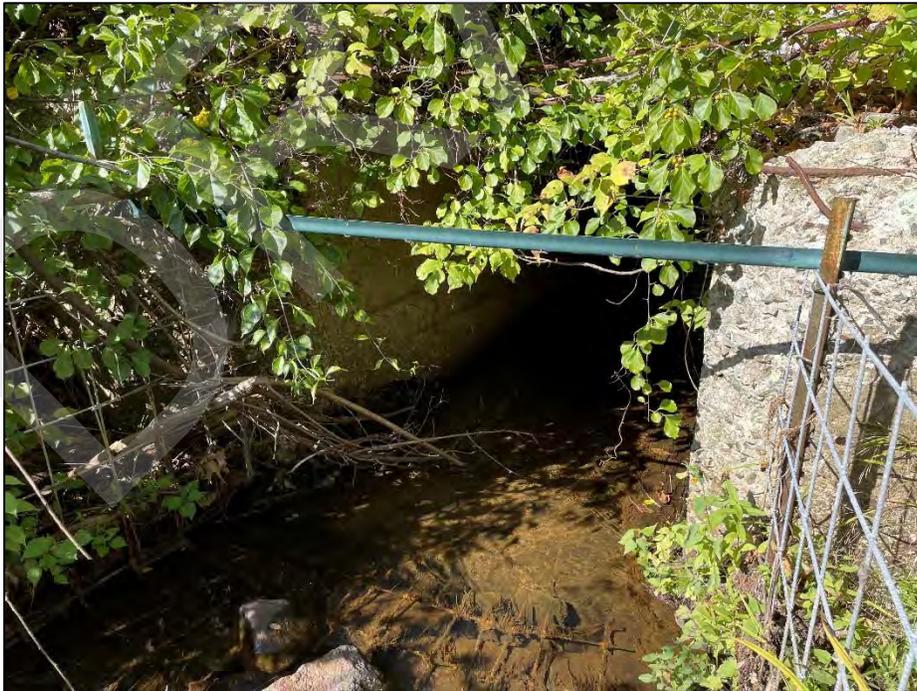
Photo No. 18.: Putnam Hill Road culvert crossing upstream end (1.2)

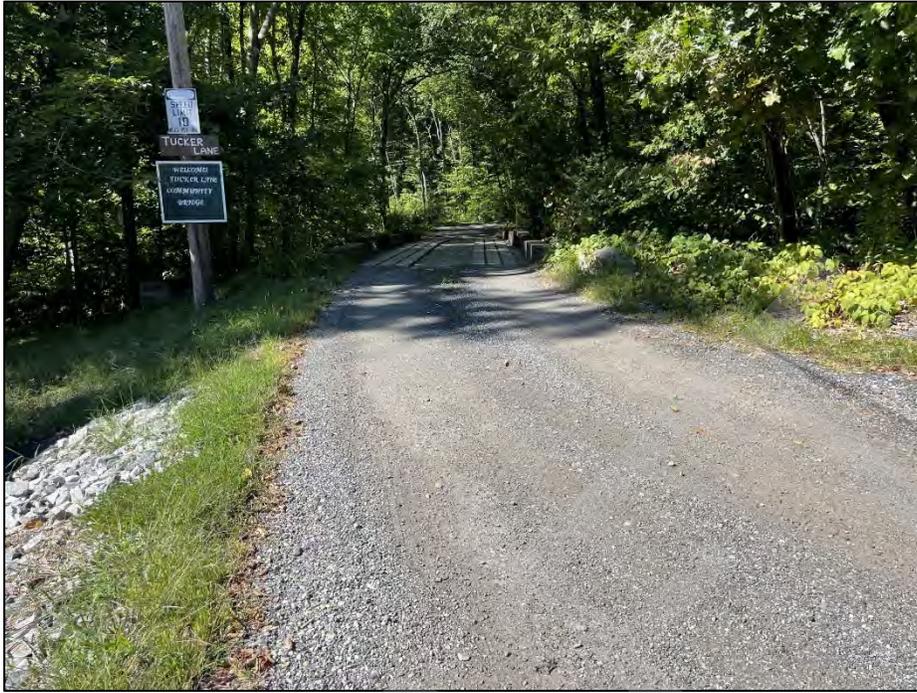
Photo No. 19.: Tucker Lane (2)

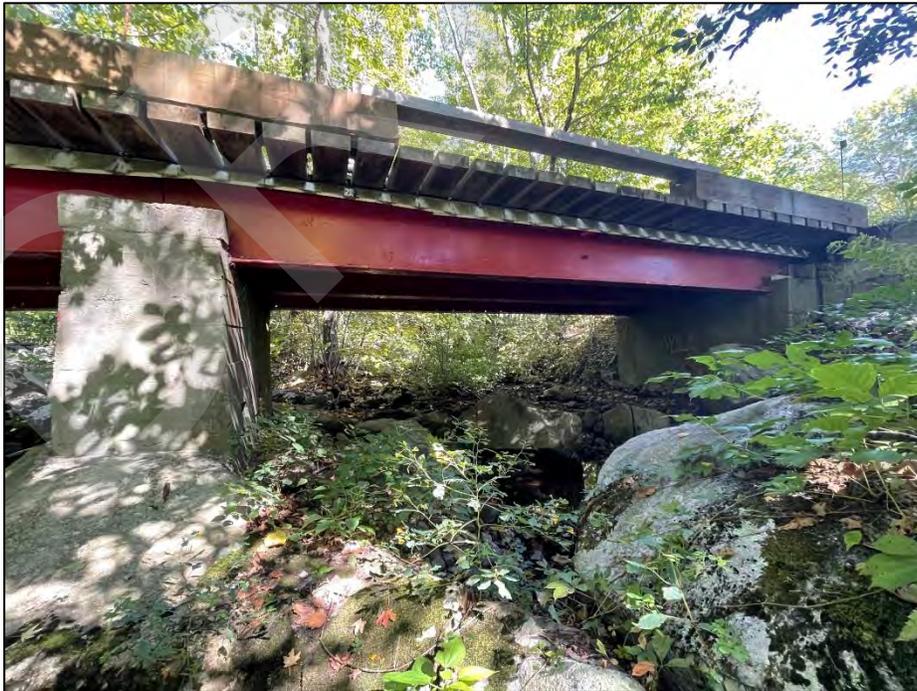
Photo No. 20.: Tucker Lane bridge overview from downstream looking upstream (2)

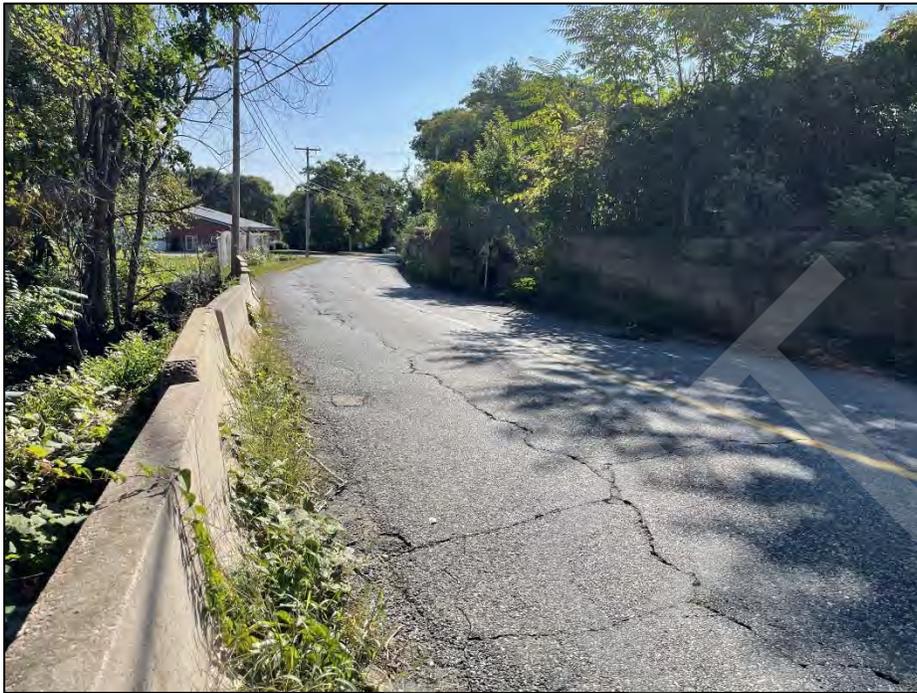
Photo No. 21.: Manchaug Road (3.1)

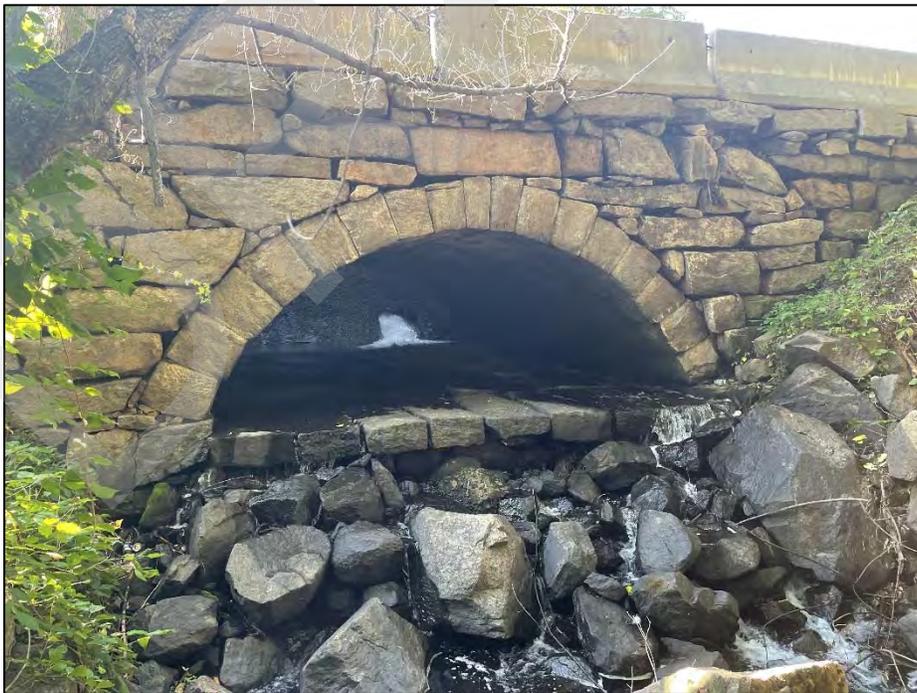
Photo No. 22.: Manchaug Road bridge (3.1)

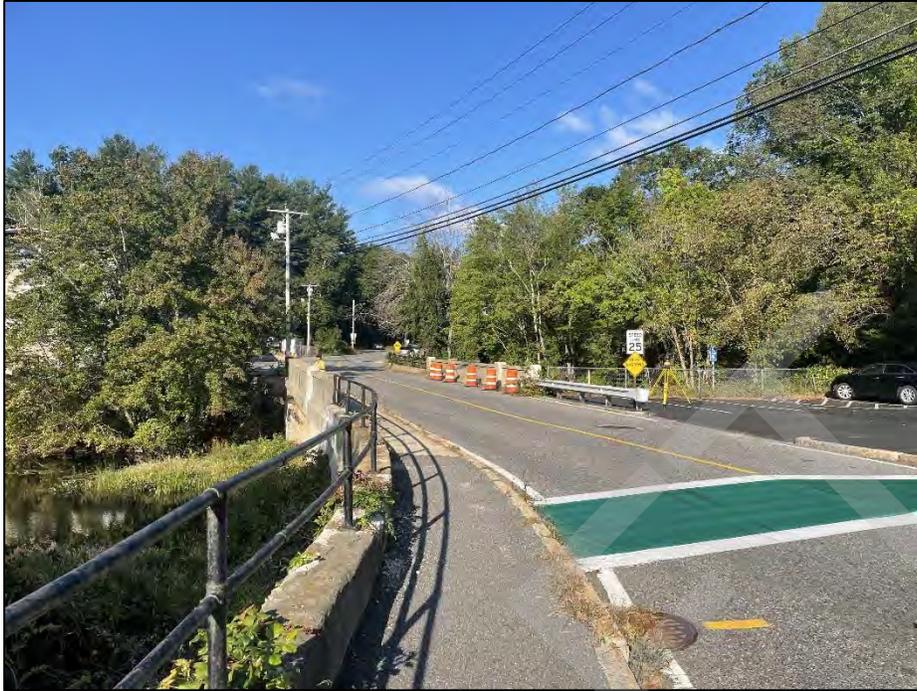
Photo No. 23.: Manchaug Road (3.2)

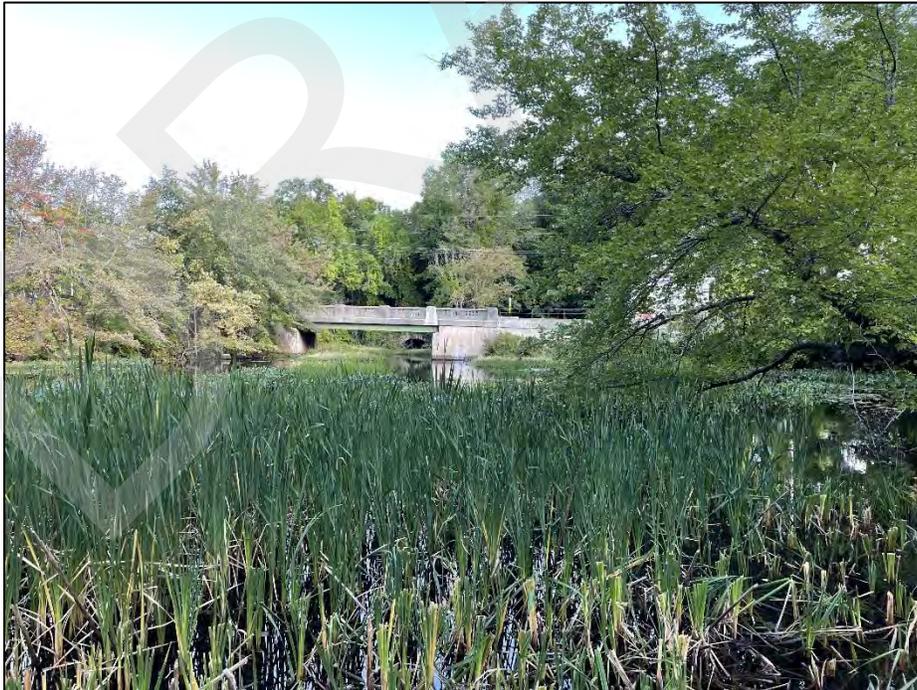
Photo No. 24.: Manchaug Road bridge (3.2)

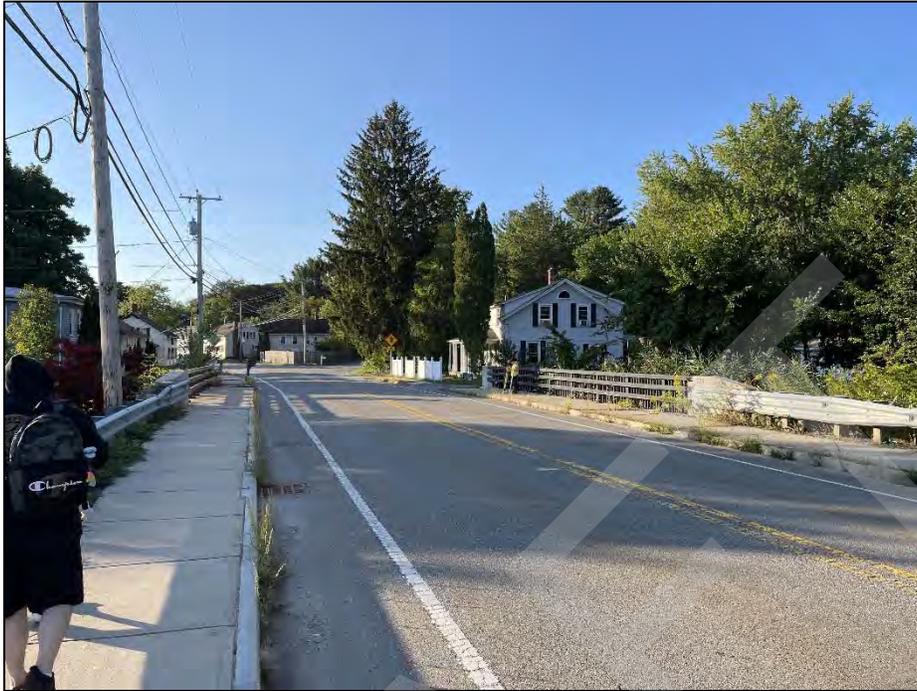
Photo No. 25.: Manchaug Road 3.3

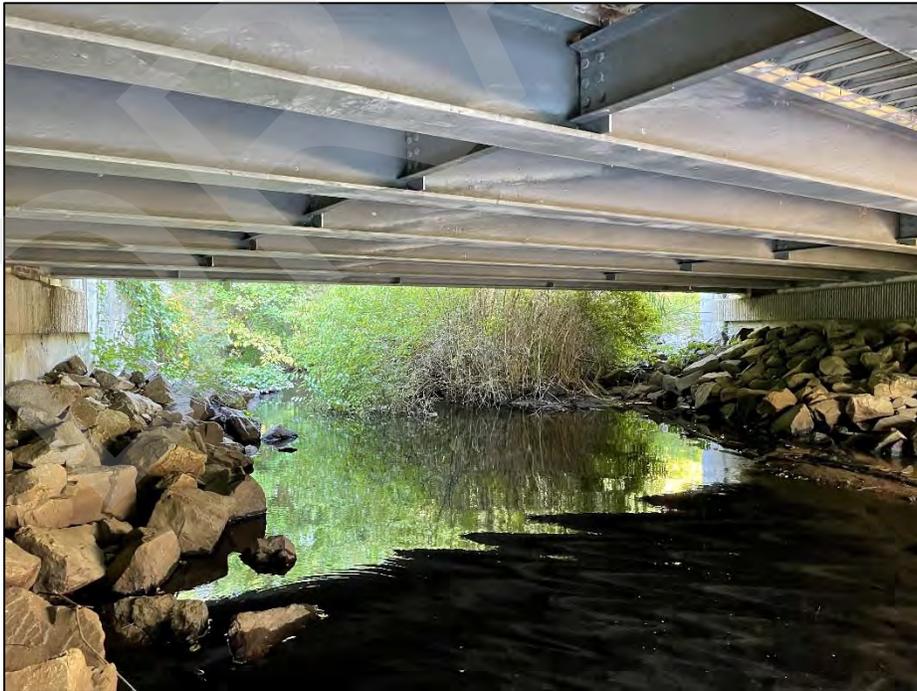
Photo No. 26.: Manchaug Road bridge looking upstream (3.3)

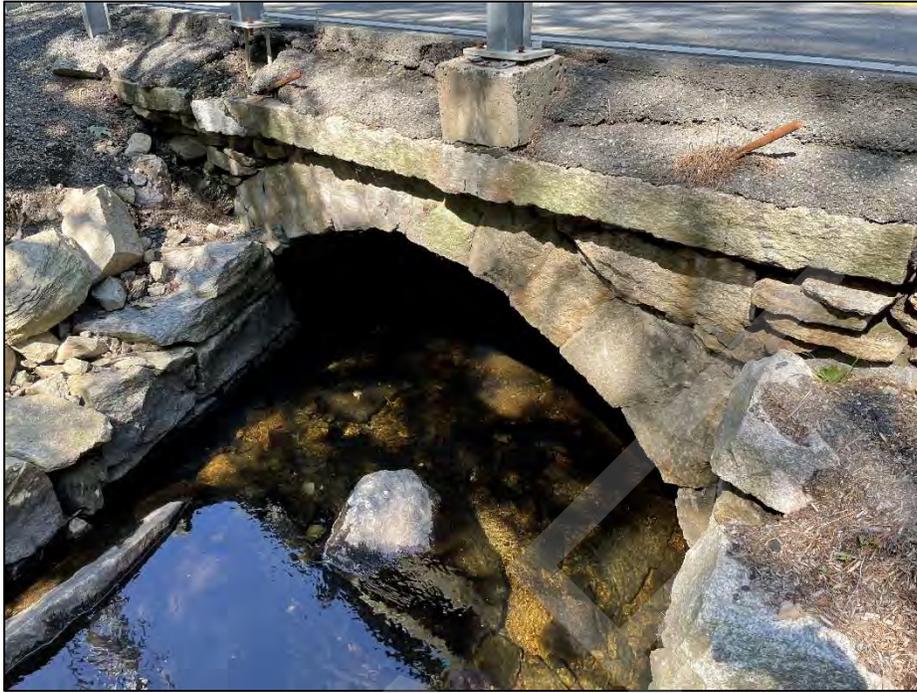
Photo No. 27.: Manchaug Road culvert upstream end (3.4)

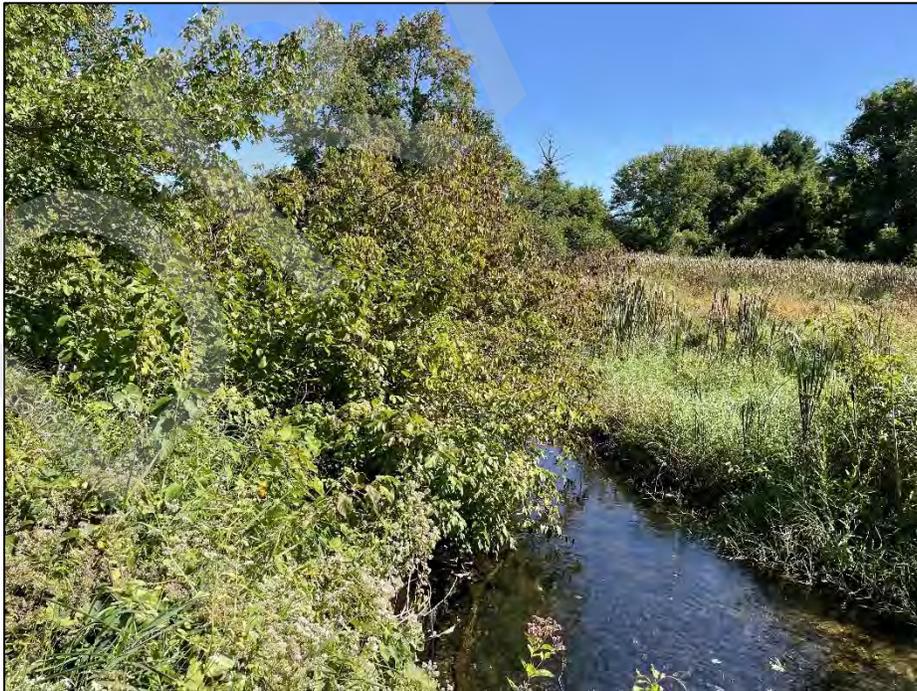
Photo No. 28.: Manchaug Road culvert discharge area / downstream channel (3.4)

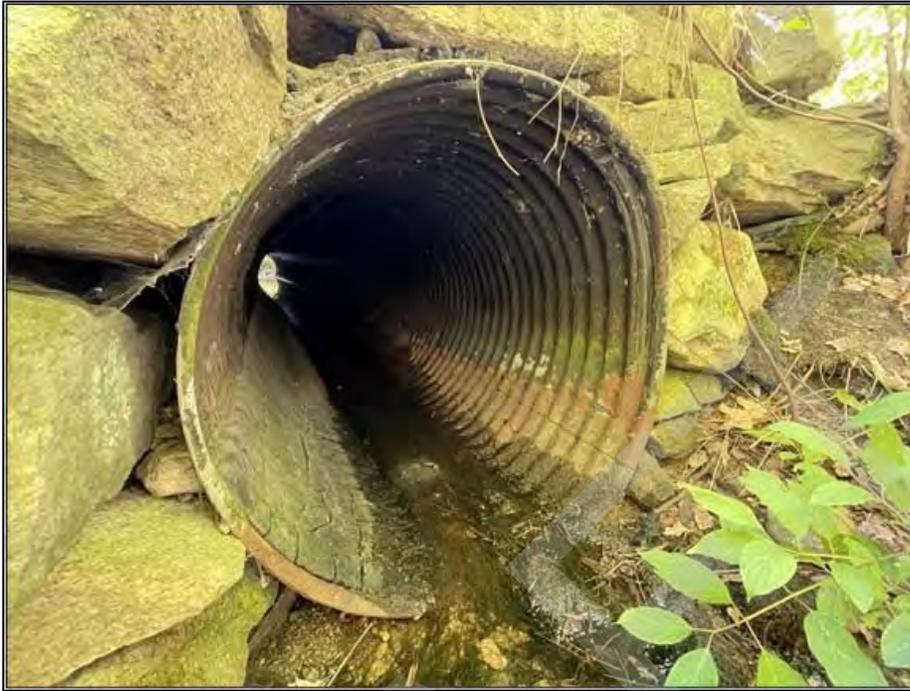
Photo No. 29.: Whitins Road culvert from downstream end (4.2)

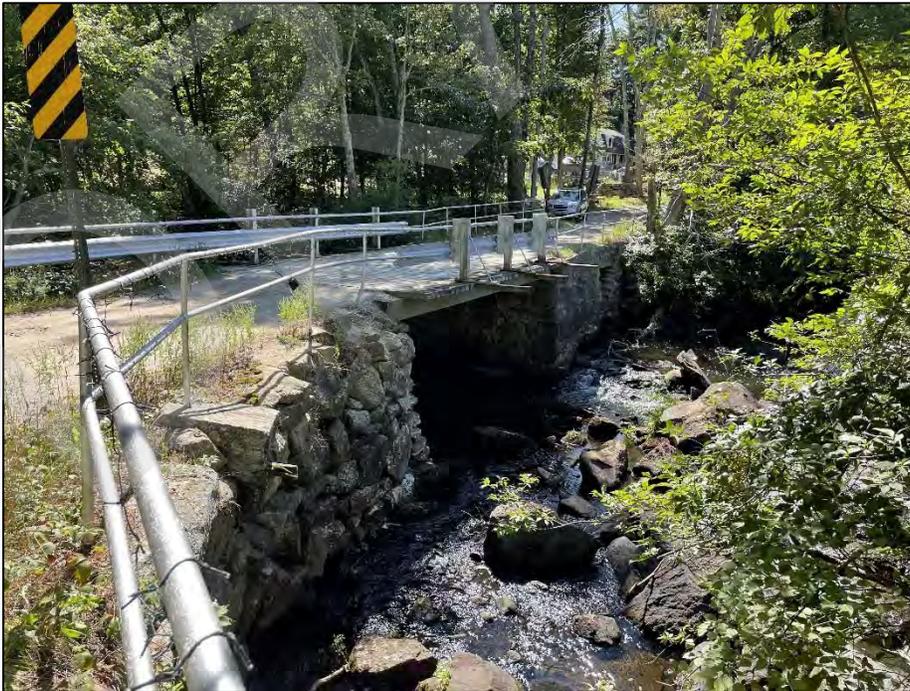
Photo No. 30.: Potter Road bridge (6)

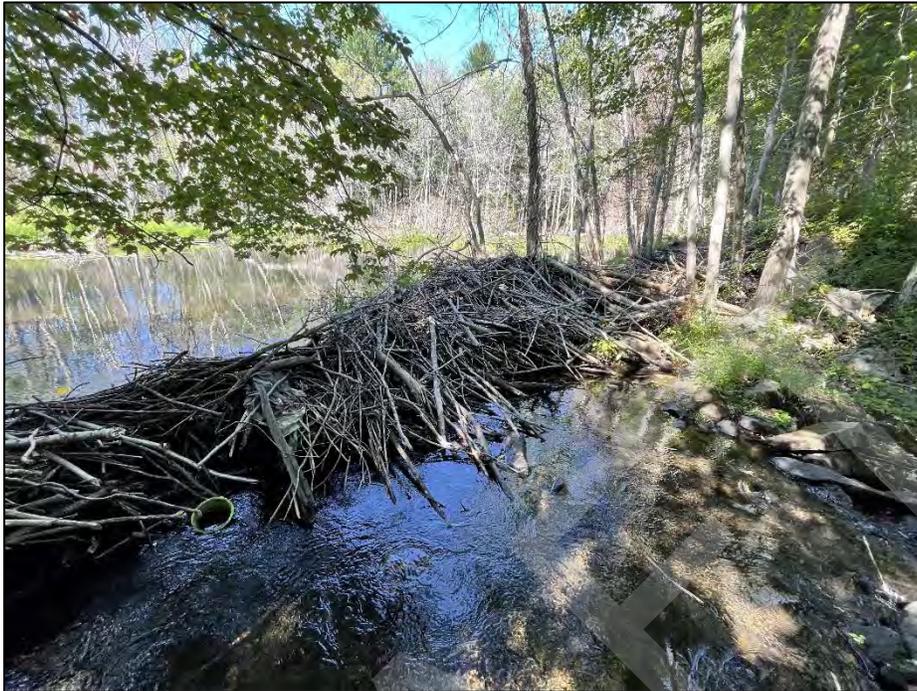
Photo No. 31.: 3-foot high beaver dam (A1) that has formed within breached section of the former dam embankment at Mill Site #1 (B1).

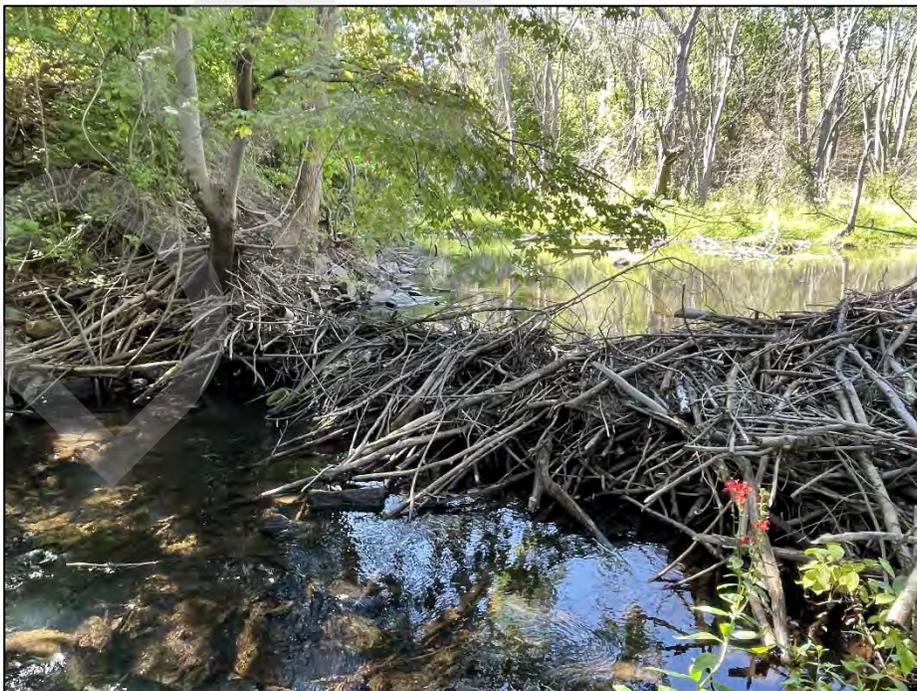
Photo No. 32.: Another view of the 3-foot high beaver dam (A1) that has formed within breached section of the former dam embankment at Mill Site #1 (B1).

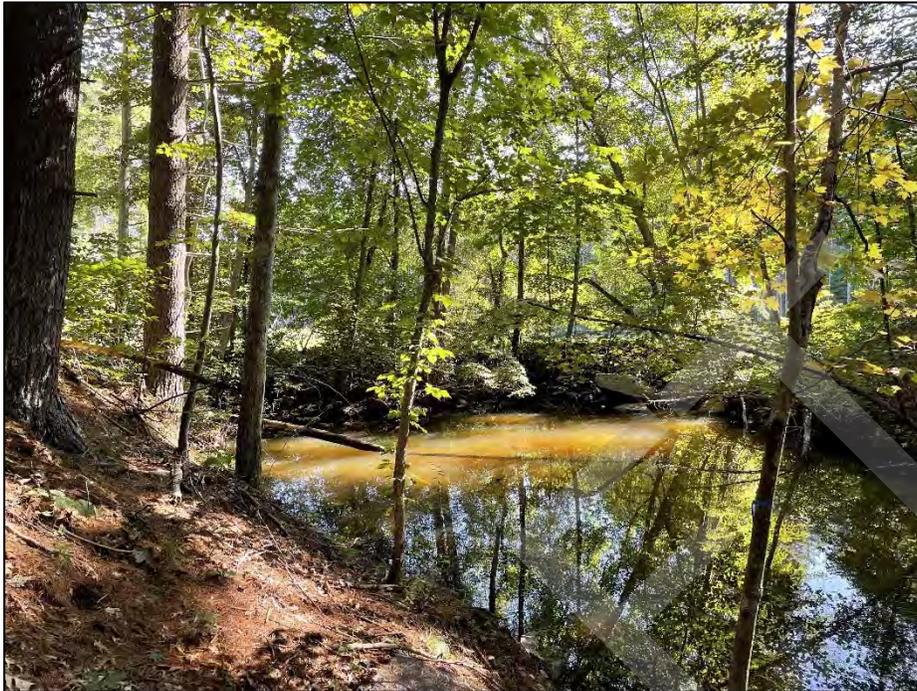
Photo No. 33.: View of the 6-foot high beaver dam (A2) that has formed within the breached section of a former dam embankment (B2).

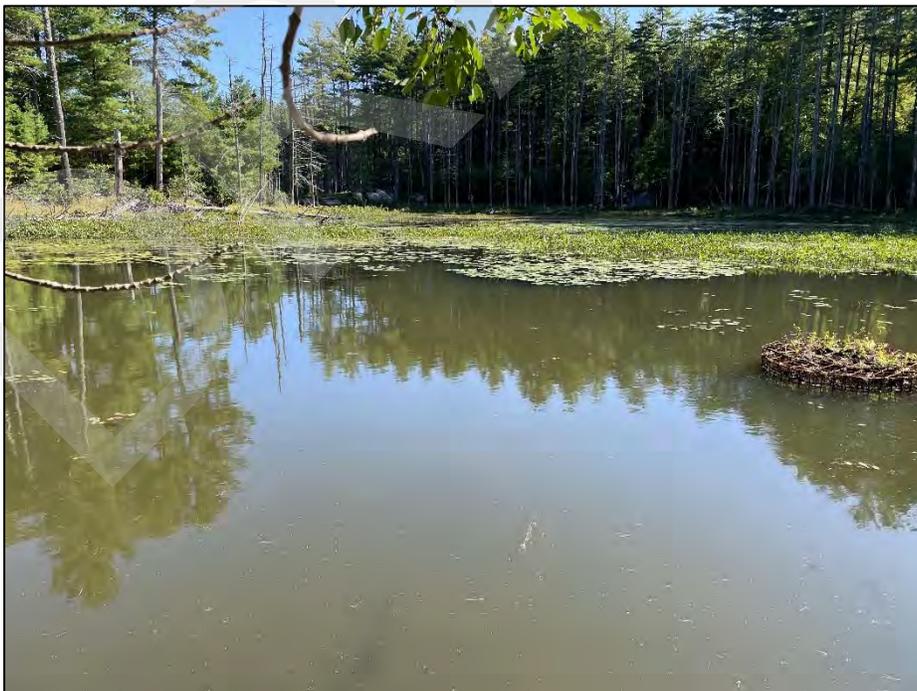
Photo No. 34.: View of the impoundment created by this beaver dam; note the beaver diver inlet cage photo right (A2 / B2)
