PREPARED FOR: TOWN OF SUTTON

MANCHAUG WATER RESOURCES RESILIENCY ACTION PLAN Sutton, Massachusetts

PREPARED BY:
PARE CORPORATION
10 LINCOLN ROAD, SUITE 210
FOXBORO, MASSACHUSETTS 02035
PARE PROJECT NUMBER 22153.00

DRAFT Report – May 2023

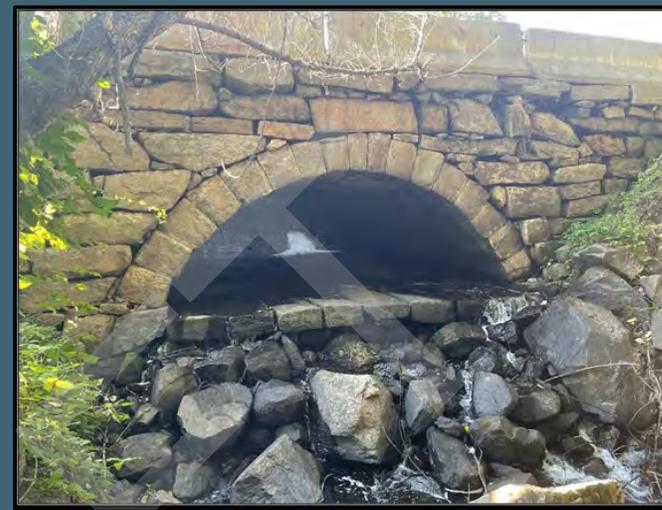
Stevens Pond Dam Modifications

1. **Replace Spillway Controls:** Remove flash boards & top 2' of concrete control section; replace with 16'w x 3'h rotary/tainter gate; automate operations
2. **Low Level Outlet (LLO) Controls:** Remove existing gate; Square DS end of conduit & install 3' square upward operating orifice gate; automate operations
3. **Crest Elevation:** Establish a consistent crest elevation of El. 475 (Current mins El. 474.2)
4. **Embankment Improvements:** Upstream slope riprap, regrade crest & downstream slope, toe drain system, grass vegetation
5. **Other Dam Repairs and Modifications:** If Needed
6. **Operational Plan:** Pre-storm (1/2 PMF) drawdown to El. 467 (~2.5' below normal pool – El. 469.5); Other operational procedures to limit outflows
7. **Manchaug Road Improvements:** Replace bridge, widen roadway, improve site distance

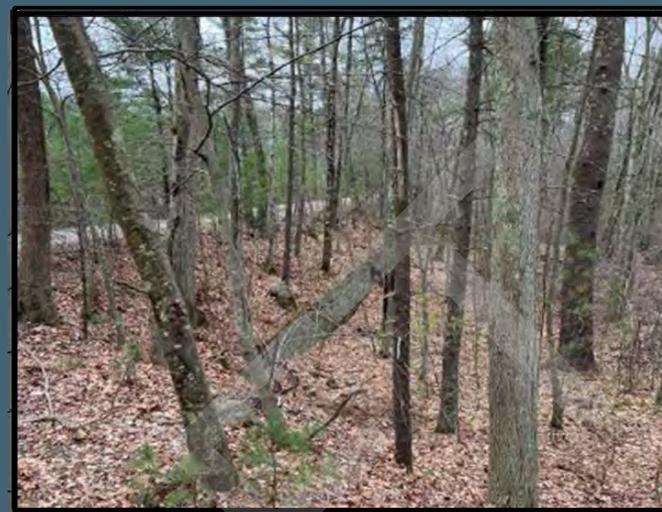
Reach C (Village)

- 25 w/ potential for EAD
- + 5 from Mtg Input
- Mill Site #1
