APPENDIX A:
Supporting Graphics

Graphic #1: Overview of the study area. (Report Section 1.0)

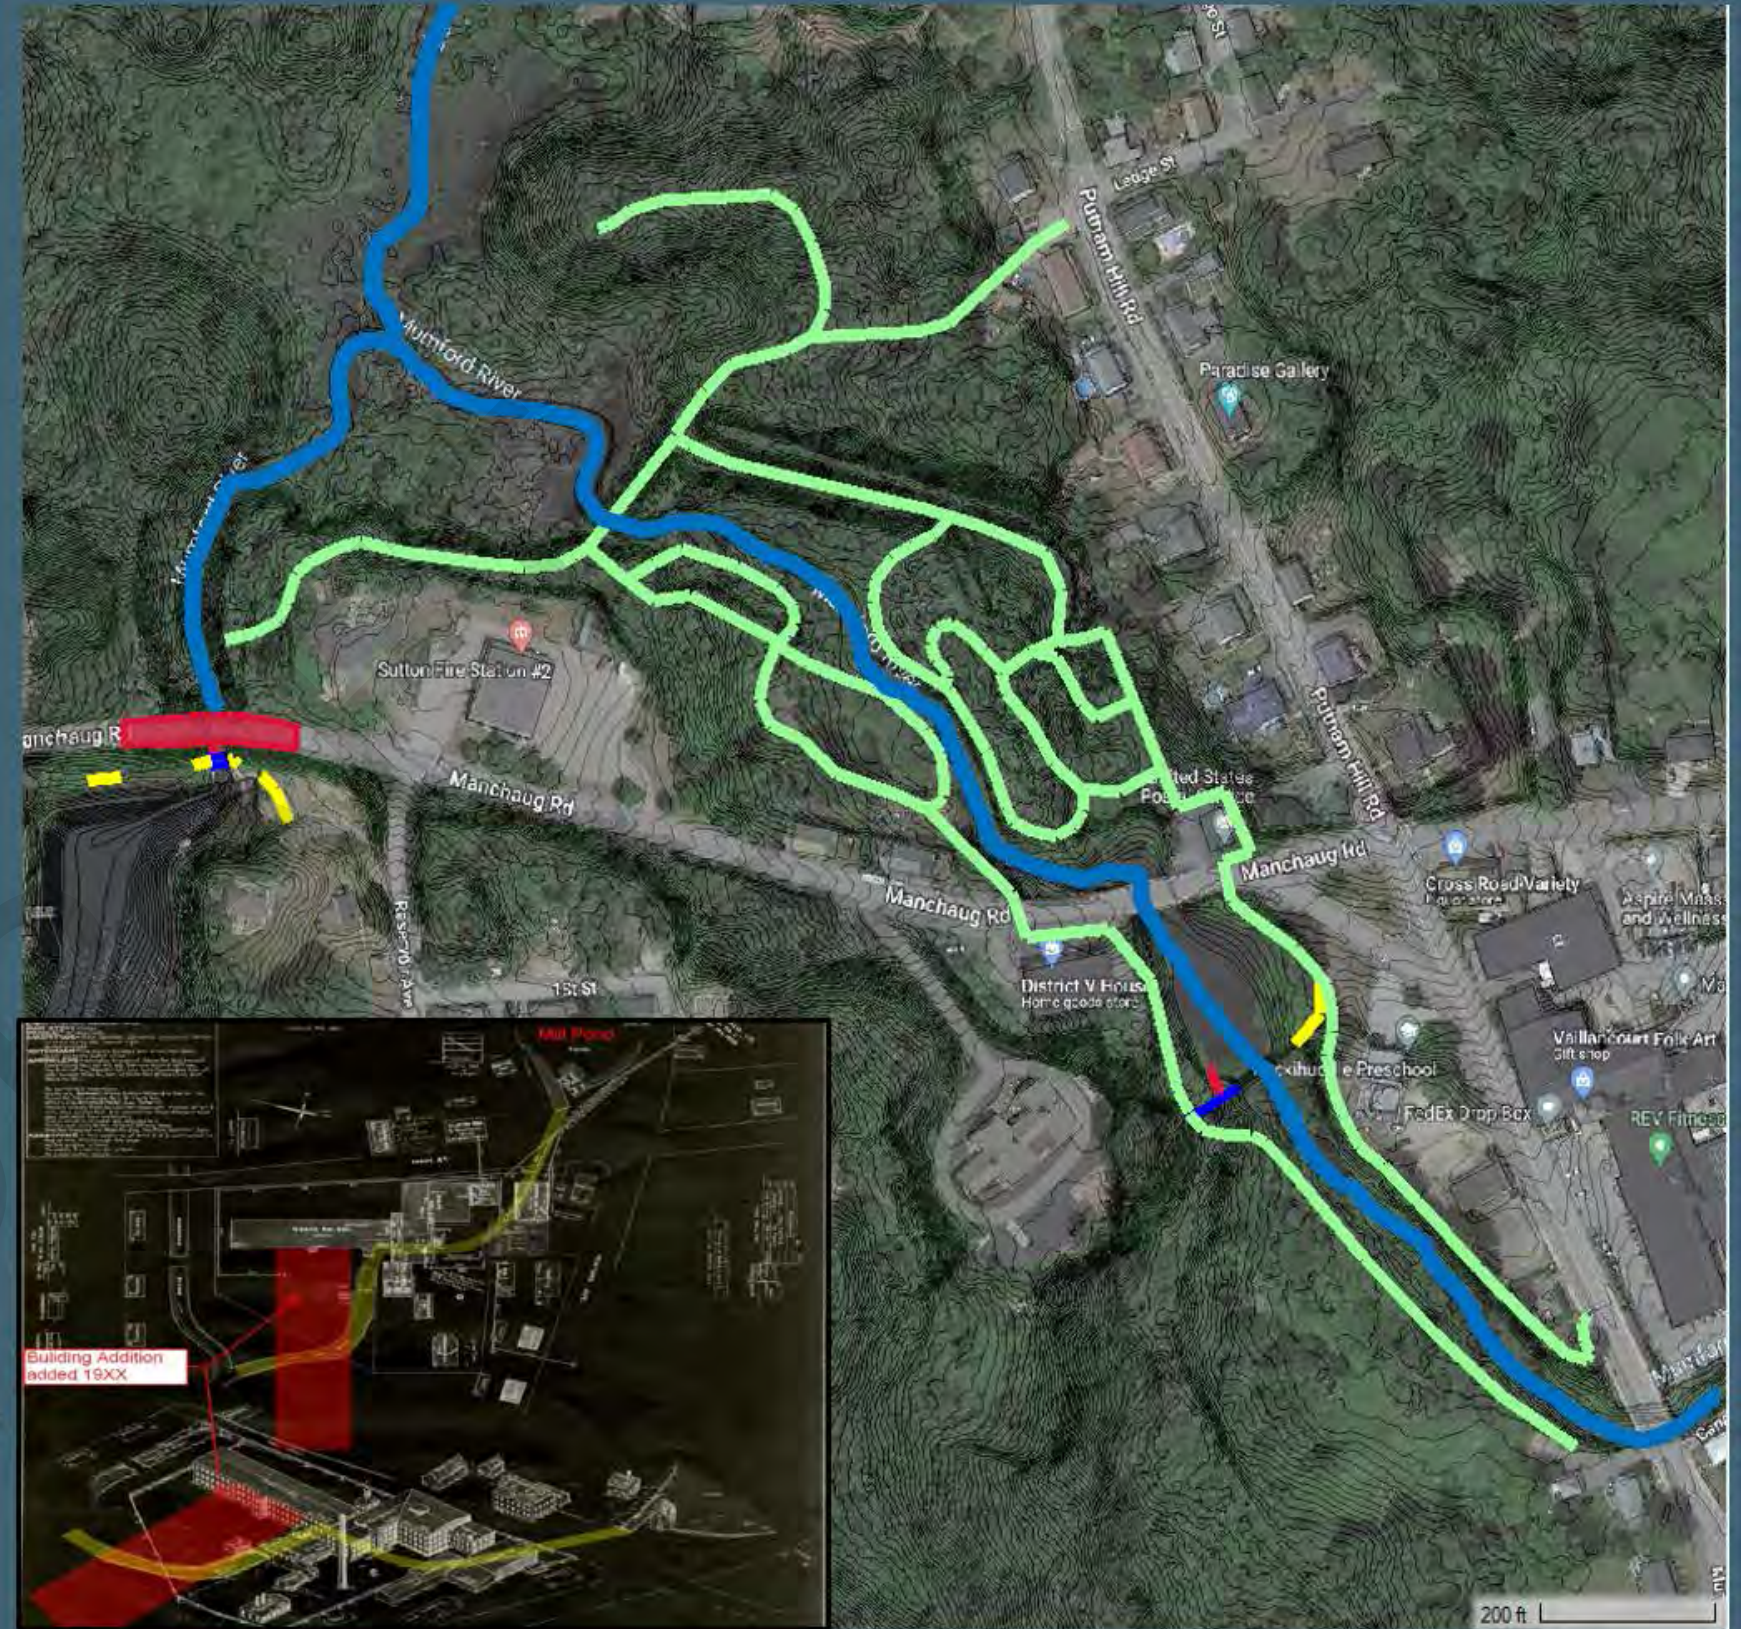
1. **Trails:** Establish trails with educational & recreational amenities throughout the historic mill sites
2. **Mill Site Restoration:** Restore certain features of Mill Sites #2 and #3 with educational amenities
3. **GSI:** Incorporate GSI along trails with educational amenities: Fire Station, Post Office, others

1. **Extend "Waterfall Spillway"**: Extend the waterfall spillway 60 feet right to the right abutment.
2. **Low Level Outlet (LLO) Controls**: Install new upward operating orifice gate; automate operations.
3. **Impoundment Dredging**: Dredge impoundment
4. **Abandon Sluiceway**: Formally plug/abandon sluiceway to Mill Building #1

Graphic #28: Reach C (Mumford River – Manchaug Village) Solutions – Mill Site Trails & Mill Pond Dam #1 Modifications (*Report Sections 6.3 #8 and 8.3.1.1*)
